**Document ID:** IK1201012

**Title:** SPN 731 FMI 16 Knock Detected: Cylinder Acceleration above Normal

**Applies To:** All 2010 MF 11/13, 2013+ N13 Big Bore Engines with the latest 3.15 Software Level (Calibration ID xxxxARxx or higher)

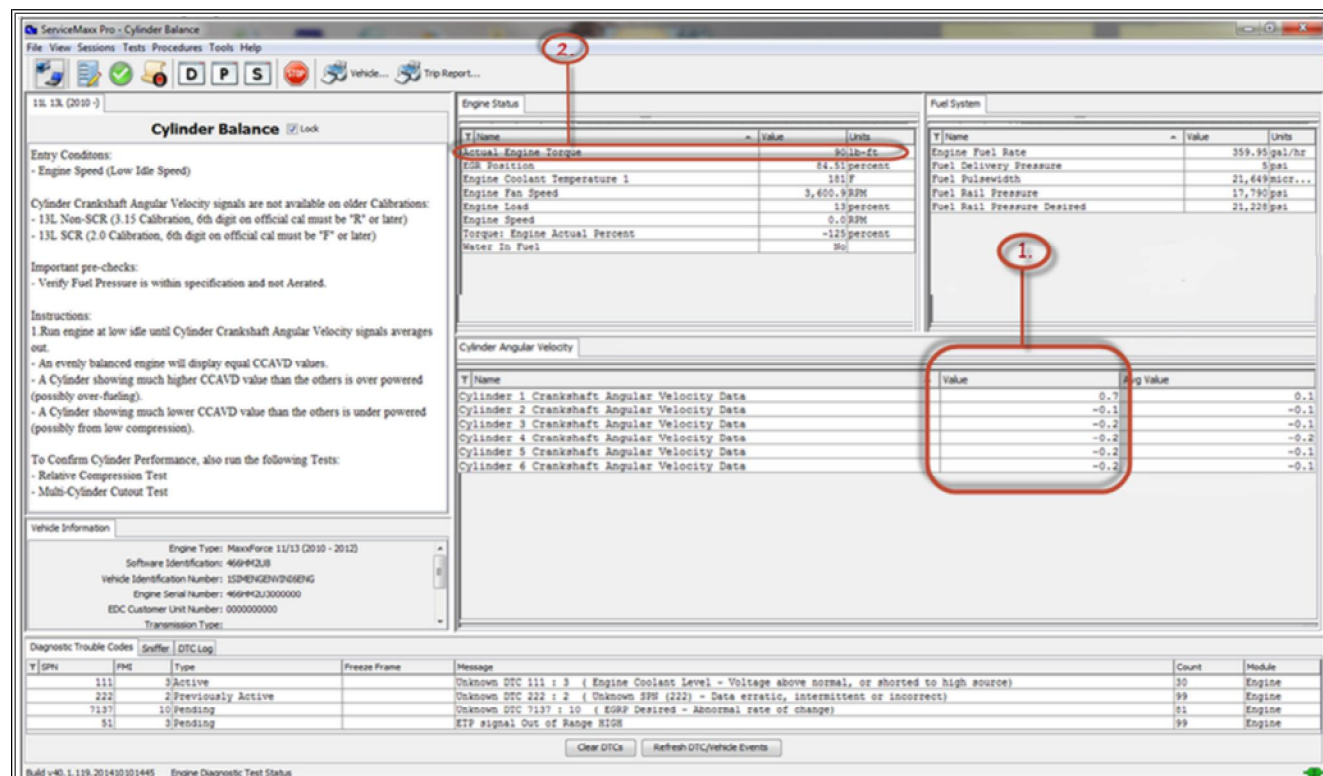
Figure 5. Screen Shot of Cylinder Balance Session

Cylinder 1 is reading the highest and is not consistent with other 5 cylinders that is the suspected cylinder causing the fault.

Item 1: Cylinder (x) Crankshaft Angular Velocity Data - Values  
Item 2: Actual Engine Torque Value

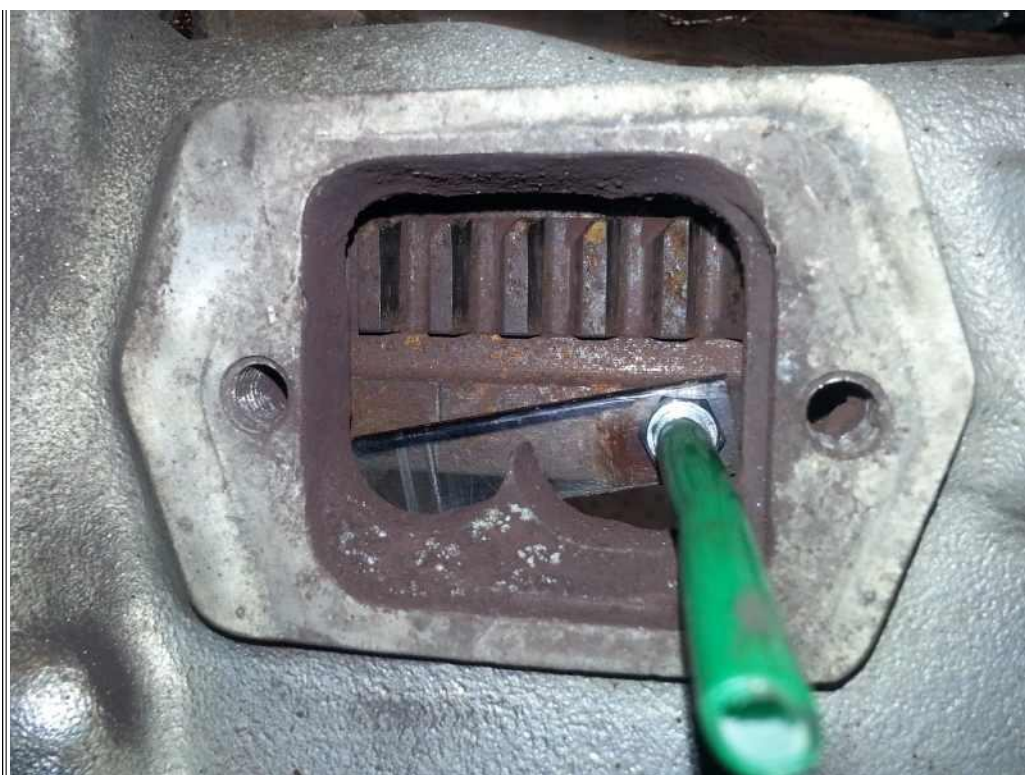
**Figure 2: Flywheel Timing Tool Installed**

Note: Tool is angled away to show flywheel timing mark, relative to the tool mark.
