**Document ID:** IK0900087

**Title:** Low Power No MIL Diagnostics

**Applies To:** 2010 MaxxForce 11, 13L Engine

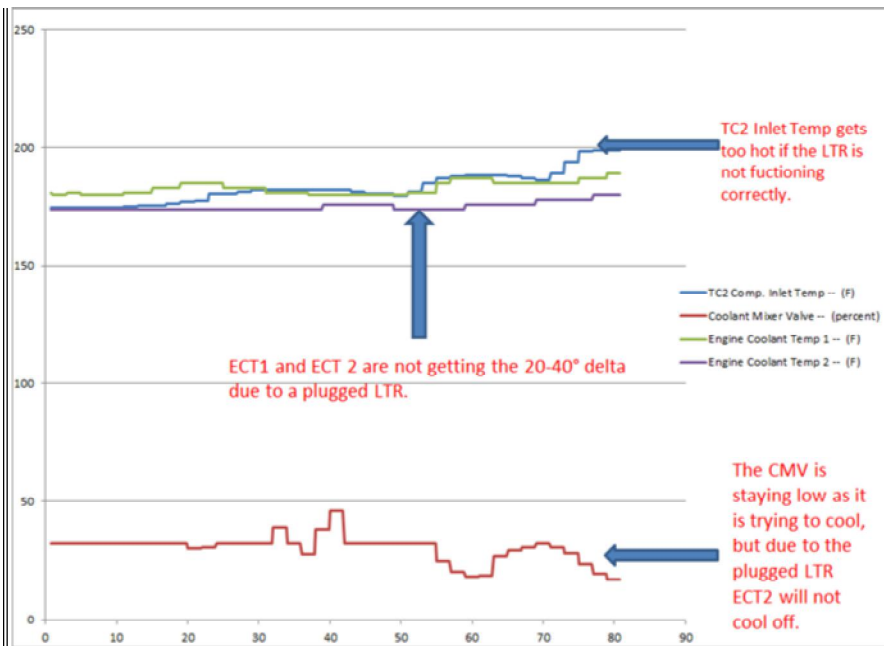
**Example Snapshot(s)****Graph 1: Plugged LTR**

Snapshot of a Plugged LTR

| Step | Action | Decision |
|---|---|---|
| | | No: Replace the LTR. Add Phosphate conditioner p/n 2611268C1 in cooling system when replacing the LTR. |

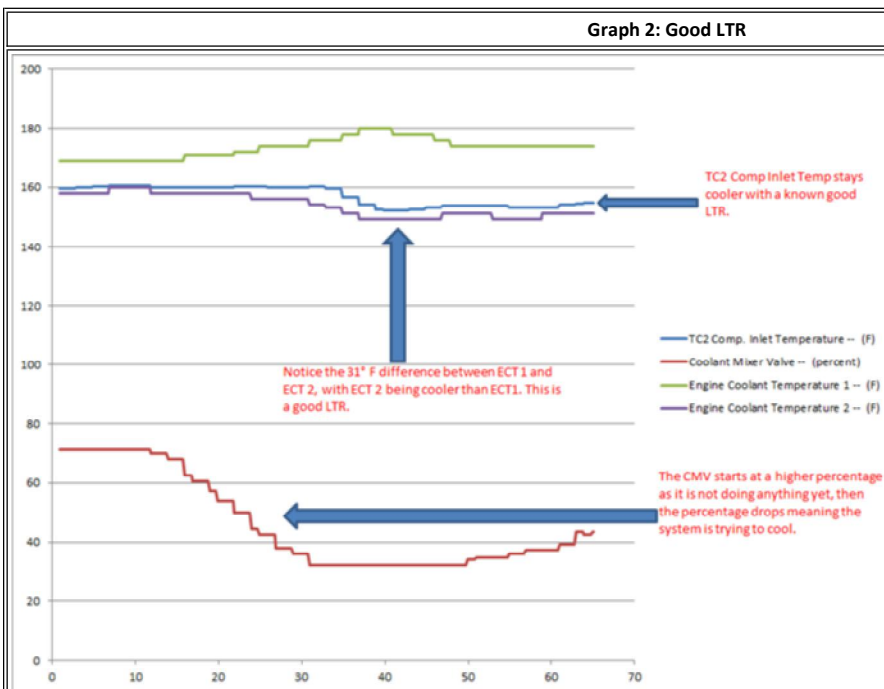
Snapshot of a Clean LTR
