Title: Eaton Clutch Information

Applies To: Transtar Workstar Prostar Lonestar

Information For Troubleshooting Eaton Clutch Complaints

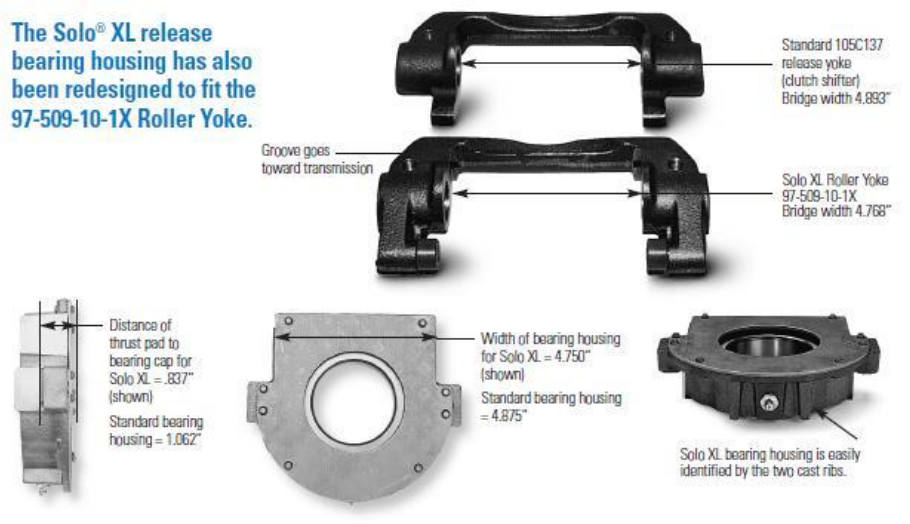
Figure 1

- Verify the part numbers you recorded with your parts department to insure you have the correct parts installed on the unit. **[It is possible to install a standard fork in a roller clutch resulting in poor clutch brake operation or possible fork hitting pressure plate when the pedal is fully depressed. See Figure 1]**
- A incorrect lever or cross shaft can also cause no clutch brake issues or interference issues.
- Install the correct part if you determine that the incorrect one was installed.
- Open a Parts Inquiry case file if you have questions determining the correct parts.
- Make sure cross shafts and linkage is lubed properly.
- Replaced seized hyme joints. **[They will break and leave the driver without clutch operation if the issue gets to severe]**

The Solo® XL release bearing housing has also been redesigned to fit the 97-509-10-1X Roller Yoke.
