Technical Service Bulletin

46 Brake pad wear warning - pads not at minimum

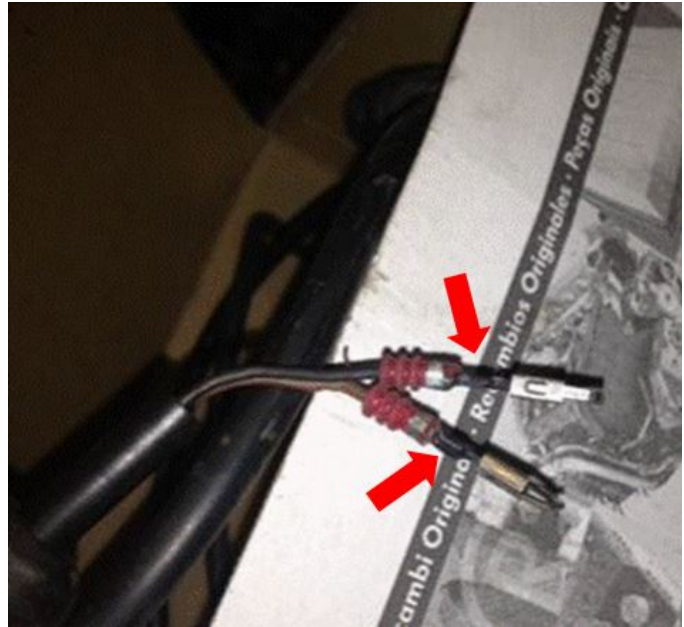
Figure 1. Corrosion (black deposits) on connector pins.
