Technical Service Bulletin

57 Remote control key low battery voltage warning in DIS (DTC B147918)

57 15 07 2039814/1 February 13, 2015.

Model(s)	Year	VIN Range	Vehicle-Specific Equipment
A3	2015	All	Not Applicable

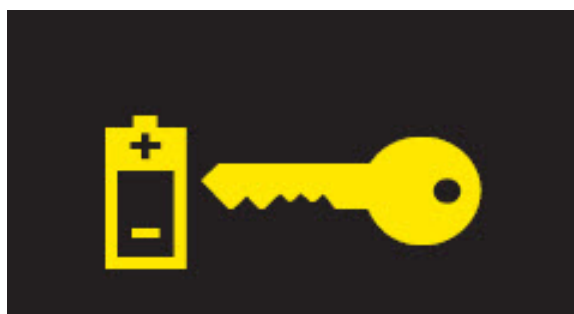
- A remote key low battery warning icon and the warning message “Please change key battery” appear in the instrument cluster (Figure 1).
- **DTC B147918** (Remote key 1 voltage too low) is logged in the vehicle electrical system control module (BCM1), J519 (address word 09).
- The remote key battery is correct.

Figure 1. Warning icon in instrument cluster for remote key low battery.

Incorrect diagnostics for determining low remote key battery voltage in the software of the vehicle electrical system control module (BCM1).

1. Update the software and parameters of the vehicle electrical system control module (BCM1) using the instructions below. The parameter part number and version can only be seen after the SVM code completes.
2. After the software update is complete, test by unlocking and starting the vehicle multiple times to ensure that the low battery warning does not return.
