66 Outside mirrors noisy when folding in or out

66 15 54 2025323/4 June 19, 2015. Supersedes Technical Service Bulletin Group 66 number 12-20 dated April 9, 2012 for reasons listed below.

Model(s)	Year	VIN Range	Vehicle-Specific Equipment	
Q5	2009 - 2013	All	Power folding mirrors	
A6	2012 - 2013	All	Power folding mirrors

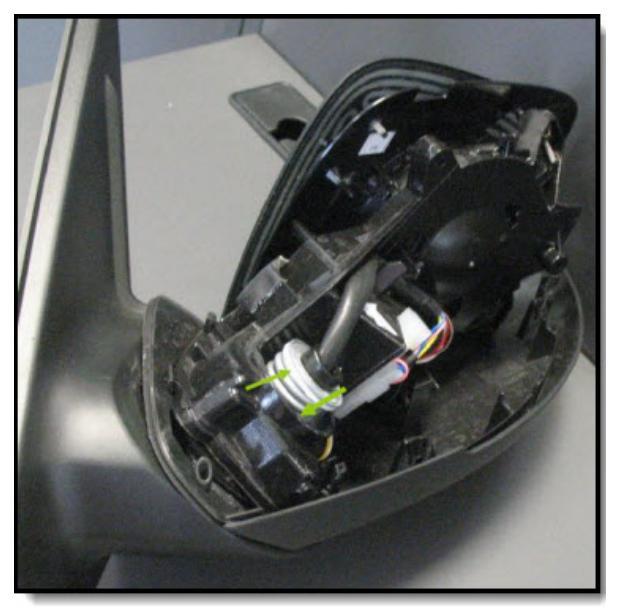
Figure 1. Driver Side view mirror with cap removed.

1. Remove the housing cap to the exterior rearview mirror housing as indicated in the Elsa Repair Manual (Figure 1).

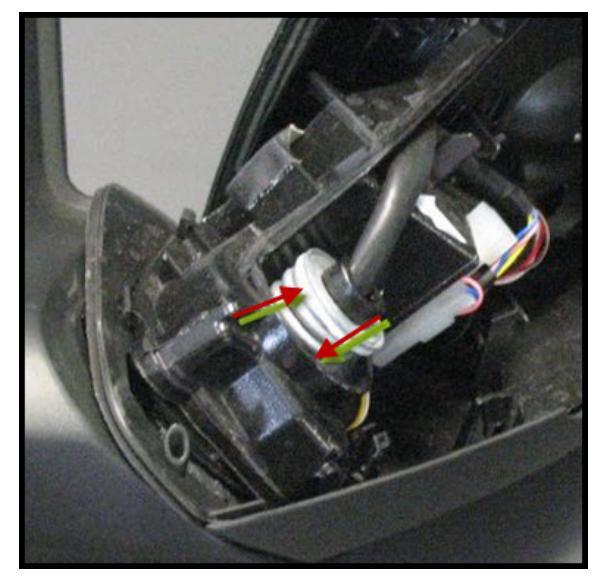
The noise originates in the metal spring inside the hinge area of the mirror housing. This spring is used for stabilizing the mirror when the vehicle is driven over rough roads to minimize mirror glass shake. When the mirror housing is folded in or out, the spring must turn or twist with the movement of the housing. The bottom and the top of the spring sit on a plastic base and due to increased friction at these contact points, the spring will skip along the plastic base during the folding operation and creates the noise. The normal functionality of the mirror is not affected.

Figure 2. Arrows indicate the areas requiring *lubrication.*

2. Lubricate the spring and plastic surfaces (Figure 2) with grease (G 000 450 02).

- 3. Operate the power folding mirror feature by locking the vehicle and starting the engine multiple times to work the grease in to the spring contact areas. Repeat until the noise is gone.
- 4. If the noise cannot be eliminated, open a Technical Assistance Center (TAC) ticket and contact a TAC consultant for further instructions.
- 5. Reassemble the exterior rearview mirror housing. Ensure proper fit. Wind noises can be created if the housing is not fitted properly.
