#### 20 MIL on (DTC P045600 - EVAP system leak detected NVLD (very small leak))

20 15 48 2035073/10 October 15, 2015. Supersedes Technical Service Bulletin Group 20 number 15-46 dated May 15, 2015 for reasons listed below.

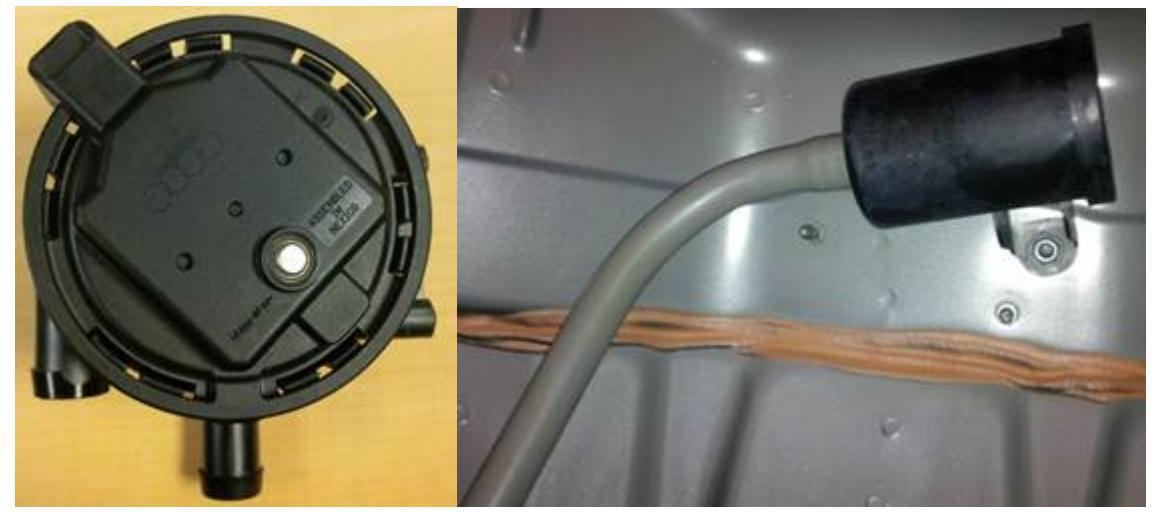
Figure 1. NVLD pressure sensor (left) and NVLD filter (right).

- 1. Ensure that **DTC P045600** (EVAP System Leak Detected NVLD (very small leak)) is stored in the engine control module (ECM), J623 (address word 01). If DTC P045600 is not present, this bulletin does not apply.
- 2. Replace the NVLD pressure sensor G400 and the NVLD filter with the latest part number available (Figure 1).

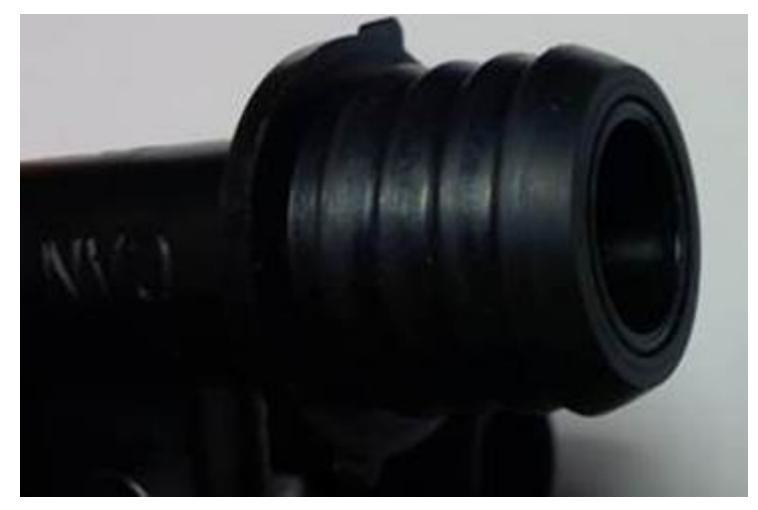
Figure 2. Align grommet and sensor outer edges.

• Align grommet and sensor outer edges (Figure 2).

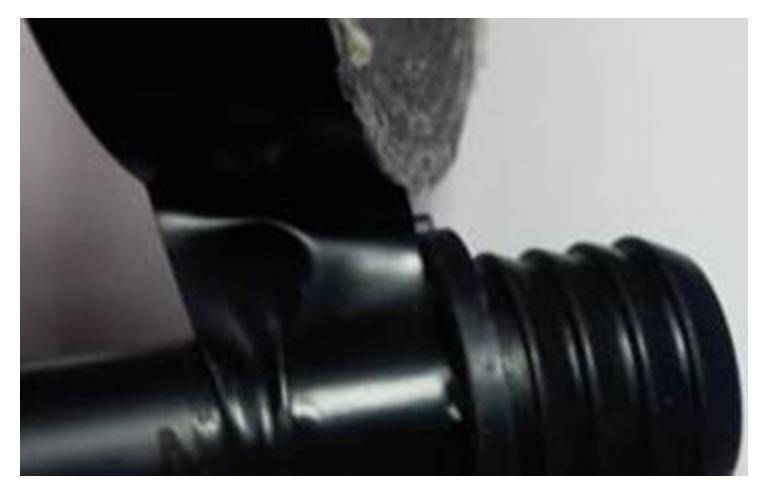
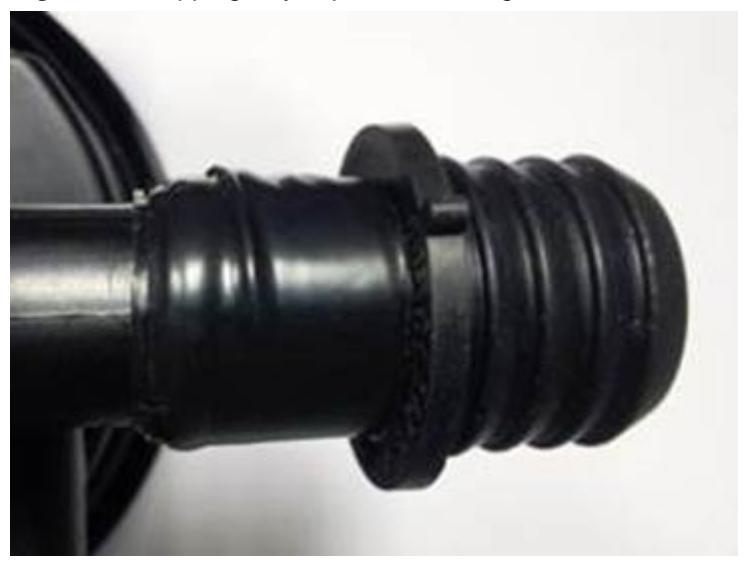
Figure 3. Wrapping vinyl tape behind the grommet.

Figure 4. Vinyl layer supporting grommet.

• To aid installation, wrap several (~10) layers of vinyl tape behind the grommet to ensure that it does not slip during installation (Figure 3 and Figure 4).

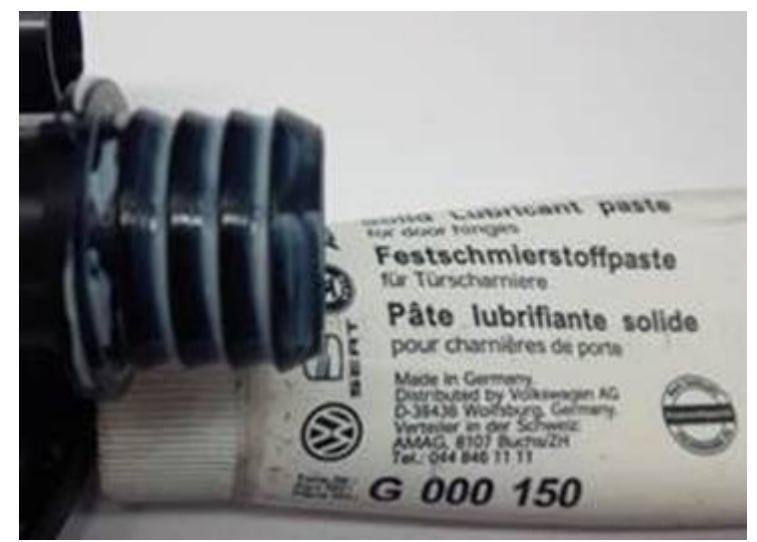
Figure 5. Grease film on outer surface of grommet.

• Apply a small amount of grease to create a film on the outer surface of the grommet before installing the sensor (Figure 5).

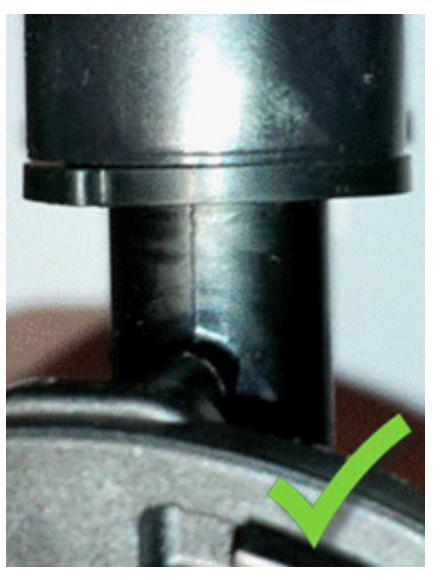
Figure 6. Correctly-installed sensor and grommet.

• When the sensor and grommet have been correctly installed, the grommet and canister will be flush (Figure 6). At this point, the vinyl tape can be removed (or it can be left in place).

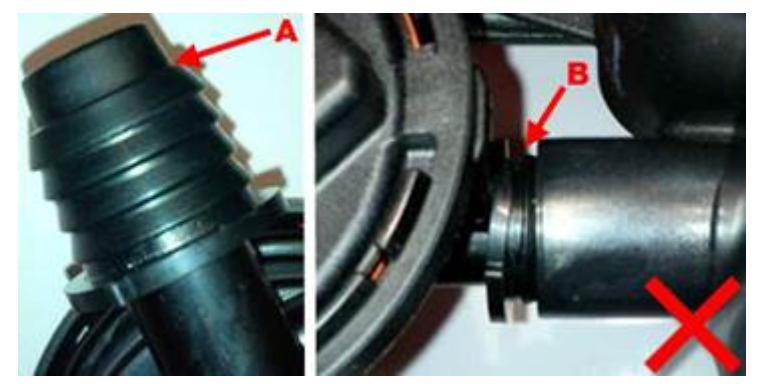
An incorrectly-installed sensor and grommet (Figure 7) can cause an EVAP leak and repeat failures. Issues can occur when the NVLD switch is pressed too far into the canister, then pulled back out in an attempt to align the NVLD switch with the mounting holes.

*Figure 7. Plastic port extending past the grommet (A) causing installation issues (B).*

Do not apply any lubricant between the sensor and the grommet.
