VW Elsa Newsletter

Edition 144: July 13, 2015

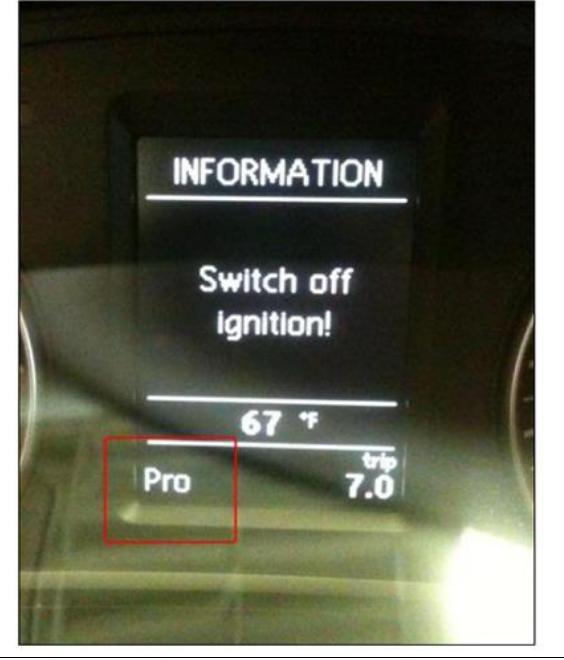
During PDI, or after installation of a replacement cluster, "Pro" may be displayed in place of the odometer. The high beam indicator may be flashing in the instrument cluster as well. This indicates the cluster is in Production mode. Production mode is not the same as "Transport" mode.

To remove Production mode go into VSD>Address 17 – Instrument Cluster>Adaptation>Select either channel 22 if available, or the listing for Production Mode. Toggle Production mode 'OFF">save and accept>back out of address 17. Cycle the key and check the cluster display.
