**Document ID:** IK1201086

**Title:** EPA 2010 & 2013 (OBD) Maxxforce DT/9/10 EGR Cooler Diagnostics

**Applies To:** 2010 + MaxxForce DT, 9, 10, N9 & N10 (ESN 3,300,000 and later)

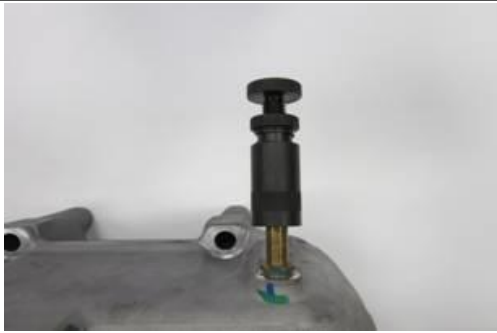
**Figure 3: Deaeration Fitting Plug**

Note: Do not over tighten as o-ring damage could occur and cause false positives

- a. Attach plug 20020-1 to the deaeration fitting, and tighten.

**NOTE:** Some kits do not contain this. In this case, a capped off piece of 3/8" hose will work. Ensure the connection/plug are not leaking.

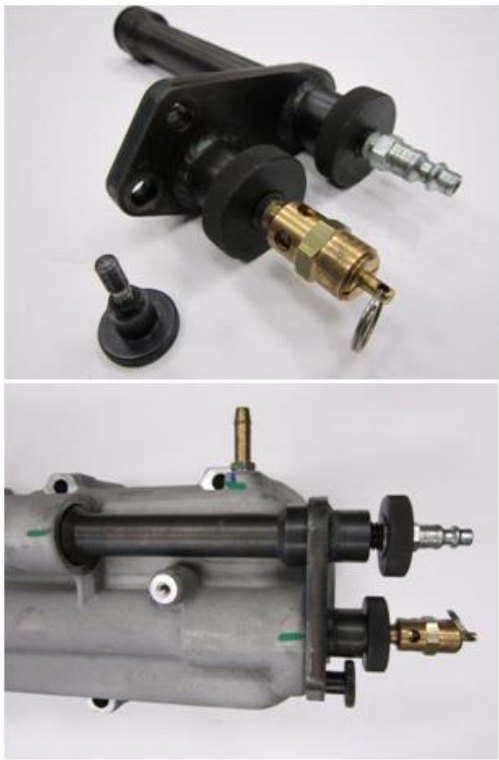
**Figure 4: Coolant Port Plug**

- b. Install the coolant port plug assembly (20020-2) into the coolant ports, as shown in Figure 4.

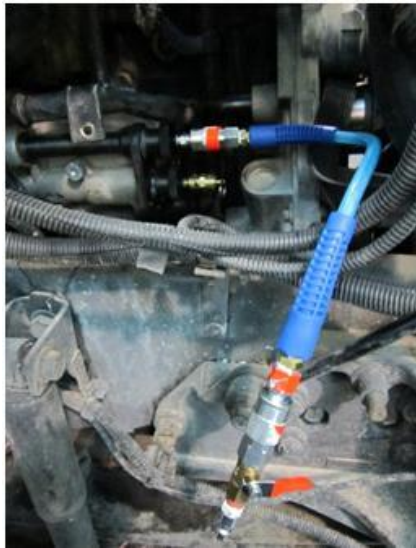
**Figure 5: Air hose extension and shut-off installed in chassis**

- c. Attach a pressure regulator with shut-off valve to air hose fitting on the coolant port plug. It may be necessary to use a short hose extension, depending on the chassis or shut-off valve.
8. Pressurize the EGR cooler to 55 psi, and close the air supply valve.
9. Monitor the gauge for 10 minutes
- a. Pressure drop **GREATER THAN (>) 5 PSI**--cooler failed, **REPLACE**
- b. Pressure drop **LESS THAN (<) 5 PSI**--cooler not failed. Continue using the procedure, "Coolant Leak to Exhaust/Intake" in the diagnostic manual.
