**Document ID:** IK1201245  
**Revision:** 7  
**Created:** 11/25/2014  
**Last Modified:** 6/22/2015  
**Author:** Michael Sokolowski

**Title:** 2010+ DT/9/10 EGR Valve Diagnostics

**Applies To:** 2010+ MaxxForce DT/9/10

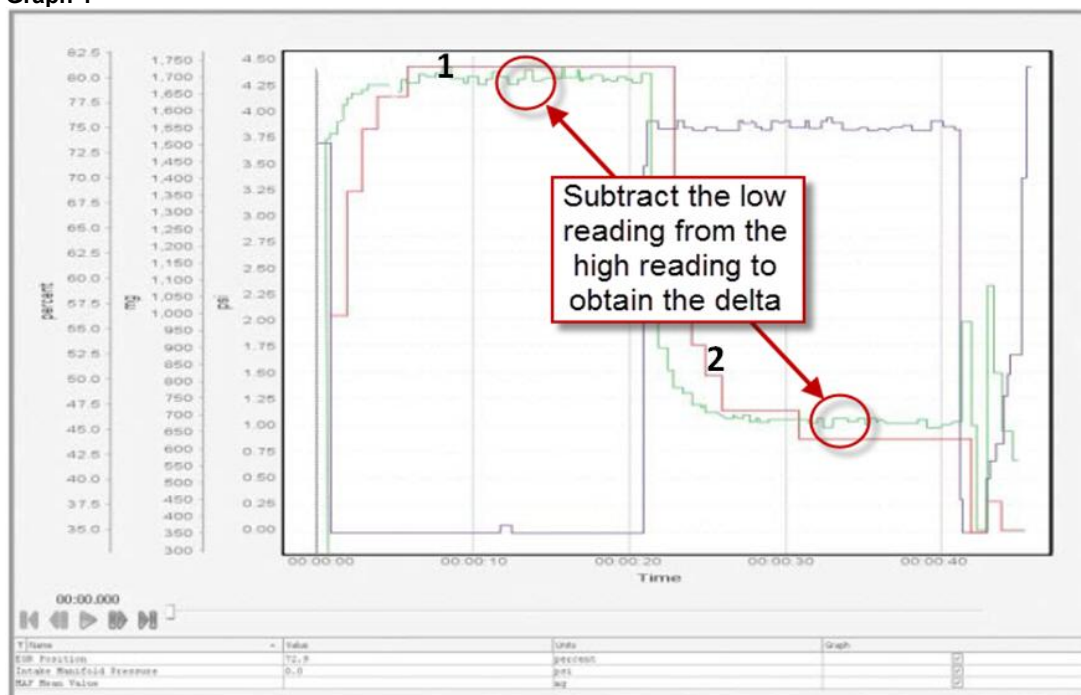
Graph 1

| | Did the MAF sensor calibration run successfully? | 2659 FMI 21/14/10. If code remains, continue to step 4 |
|---|---|---|
| 5 | Perform & Record Air Management Test.<br>MAF Mean Value Delta obtain the reading by subtracting the high reading in the beginning of the test to the low reading near the end as shown below in Graph 1:<br><br>1. 466 ST $\geq$ 690 mg<br>2. 466 HT $\geq$ 740 mg<br>3. 570 $\geq$ 850 mg<br><br>Intake Manifold Pressure (IMP) Graph 2:<br><br>1. 2 - 6 PSI<br><br>Does Air Management test meet specifications listed above? | <b>Yes:</b> No further action required<br><br><b>No IMP:</b> Go to step 6<br><br><b>No MAF Delta:</b> Go to step 7 |

1. MAF Mean Value High Point (mg)
2. MAF Mean Value Low Point (mg)
