Document ID: IK0800080

Title: 1939 Data Link Troubleshooting

Applies To: All models EXCEPT ProStar / LoneStar.

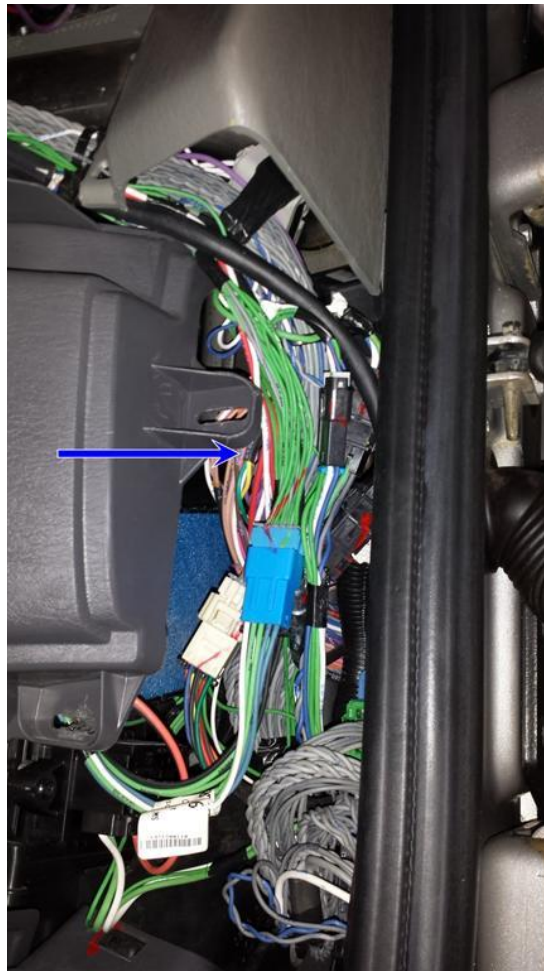
- 6/9/2014 - Recent information from the field has shown a potential failure location
- A poor connection on the splice the ties the ABS module into the Back-bone of the data link was found on multiple units
 - This splice is in the cab, and the harness is common between multiple chassis and engine platforms
 - At this time (6/9/2014) the earliest build date affected is 09/23/2013

Crimp location: Right side of cab above the ABS module, next to the HVAC box. The condensation module (if installed) will be zip tied to or near the splice.

- If you have these faults and the vehicle build date is near August 2013 or Newer you will need to troubleshoot this splice in the data link if no obvious failures are found
- Follow the harness from the ABS module to the Data Link Backbone. Once you locate the splice, wiggle test that connection (also twist the spice in your fingers) while monitoring the data link resistance. (If a resistance check does not show any fault, repeat this test monitoring data link voltage as well)
- Cab temperature was effecting the data link behavior in one of the vehicles found to have this issue

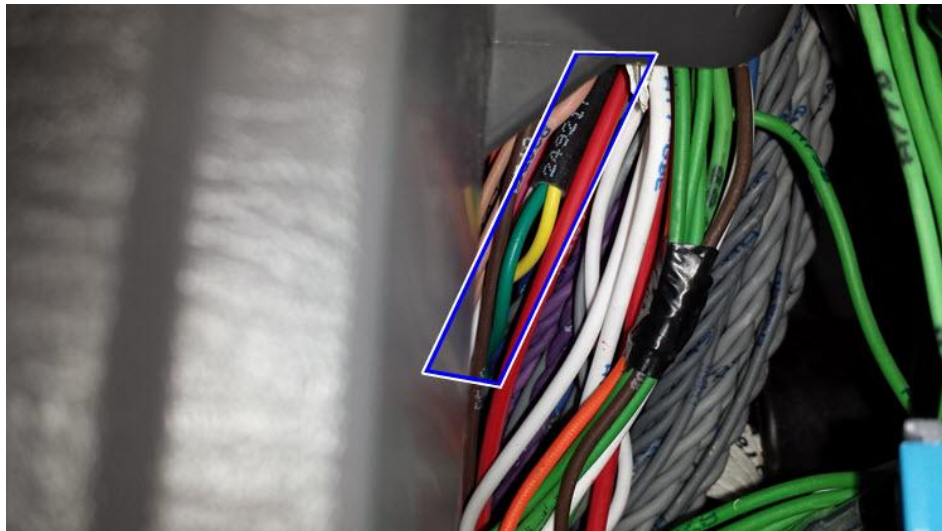
Close view of crimp location

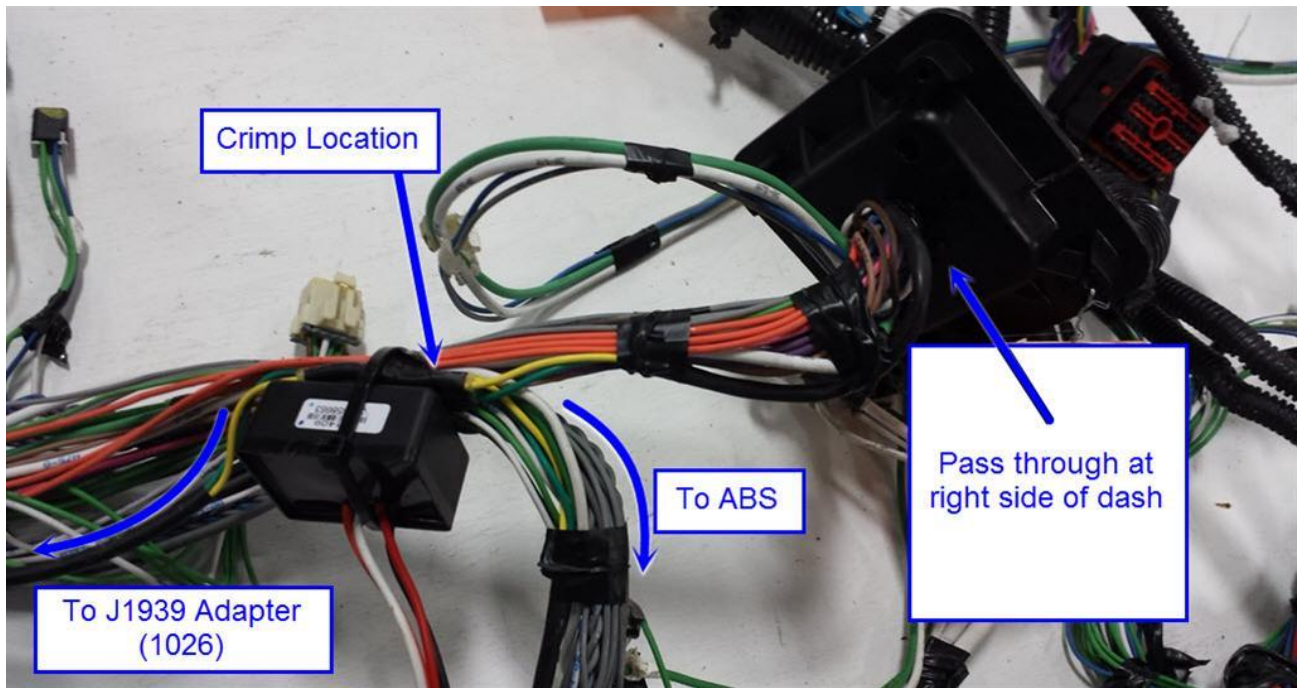
Harness removed from truck for identification

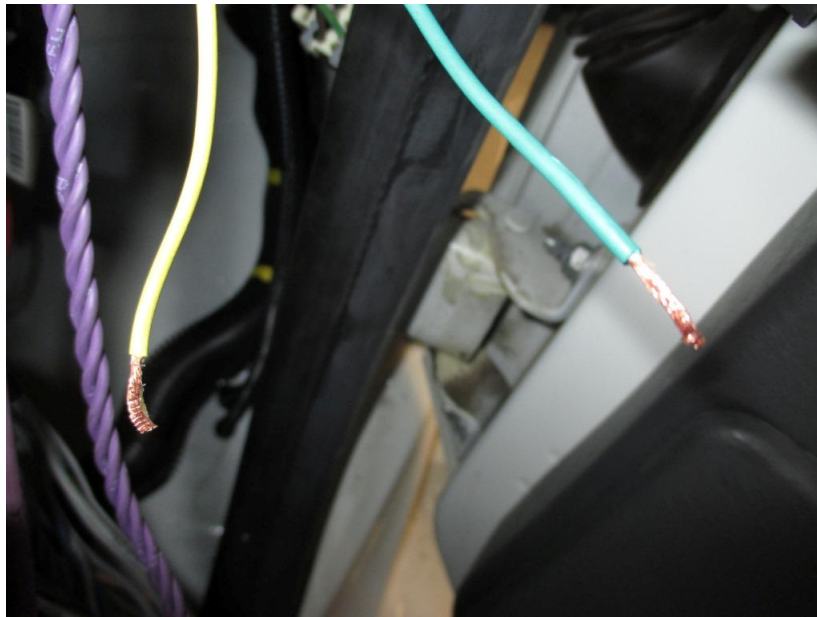
Wire condition at crimp to ABS module

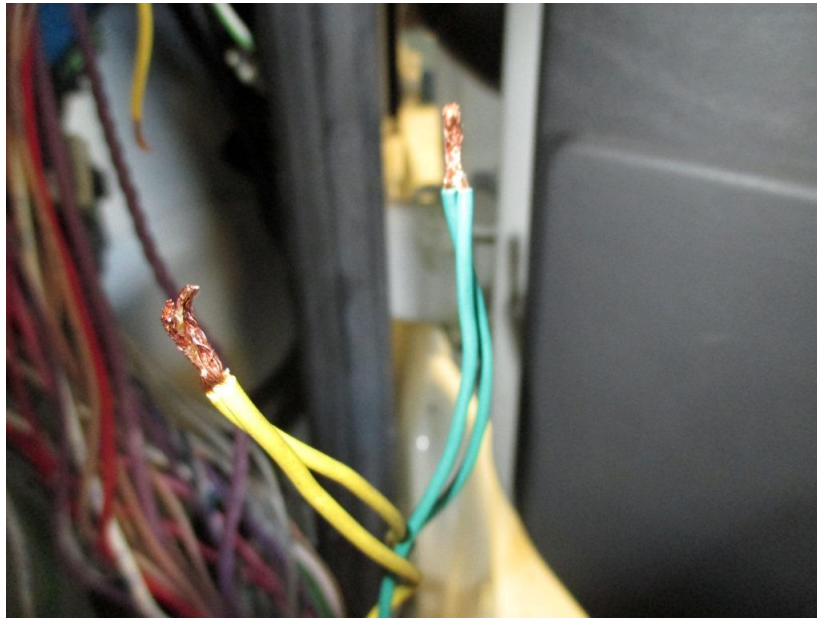
Wire condition at crimp to ABS module (2nd photo)
