STAR CENTER NEWS

STAR Center News

Nov/Dec 2015

No. 88

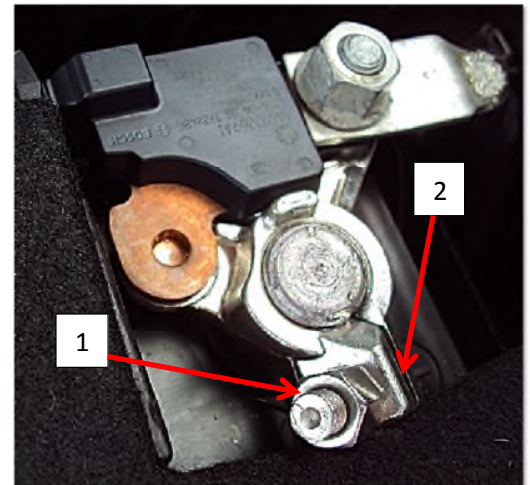
Service Procedure for KL Negative Battery Cable/IBS Module

Due to incidences of damage to the IBS module occurring during the performance of service procedures, please be sure to adhere to the following recommendations when removing and installing the negative battery cable/IBD module.

1. Loosen M6 captive hex nut (1) without removing.
2. Insert medium-sized flat end of screwdriver in pole clamp slot (2).
3. Lightly tap screwdriver to open pole clamp slot to 3mm max.
4. Carefully lift IBS module upward to remove it from the negative battery post.

1. Place IBS module onto negative battery post and push down to ensure it is properly seated.
2. While applying downward force (20N max) on IBS module to prevent

rotation, tighten M6 captive hex nut to 7Nm +/- 1Nm.

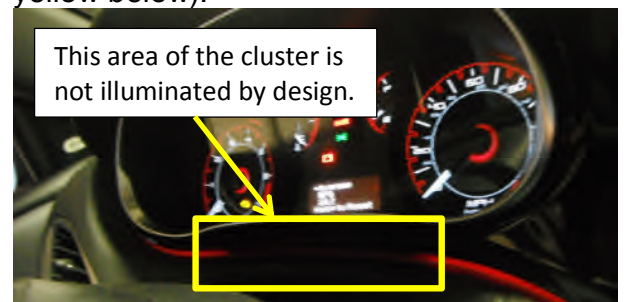
PF Lighted Cluster Bezel Appearance

The lighted feature on the cluster bezel for the PF is not lit in the area above the steering wheel shroud by design (area in yellow below).

If a customer notes this, explain that it is by design intent and that all Darts equipped with the lighted bezel feature have this appearance. Comparison to another PF that is similarly equipped may be helpful.

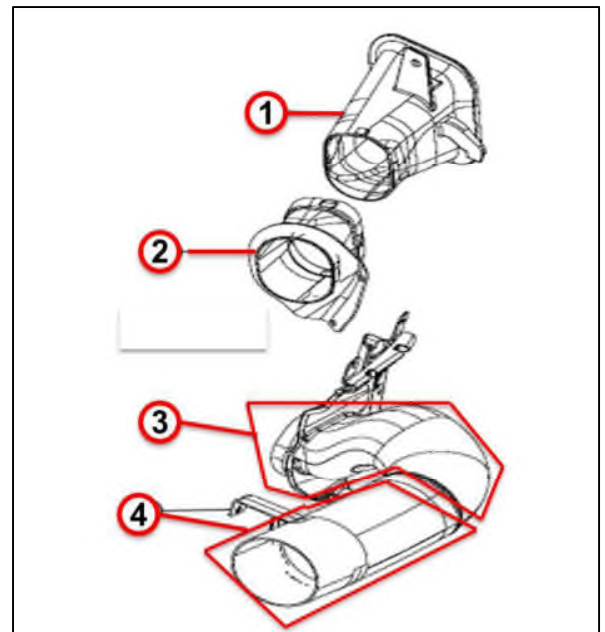
Some customers may experience a premature "Service Air Filter" message displayed on the EVIC. The mil may also be illuminated when this occurs. If the MIL is on, fault code P2280 - AIR FLOW RESTRICTION / LEAK BETWEEN AIR CLEANER AND MAF is likely to be set in the PCM. This condition may occur on vehicles with relatively low mileage.

The message in the EVIC as well as the DTC is intended to inform that the air filter has become restricted, requiring replacement. However, other inlet restrictions may also trigger the message and fault. Other possible causes are:

1. Debris blocking the Air Inlet Adapter or Ambient Air Duct (1) and (2).
2. Blocked air intake shield plastic tube (3).
3. Collapsed air intake shield porous tube (4).

Before replacing the air filter, make sure to remove the inlet shield ducting (3 and 4) to the lower portion of the air box.

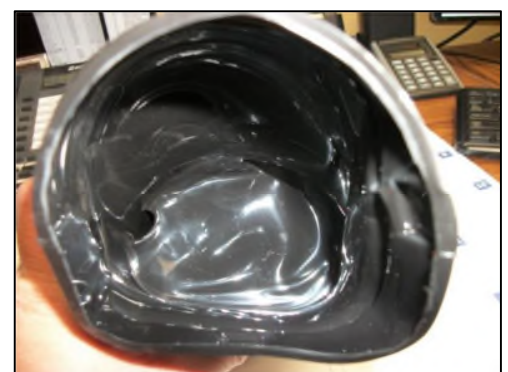
Inspect for signs of flashing material in the air intake shield plastic tube (3) (see photo below).

If both pieces have no problem found, replace the air filter.

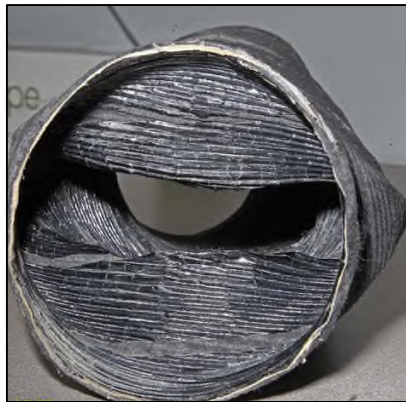
Also inspect for a collapsed air intake shield porous tube (4) (if equipped) (see photo below).

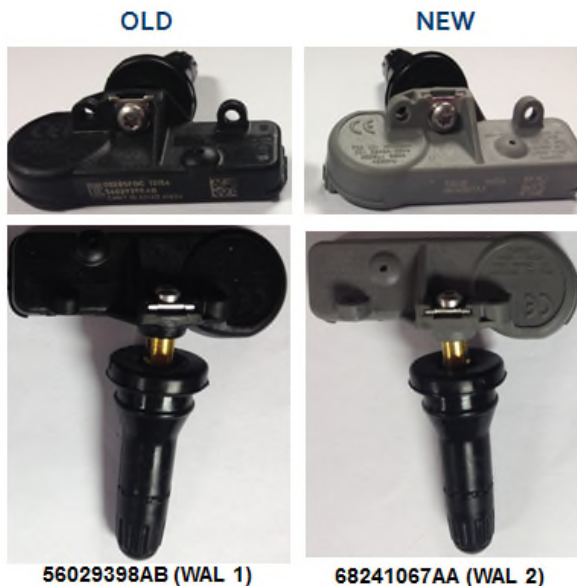
The old sensor, a Schrader WAL I model, is black. The new sensor, a Schrader WAL II, appears identical in shape to the WAL I but is colored gray to distinguish it from the old sensor.

New MY2016 production will use the new gray sensor and, as Mopar inventories are depleted, the gray sensor (68241067AB) should be ordered and used in place of the black sensor (56029398AB). Please, always refer to STAR PARTS to check for part supersedence. There is no change in installation procedures and the new sensor is interchangeable with the old sensor. Gray and black sensors can be mixed on the same vehicle. All four wheels do not need to use the same color sensor.

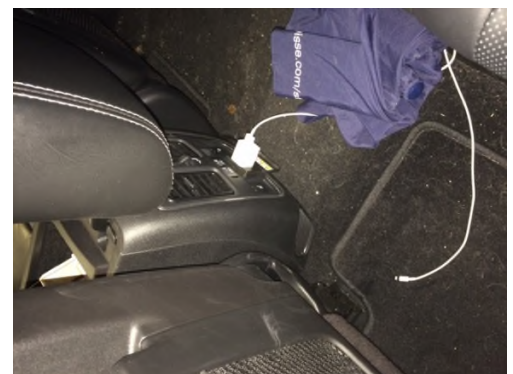
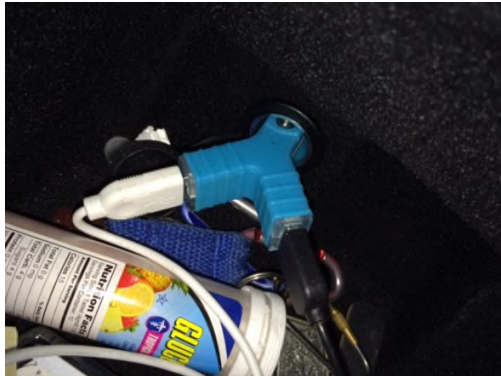
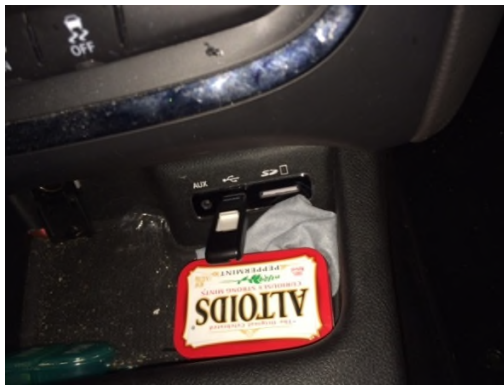
Our field technicians have been experiencing intermittent problems, ranging from the RKE not working to the Keyless Go indicating "KEY HAS LEFT THE VEHICLE", that are being caused by RFI from various charging and USB interface devices for portable electronics.

Examples of such devices are displayed below:

Your chances of identifying the cause of the customer's concern should greatly increase.

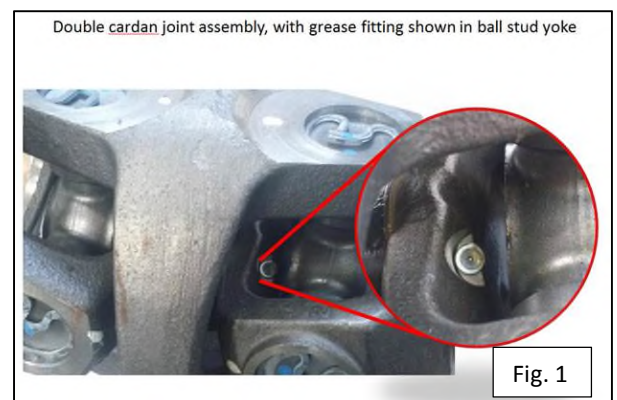
Fig. 1

The assembly has a small grease fitting in the middle of the joint (Fig. 1).

The fitting is actually a conical depression in the joint that has a small steel check ball at the bottom.

As a reminder, these double cardan joints require lubrication periodically.

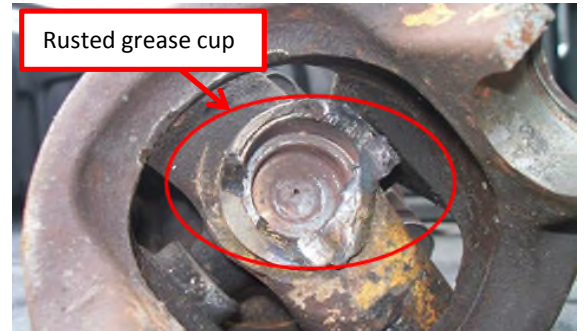
As pictured below, failure to lubricate this joint may lead to premature front propeller shaft joint wear and failure.

Rusted grease cup

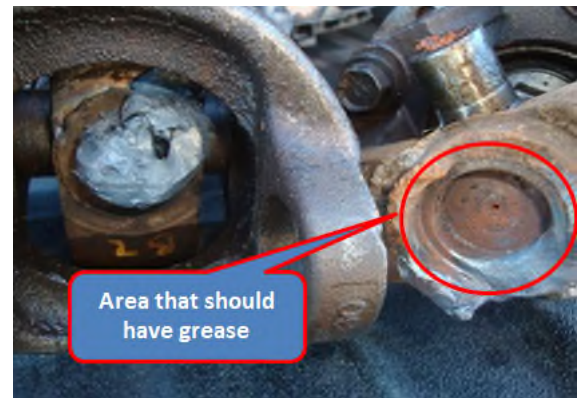
Area that should have grease

It is easy to see the evidence of a lack of proper maintenance after the joint has separated. Lack of grease in the cup area suggests that the joint was not maintained. Remember this failure and any collateral damage caused by it may not be considered warrantable failures.
