HYUNDAI NEW THINKING, NEW POSSIBILITIES. Technical Service Bulletin		GROUP	NUMBER	
		FUEL SYSTEM	15-FL-005	
		DATE	MODEL	
		OCTOBER 2015	2015~ Genesis (DH) 3.8L

DTC P0315 AND P0300

Description: Some Genesis (DH) 3.8L vehicles may experience the symptoms and/or both DTC as shown below.

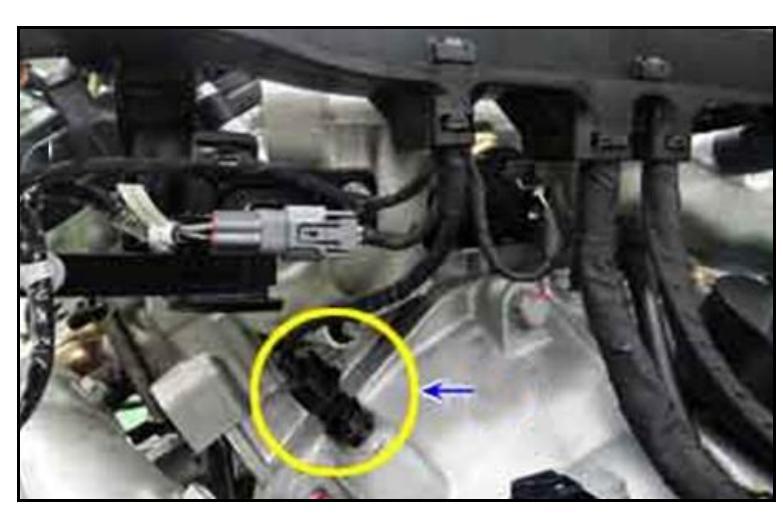
If the Actual Engine Speed shows the engine rpm about 600±50 rpm and continuously fluctuating, the wiring harness to the crankshaft position sensor <u>currently</u> has no open or short circuit. **Go to Step 2**. If not, repair or replace the control harness.

If cylinders #1, 3 and 6 have higher misfire counts than the other cylinders or both DTC are found, the C.P.S. wheel may be out of specification. **Go to Step 2**.

1. Attach a GDS and select VIN, **Engine** menu, **Data Analysis** and the parameters shown to the right.
