Service Bulletin

File in Section: -Bulletin No.: PIT5457 Date: September, 2015

Subject: Service ABS / TCS / Power Steering and/or Suspension Message DTC U0077 U0121 U0126 U0131 U0139 U0401 U0415 U0428 (Circuit 5986 High Resistance)

Models: 2015 Cadillac Escalade Models 2014 Chevrolet Silverado 1500 2015 Chevrolet Silverado, Suburban, Tahoe 2014 GMC Sierra 1500 2015 GMC Sierra, Yukon Models

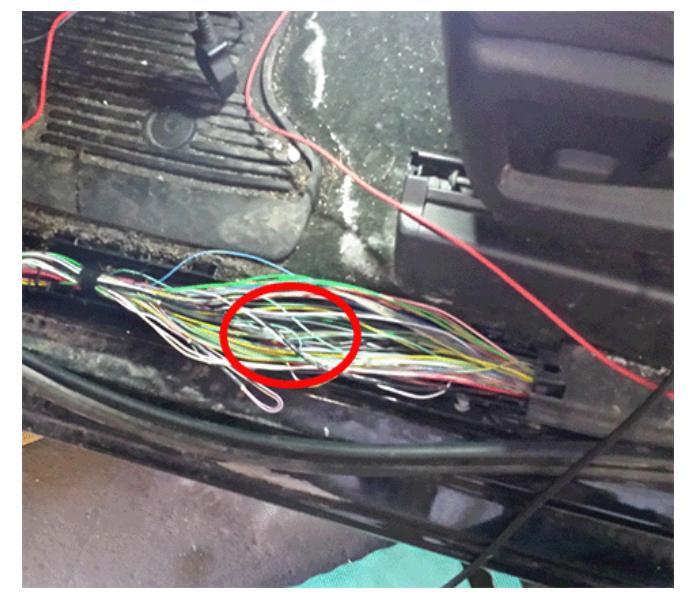
These concerns could be caused by high resistance/open in the Communication Enable circuit 5986. The BCM activates this circuit when the ignition key is in ACC, ON, and START positions (There will be voltage present in the OFF position only for a short time until the BCM goes to sleep). The communication enable circuit wakes up the module for serial data bus communication. Circuit 5986 will have approximately 12 volts and should light a test light, but is not designed to handle heavier electrical loads like a headlight bulb. Shown below are two known areas where circuit 5986 has been found to be open or have high resistance:

- 1. Under the driver's sill plate
- 2. Splice J365 located under the passenger front sill plate

Monitor the voltage on the communication enable circuit 5986 at any of the modules affected, example EBCM, PSCM, and/or SCM. If low voltage or no voltage is present when the concern occurs, inspect for high resistance under the driver's or passenger's sill plate area. Repair any opens or high resistance in the circuit.
