SAFETY RECALL BULLETIN

November 2015
15R-3 (FL-691)
NHTSA #15V-613
Transport Canada #15-485

Subject: **Detroit Axle Steering Arm Capscrew Replacement**

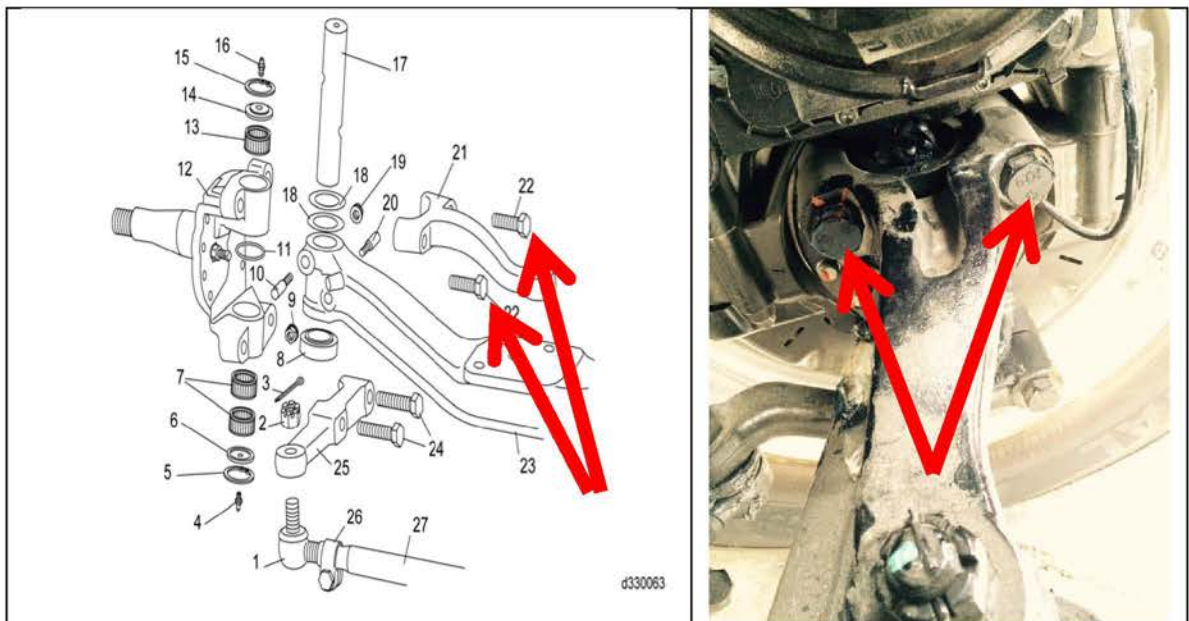
Figure 1 – Steering Arm Capscrew Location

On certain vehicles, the steering arm capscrews that join the steering arm to the knuckle may not have been torqued to specification. Loose steering arm capscrews may result in a loss of steering, increasing the risk of a crash.

1. Park the vehicle in the designated repair area and turn the steering wheel all the way to the left to expose the steering arm on the driver's side of the vehicle.
2. Apply the parking brake, turn off the ignition, chock the rear wheels, disconnect the batteries, and perform any other applicable safety steps.
3. Remove the two steering arm capscrews, and remove the steering arm.
Reference section "Disassembly of the Steering Knuckle" in the Front Axles chapter of the *Detroit Axles Manual* (DDC-SVC-MAN-0141). See Figure 1.

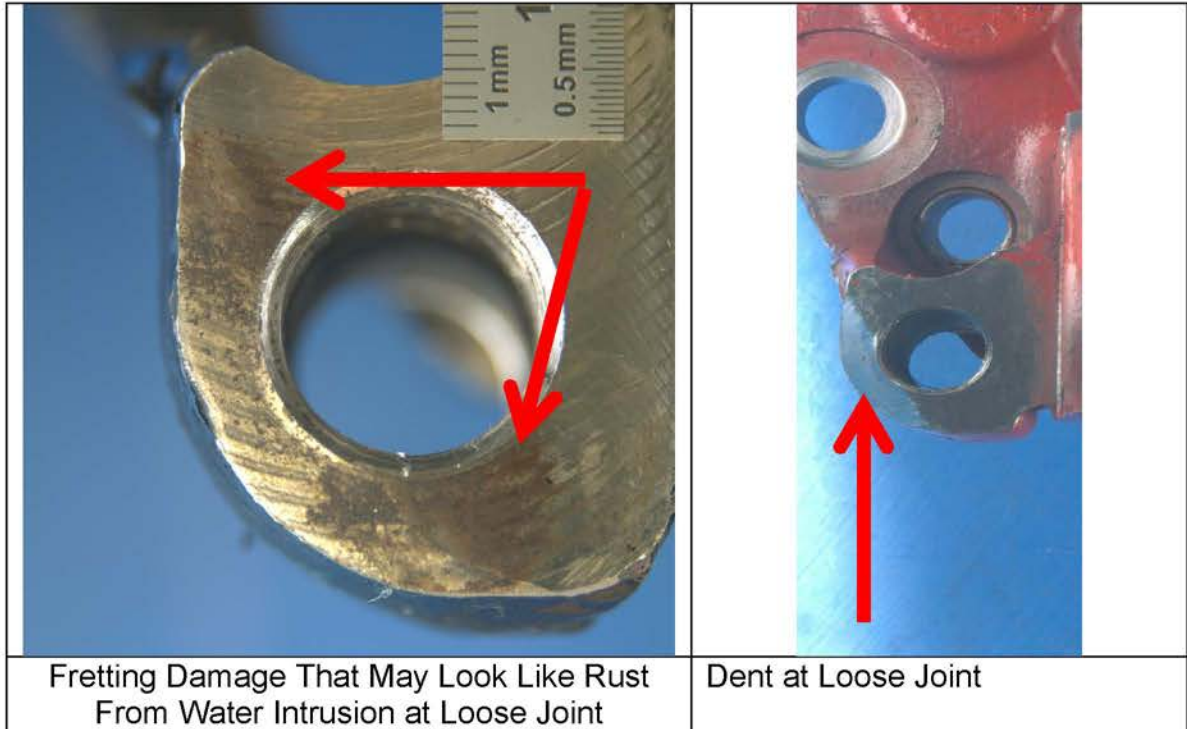
4. Inspect the joint surface between the steering arm and steering knuckle for signs of fretting, dents, or other damage from the loose capscrew(s). See Figure 2 for examples of damaged parts, and Figure 3 for an example of a new part.

Figure 2 – Damaged Joint Surfaces

6. **Remove the steering arm and steering knuckle.** Reference section “Dissassembly of the Steering Knuckle” in the Front Axles chapter of the *Detroit Axles Manual* (DDC-SVC-MAN-0141).
7. **Install a new steering arm and new steering knuckle.** Reference section “Assembly of the Steering Knuckle” in the Front Axles chapter of the *Detroit Axles Manual* (DDC-SVC-MAN-0141).
8. **Install two new steering arm capscrews.** Reference section “Assembly of the Steering Knuckle” in the Front Axles chapter of the *Detroit Axles Manual* (DDC-SVC-MAN-0141).
9. Repairs are complete.

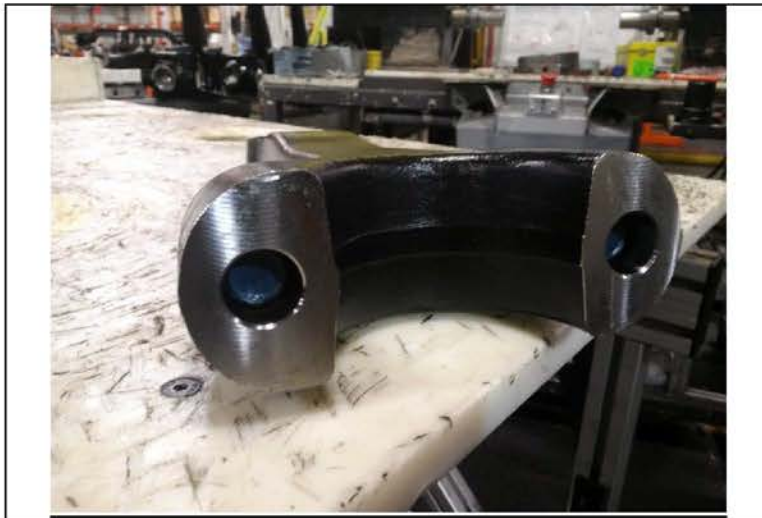
Figure 3 – New (Undamaged) Joint Surface
