# Service Bulletin

Date: April, 2016

#### Subject: Information Regarding Magnetic Drain Plugs

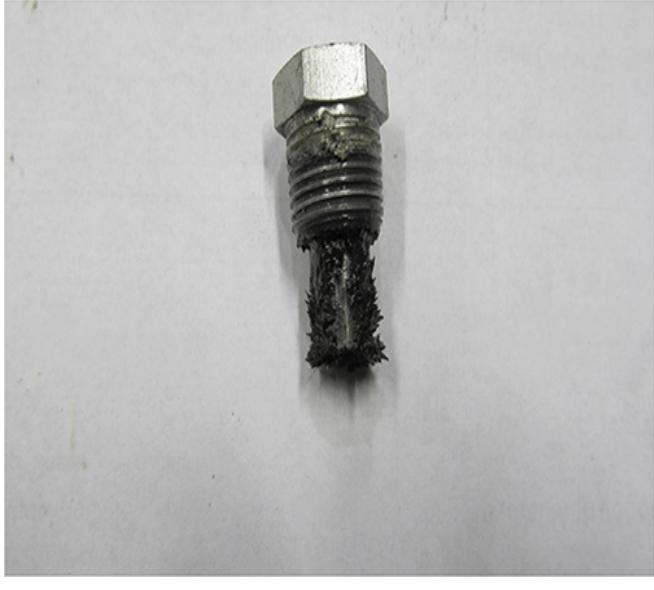
4488022

During service repairs and maintenance, inspect the drain plug for large metal deposits. Small metal flakes and fine metal dust on the plug magnet are considered normal.

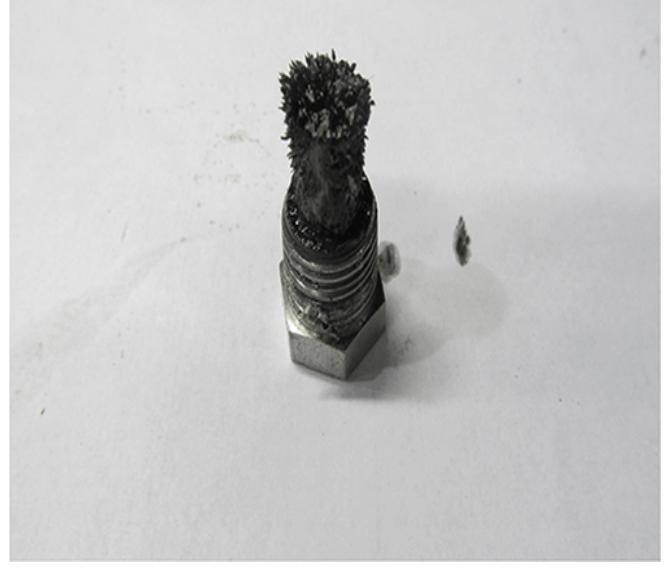
4488023

Fine metal particles, as illustrated above, are normal and are the result of internal component wear, which can shed fine metallic particles at a steady rate.

Metal shavings, which are often remnants from the housing machining process, may adhere to the plug magnet. These shavings are not detrimental to component operation and do not require component replacement.

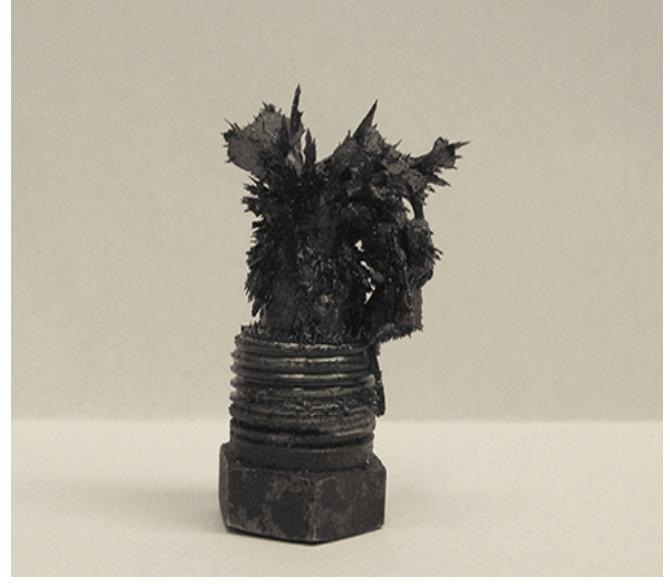
4488026

Fragments from bearings and gear teeth indicate component damage that is not considered normal. Components should be inspected for damage and repaired as needed.
