Model Type:	California / California T
Model Year:	All
Subject:	Procedure for checking RHT retractable hard top
This Technical	Information Cancels and Replaces the previous TI 2092 of April 2013

Information Request Form for RHT Retractable Hard Top Roof Faults Page 01 of 20 Model Updated on Ferrari California Classis number: September 2016

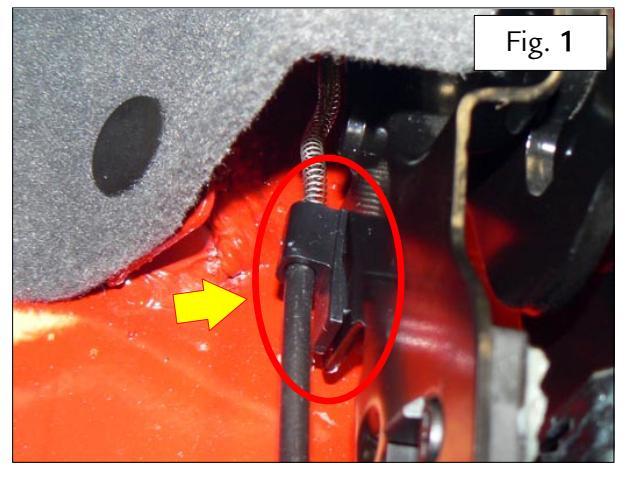
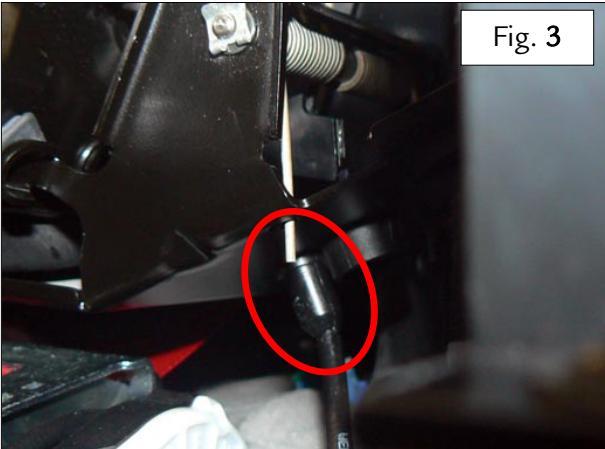
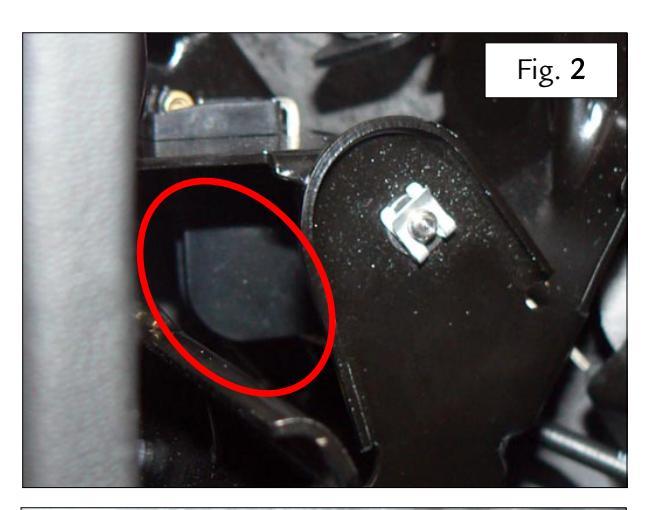
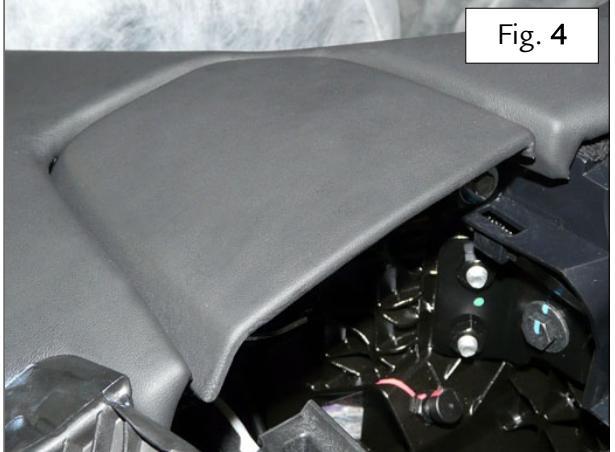
- 1.- With the RHT roof in the intermediate position, **Notes:** check that the RH and LH Bowden cables and the flap upholstery cover are fastened correctly and photograph the respective areas:
 - Clip (Fig. **1**);
 - Cable detached from pulley (Fig. 2);
 - Cable guide (Fig. **3**);
 - Flap trim (Fig. **4**).

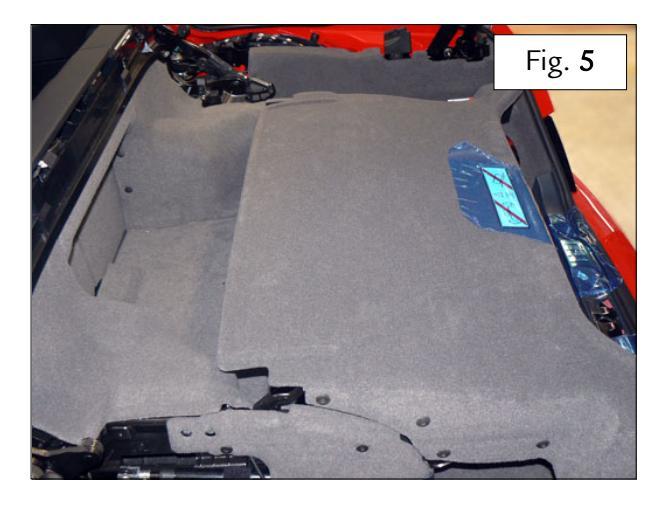
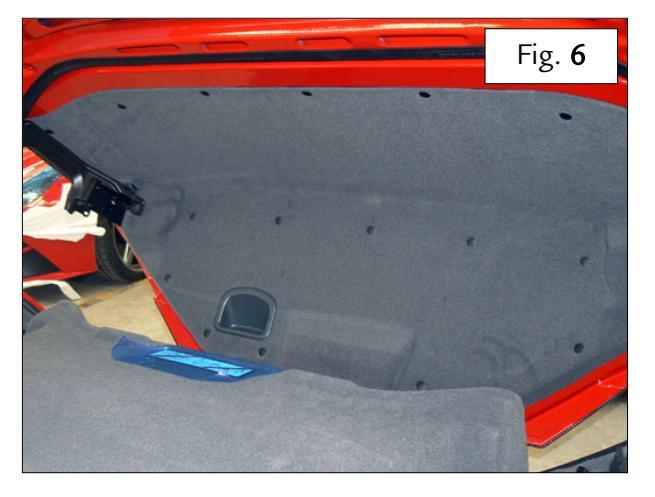
With the RHT roof in the intermediate position, Notes: check for and photograph any marks caused by contact between the luggage compartment lid and the surrounding elements (Fig. 5-6). (take several photographs of the trim elements from different angles)

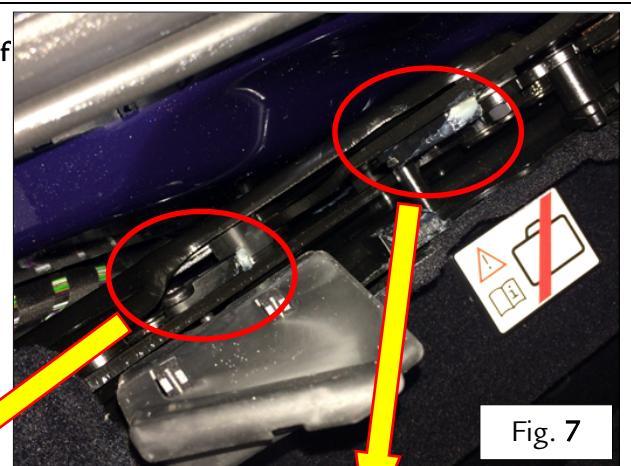
3. - For the CaliforniaT ONLY_ With the RHT roof in the intermediate position, check the condition of and photograph the two flap anti-rotation blocks on the RH and LH side kinematics of the roof respectively (Fig. 7).

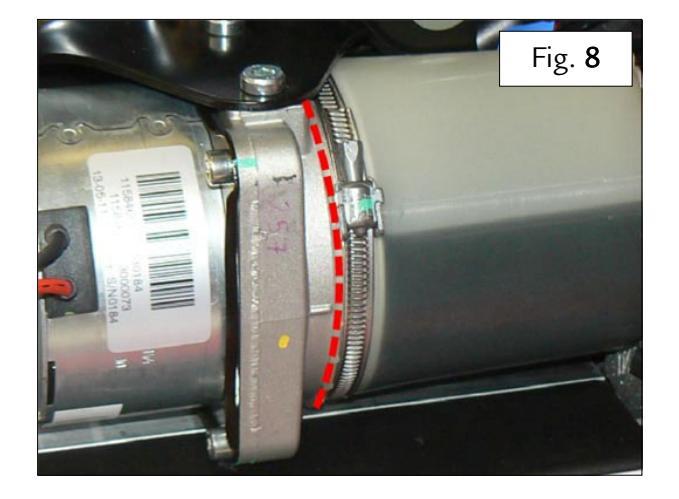
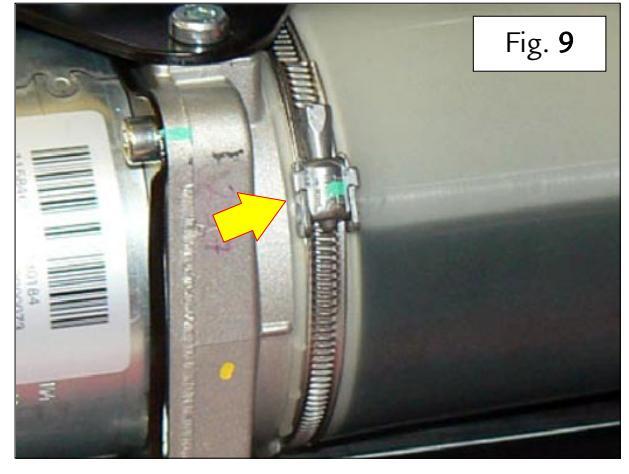
- The exact location of the oil leak located on the connection between the oil pump and the tank (Fig. 8);
- Position of the clamp on the oil tank (Fig. **9**).

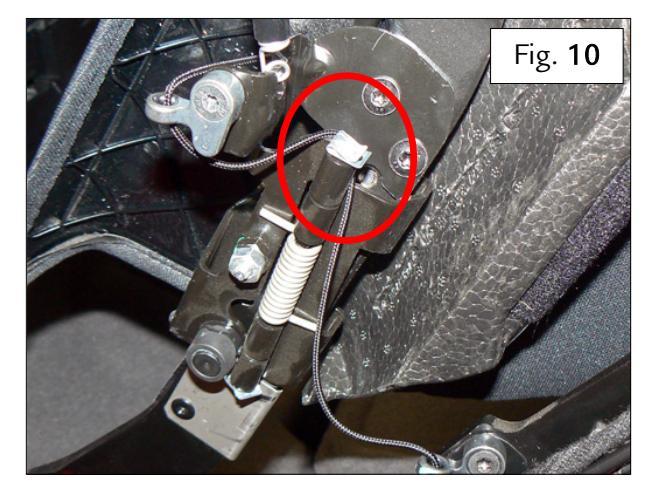
- 1. With the RHT roof in the intermediate position, photograph the following:
 - Point where ropes are incorrectly fastened (Fig. **10**);
 - Areas with rope damage (Fig. **11**).

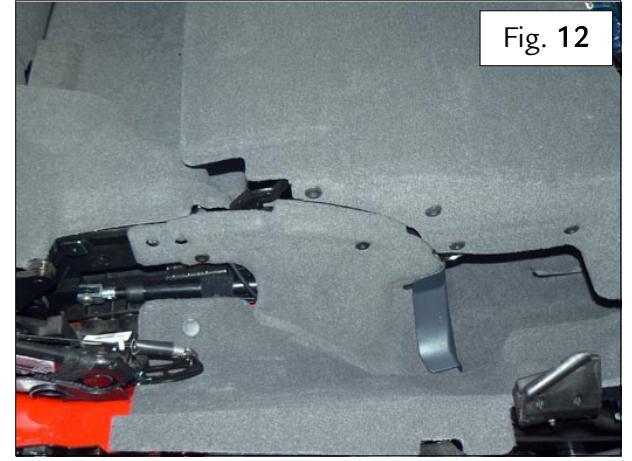
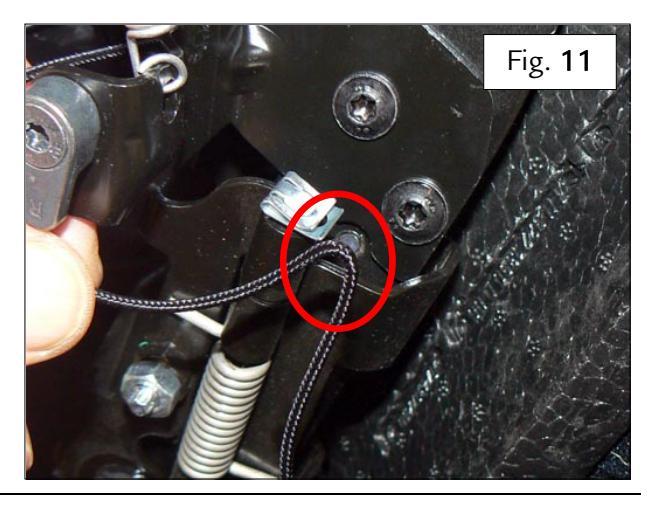
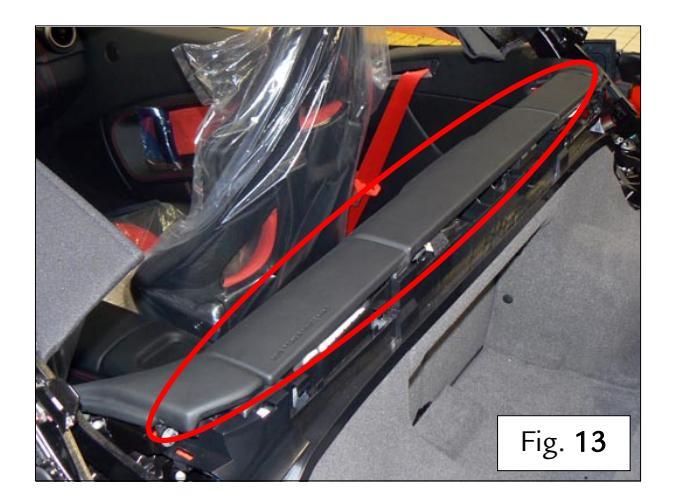
- With the RHT roof in the intermediate position, check for and photograph any signs of contact/fretting in the following zones:
 - Lateral luggage compartment trim panels (Fig. **12**);
 - Rear passenger compartment trim panels (Fig. 13);
 - Underside of tonneau cover (Fig. 14);
 - Upper side of tonneau cover (Fig. 15).

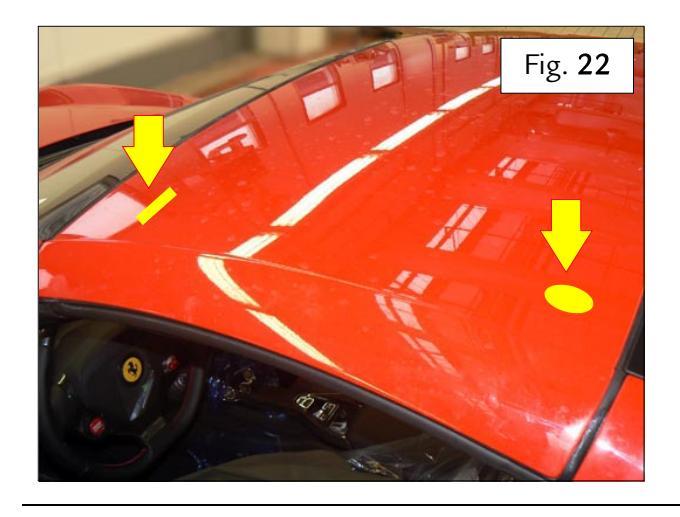
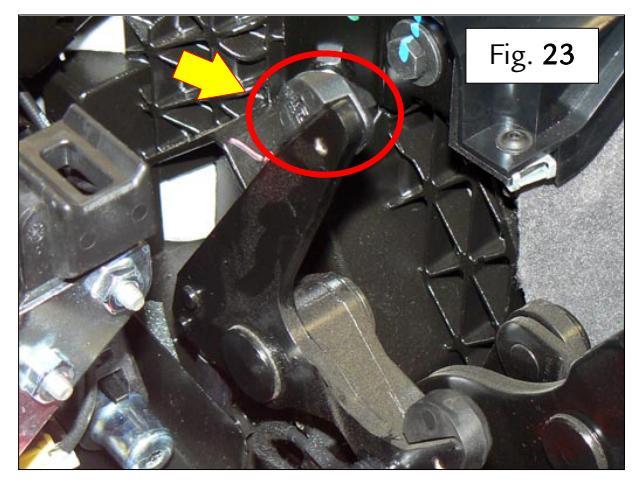
Dent/s in front roof panel (Fig. 22);
With the RHT roof in the intermediate position, check that the rubber pad is fitted correctly on both levers (Storage Lock) (Fig. 23).

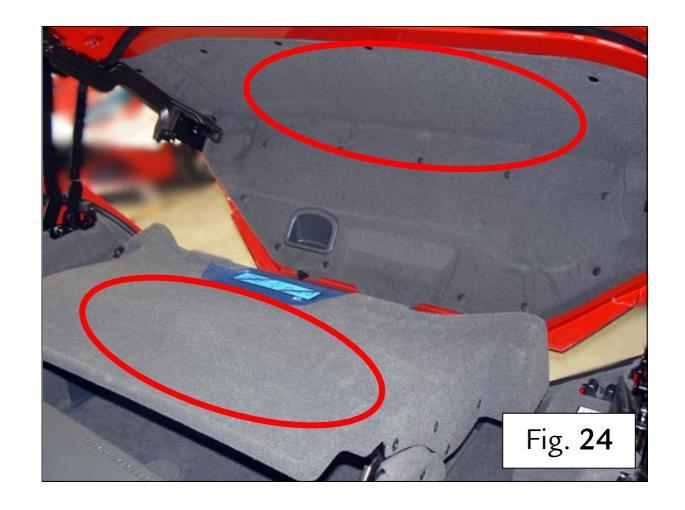
2. – With the RHT roof in the intermediate position, check for and photograph any signs of contact/fretting on the separator trim and on the luggage compartment lid trim (Fig. 24).

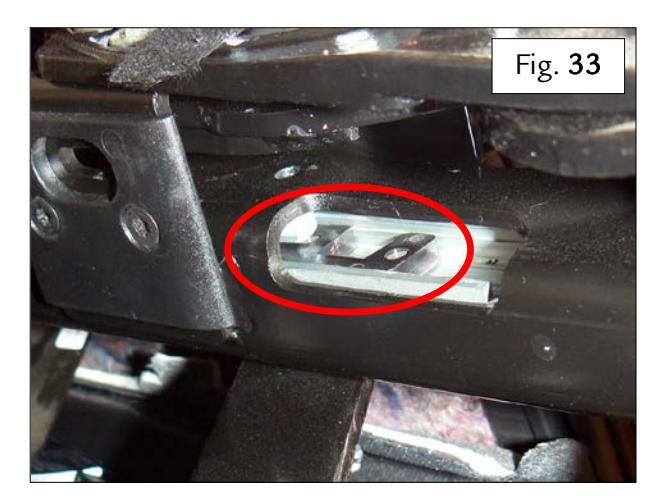
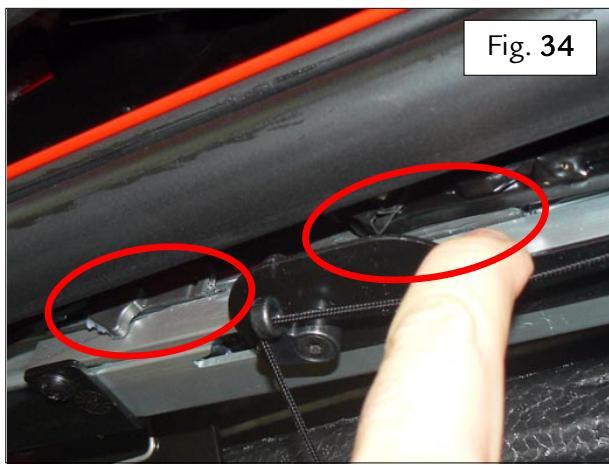
- 1. Check and photograph the following:
 - Check for bent or damaged sliders (Fig. **33 34**);
 - Front connection area (Fig. **35**);
 - Front strikers (Fig. **36**).

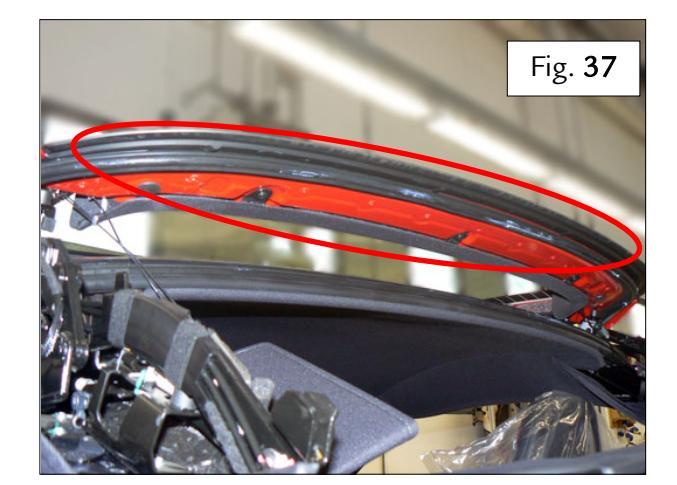
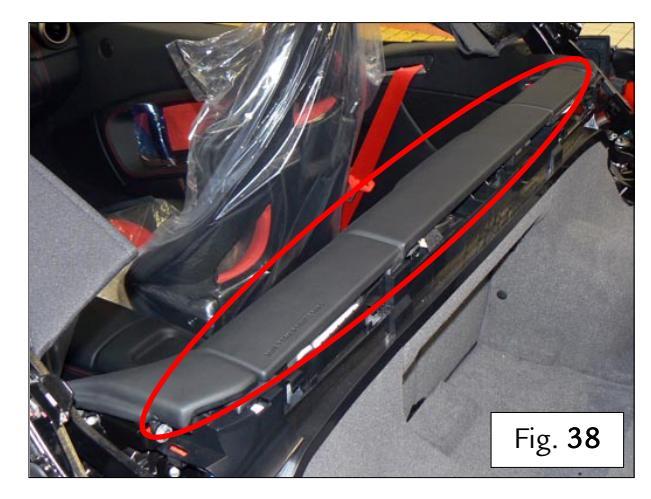
2. - With the RHT roof in the intermediate position, check for and photograph any signs of contact/fretting in the following zones:
Rear underside of rear roof panel (Fig. 37);

Underside of tonneau cover (Fig. **39**); Upper side of tonneau cover (Fig. **40**).

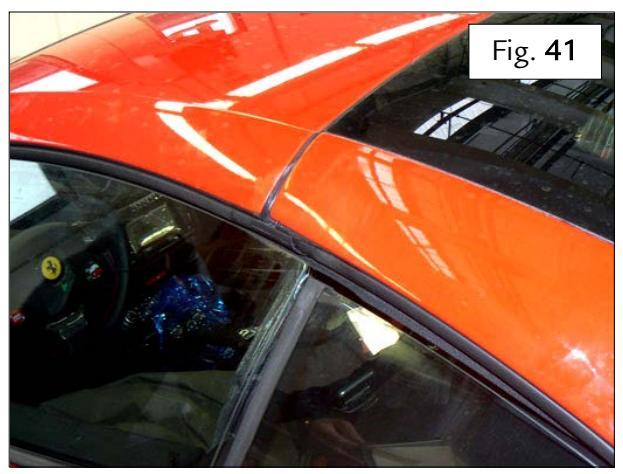
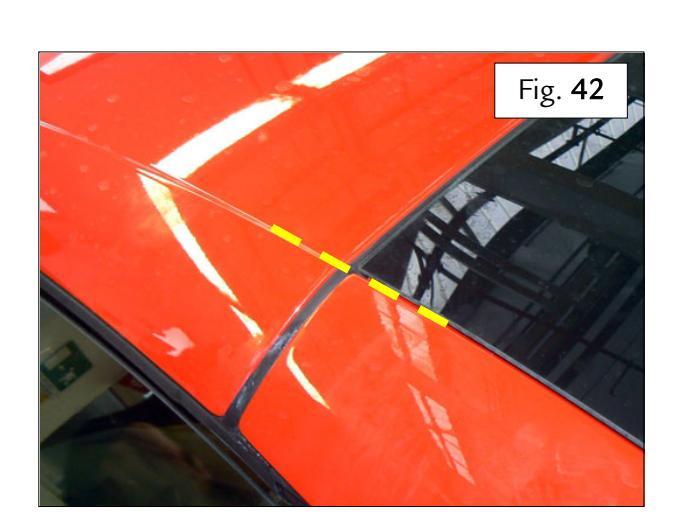
- manoeuvre the roof electrically into the coupé configuration until it is almost completely closed (Fig. 41);
- Wait for the system pressure to subside;
- Measure the alignment (Fig. **43**) at the edge indicated in Fig. **42**, and note the value measured in the space aside.

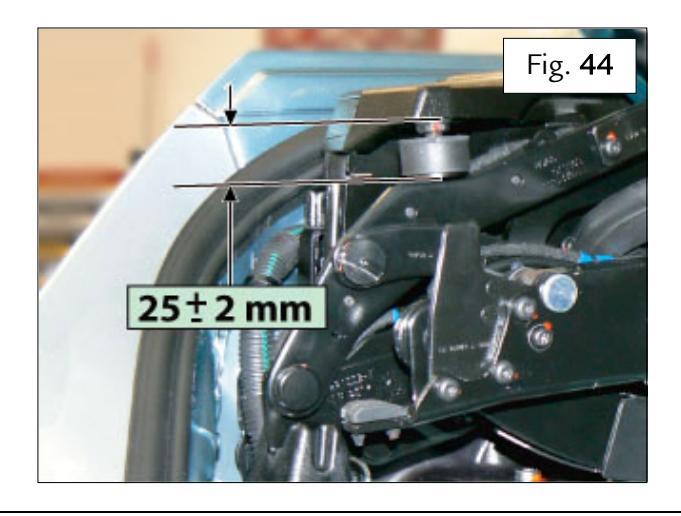
- 3.- Has the lid already been adjusted (during PDI, services, other work)? Give details of any work done (what was adjusted/replaced to rectify the fault and how).
- 4. Measure the preload of the tonneau cover by measuring the distance between the surfaces of the tonneau cover kinematics and the surface of the front roof shell (Fig. 44); enter the values measured in the space aside.

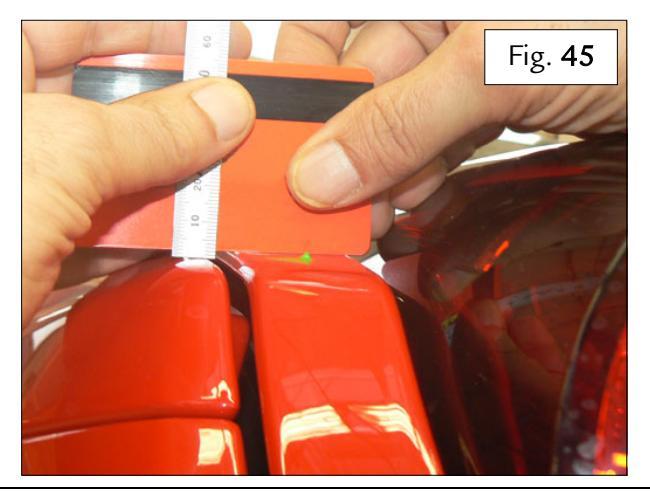
5. – Measure the alignment between the luggage compartment lid and the fender on both sides, measuring the value at 20 mm from the rear edge of the lid itself (Fig. 45); enter the values measured in the space aside.

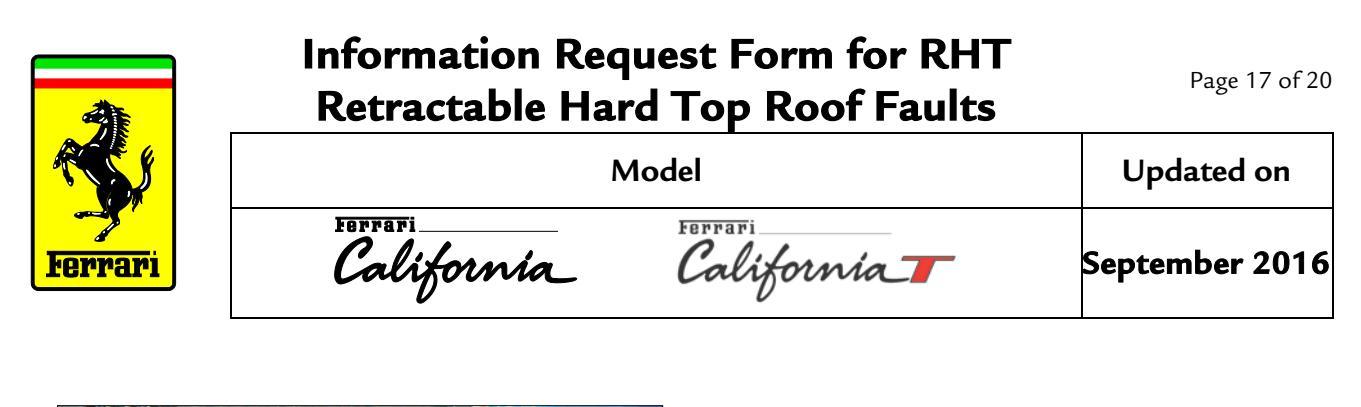
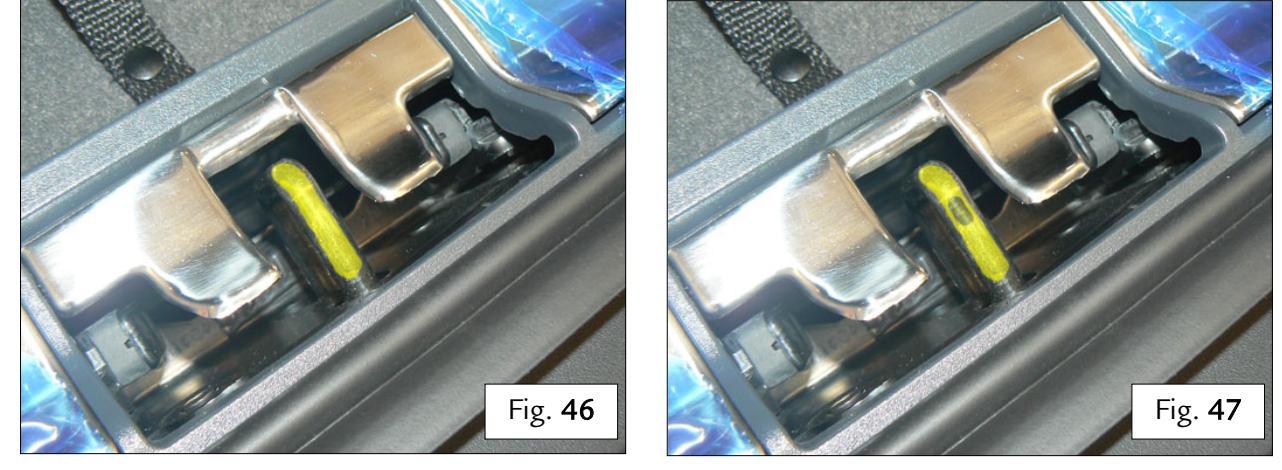
- 6. Measure the alignment along the "X" axis between the luggage compartment lid lock and striker:
 - Mark the top edge of the hook with ink using a marker pen (Fig. **46**);
 - Close the luggage compartment lid, then reopen and photograph the position of the mark left on the hook by the luggage compartment lid lock (Fig. **47**).

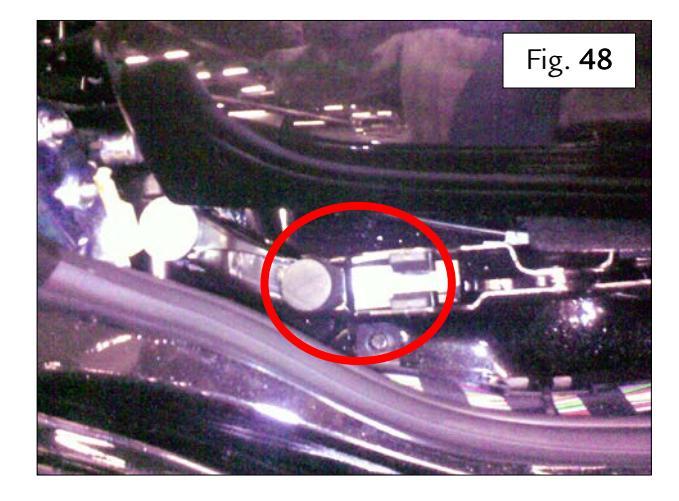
- 2. Indicate the position in which the RHT jammed and take a photograph of the broken part.
- 3. Did the roof jam while opening or closing?
- 4. Were any noises heard while the roof was opening?
 - **MISALIGNMENT BETWEEN TONNEAU COVER KINEMATICS**
- 1.- Check that each of the kinematics is centred correctly relative to the indicated point and aligned correctly with the corresponding component on the opposite side (Fig. 48).

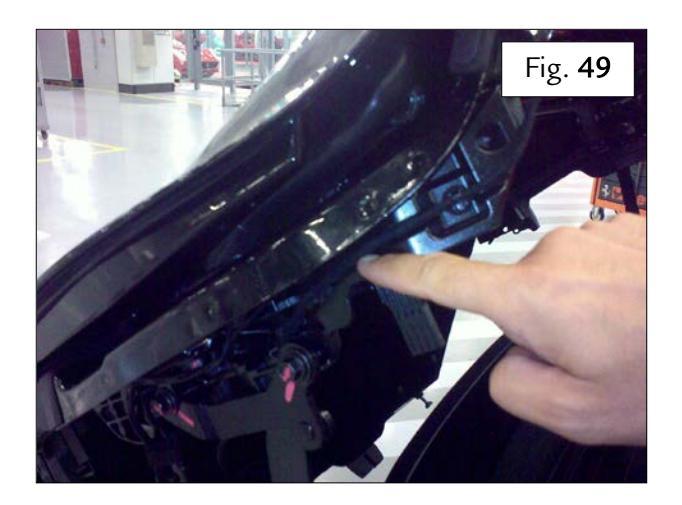
2.- Check that the cables are routed correctly and take photographs: there must be no interference when the roof is closed (Fig. 49).

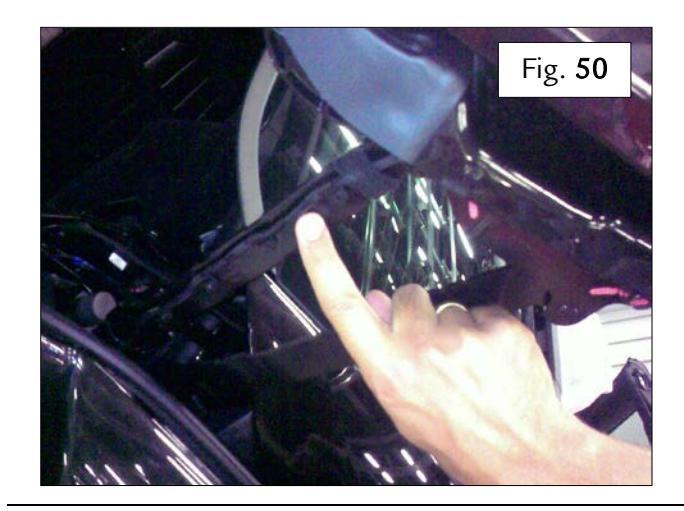
3.- Check that the cables are routed correctly and take photographs: there must be no interference when the roof is closed (Fig. 50).

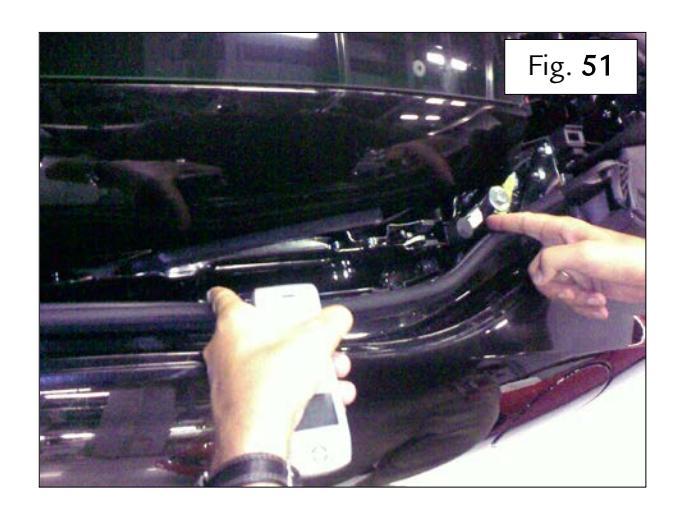
4.- Check that the indicated section of seal is fitted correctly on both sides, and take photographs. The luggage compartment must not encounter excessive resistance when opened (Fig. 51).
