Vehicle Technical Info

GROUP 00 – General

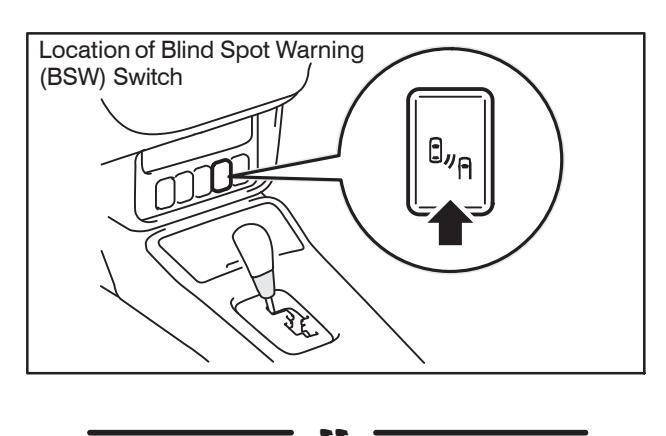
TURN BLIND SPOT WARNING (BSW) SYSTEM OFF WHEN TOWING — 2017 Outlander.

Dealers should inform customers that the Blind Spot Warning system should be set to OFF when towing a trailer, as instructed in the Owner's Manual. Customers should also be informed that turning off the BSW system also turns off the Rear Cross Traffic Alert (RCTA) at the same time.

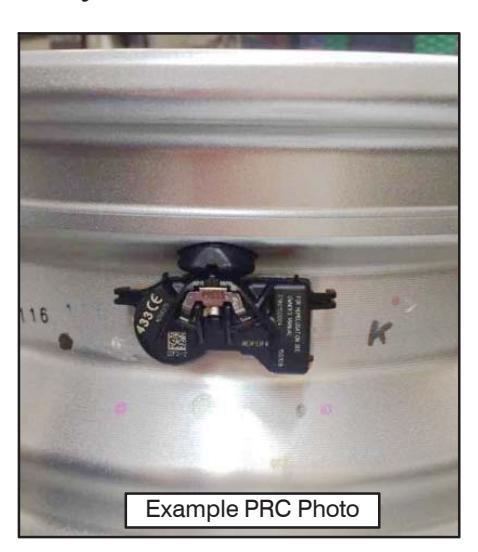
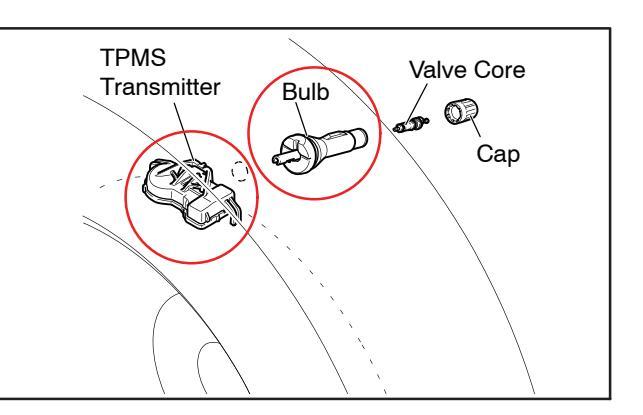
If you replace a TPMS sensor on any 2014 - 2017 Mirage or 2017 Mirage G4 you are required to submit a photo to the PRC. The photo needs to show whether or not the TPMS sensor (body) was attached to the wheel (valve stem) when the tire was dismounted.

NOTE: Below is an example of the type of photo required by the supplier in order to perform further analysis.

In addition to posting the photo, please report the failure DTC(s) on the PRC report, and add a comment describing whether or not the tire had ever been dismounted prior to this service (e.g., YES – The tire was dismounted prior to this service, or NO – the tire was never dismounted prior to this service). If it is not apparent that the tire was previously dismounted, the customer should be able to provide that information. MMNA will issue a Warranty Parts Return Request for all replaced (Mirage) TPMS sensors (which includes the valve stem and bulb in addition to the sensor body).

Once returned, the TPMS sensors will be combined with their respective PRC photos and forwarded to the supplier for analysis. Please continue posting the TPMS sensor photos to the PRC until a cancellation notice is published by MMNA headquarters. Upload PRC photos into the category titled "TPMS Sensors in Wheel Photos."

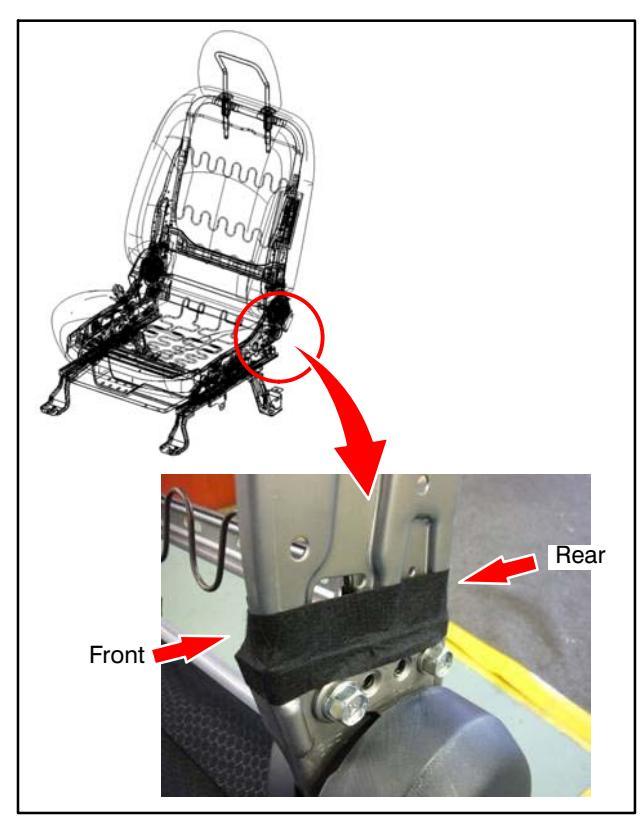
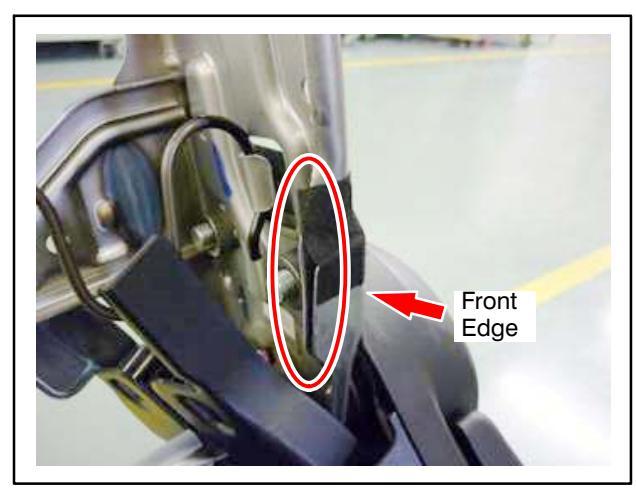
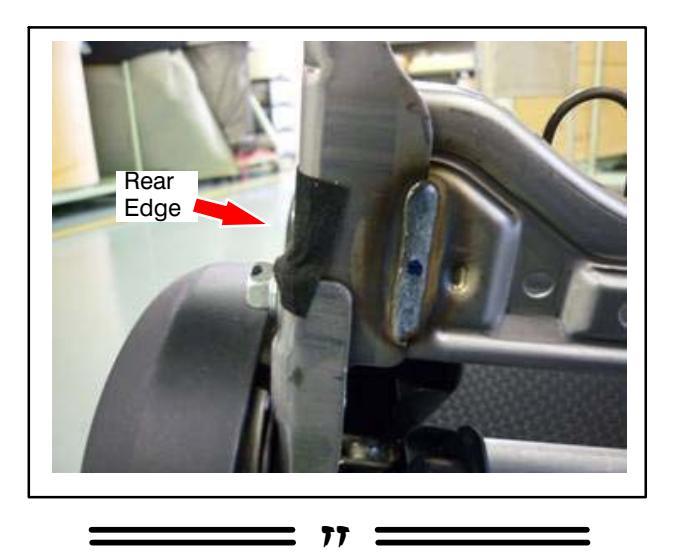
FELT	TAPE	TO	BE	APPL	IED	WHEN
REPL A	ACING	CEI	RTAII	N FR	ONT	SEAT
COMF	ONENT	<u>'S</u> -	_	2011-15	5 0	utlander
Sport/R	RVR.

When removing and replacing certain front seat components on Outlander Sport/RVR vehicles a tape kit should be provided with the following front seat parts (ASA-CAPS PNC numbers included for reference):

If additional tape is required, p/n 6979A320 may be obtained. This application may be used on both driver and passenger front seats. Apply the felt tape as follows.

- 1. Clean off any oil before applying tape.
- 2. Apply tape from the front edge in the side frame to the rear edge of the frame as shown. Make sure tape is firmly adhered to the frame.

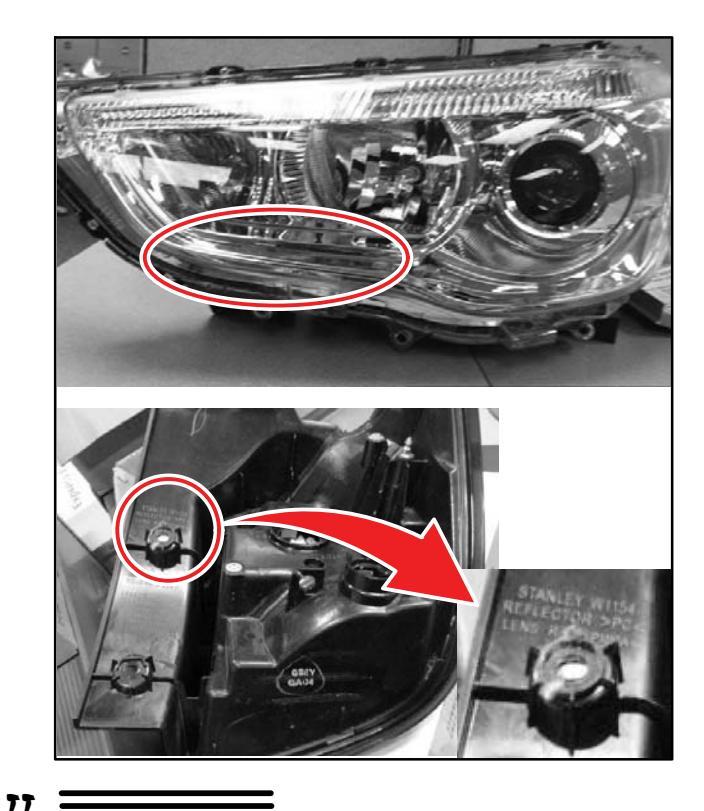
AFTER-MARKET HEAD LAMPS / TAIL LAMPS — 2013-15 Outlander Sport/RVR.

MMNA Warranty is experiencing an unusually high return of after-market head lamps and tail "Stanley Corporation" is inscribed on lamps. original Mitsubishi (OEM) parts. The inscription is located on the lower front lens of the head lamp, and on the rear mounting surface of the tail Any other manufacturer markings lamp. indicate an after-market part that cannot be repaired under warranty. Returned after-market parts that were improperly claimed will be debited to the dealer.
