Model(s)	Year	Eng. Code	Trans. Code	VIN Range From	VIN Range To
Jetta	2015-2016	1.8T (CPKA, CPRA) 2.0L TDI (CVCA)	All	All	All

01 16 05 April 25, 2016 2043736 Supersedes Technical Bulletin V011604 dated April 8, 2016 to remove CJAA engine code applicability.

MIL ON, DTC P05A3 and/or P05A0 Active Radiator Shutter Grille faults stored in ECM Fault Memory

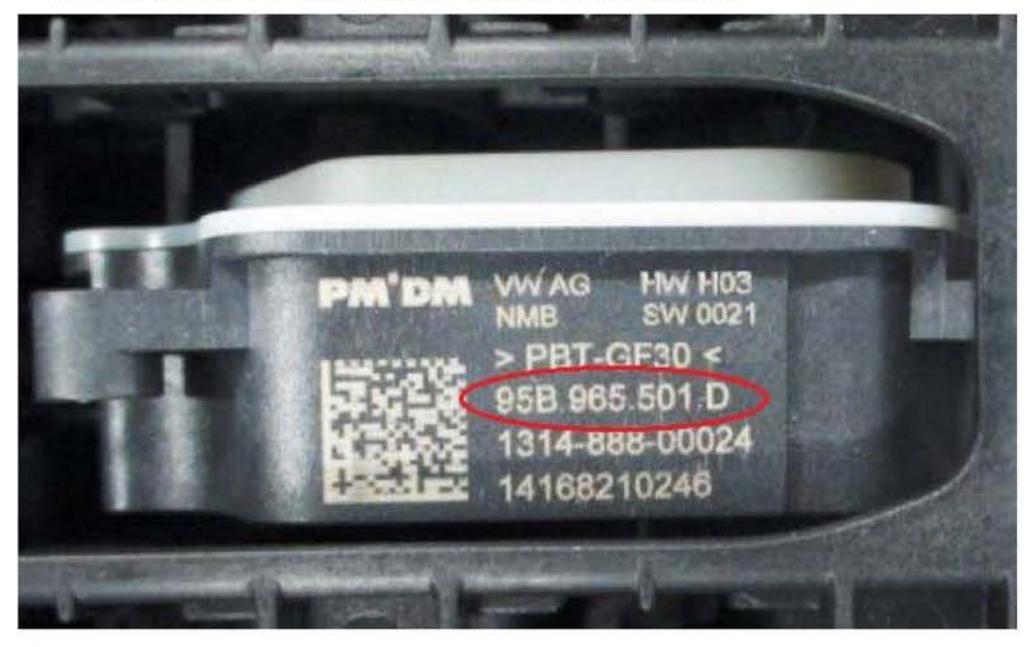
Figure 1

Inspect the Active Radiator Grille motor part number (located on the motor itself, see Figure 1) and perform one of the two following steps.

- If part number is less than 95B 965 501 H, similar to the picture below, the motor/grille will need to be replaced.
- If part number is 95B 965 501 H or higher, the motor/grille is OK and normal Guided Fault Finding diagnosis
 must be performed. <u>This technical bulletin does not apply</u>.

If the Active Radiator Grille needs to be replaced, follow the steps outlined in ELSA to replace the Active Radiator Grille.
