**Title:** The location of the 6011 connector on MaxxForce DT, 9 and 10.

**Applies To:** MaxxForce 9 and 10 only.

The location of the 6011 Engine Interface (Melrose) connector

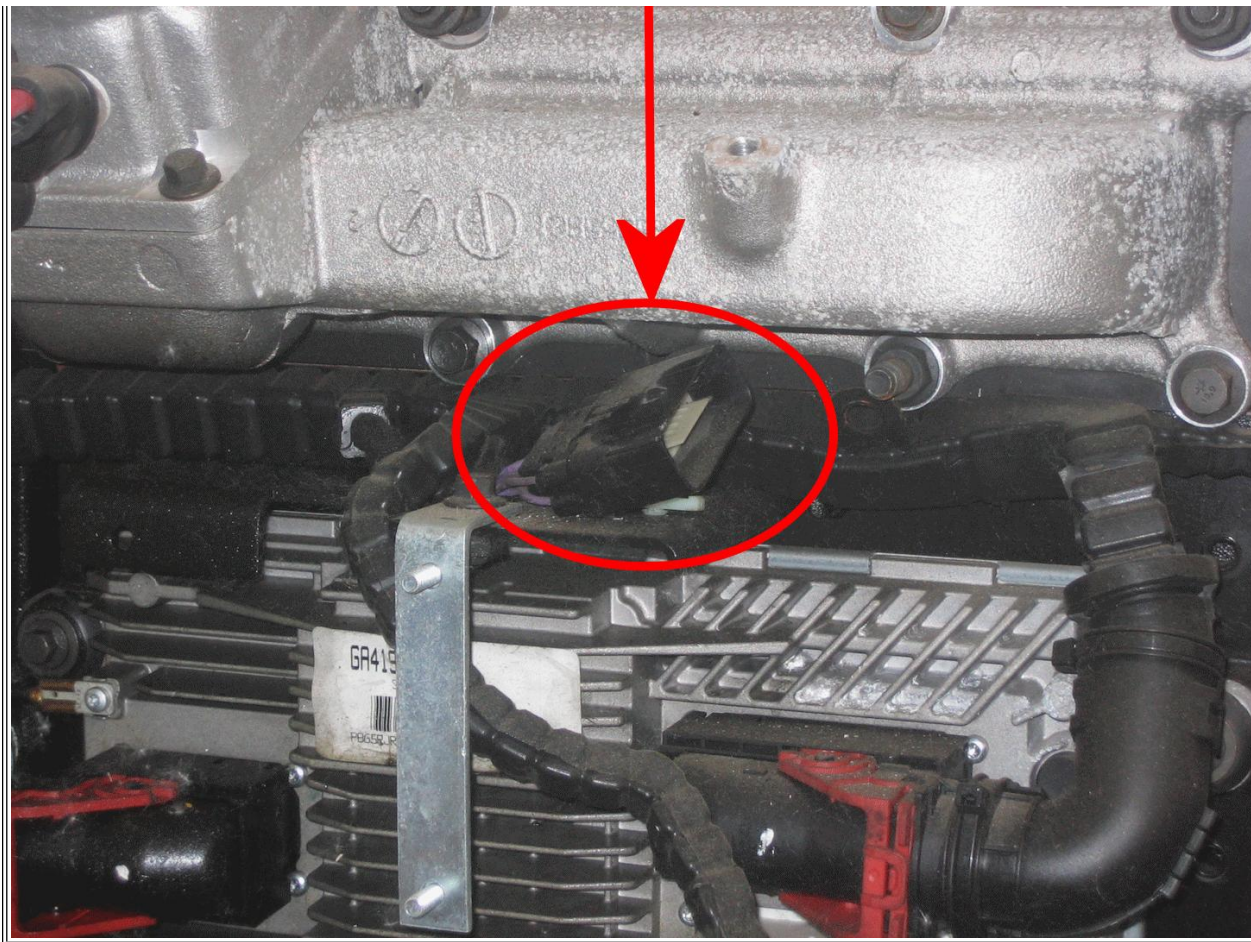
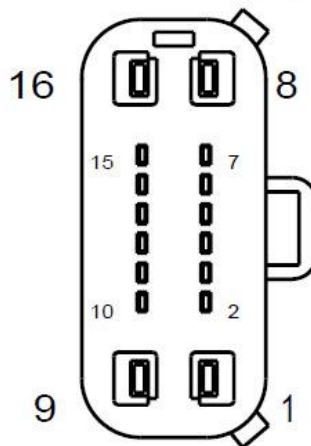
Figure 2 - 6011 Connector Composite Chassis Side

ENGINE / MELROSE (6011)  
(LOCATED ON THE  
LEFT SIDE OF ENGINE)
