**Countries:** CANADA, UNITED STATES, MEXICO **Document ID:** IK1600222  
**Availability:** ISIS, FleetISIS **Revision:** 1  
**Major System:** CAB / SLEEPER / HOOD **Created:** 6/21/2016  
**Current Language:** English **Last Modified:** 6/21/2016  
**Other Languages:** NONE **Author:** David Smith  
**Viewed:** 151

**Title:** Power Window Binding

**Applies To:** ProStar, WorkStar, TranStar, DuraStar, TerraStar

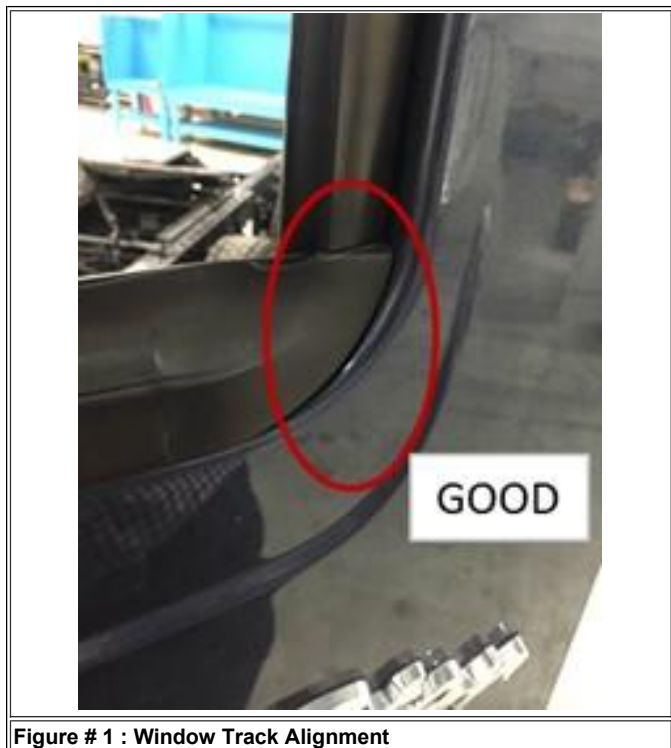
**Figure # 1 : Window Track Alignment**

**Customer states the window binds, or gets stuck when rolling up.**

Step	Action	Decision
1	<b>DIAGNOSTIC:</b> Perform visual inspection of the window tract experiencing the issue (See Figure 1 & 2)	<b>Yes.</b> Adjust window channel track to reflect proper alignment as shown in figure 1, and retest. If issue still persists go to Step 2.
		<b>No.</b> Go to Step 2

Step	Action	Decision
2	<b>DIAGNOSTIC:</b> Does the window continue to bind?  Note : If window track does not repair the concern, go ahead and continue window regulator/track diagnostics	<b>Yes.</b> Replace with window channel track with P/N : 3588772C1
		<b>No.</b> Release the vehicle.
