Document ID: IK0800080

Title: J1939 Data Link Troubleshooting

Applies To: All Models with 250k Baud Data Link (Black 9-Pin Diagnostic Connector)

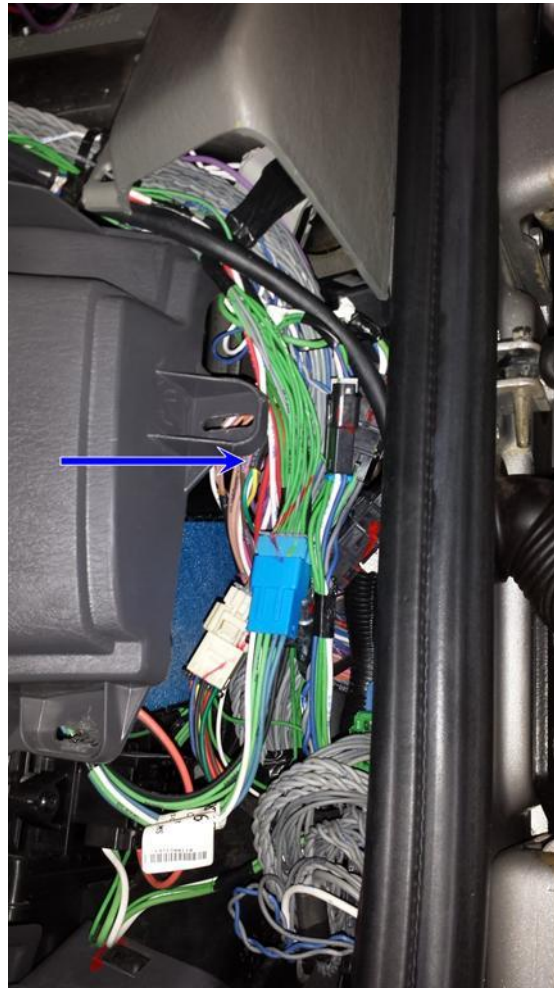
- 6/9/2014 - Recent information from the field has shown a potential failure location
- A poor connection on the splice the ties the ABS module into the Back-bone of the data link was found on multiple units
 - This splice is in the cab, and the harness is common between multiple chassis and engine platforms
 - At this time (6/9/2014) the earliest build date affected is 09/23/2013
 - Anything built after this date is suspect for splice issues

Crimp location: Right side of cab above the ABS module, next to the HVAC box. The condensation module (if installed) will be zip tied to or near the splice.

- If you have these faults and the vehicle build date is near August 2013 or Newer you will need to troubleshoot this splice in the data link if no obvious failures are found
- Follow the harness from the ABS module to the Data Link Backbone. Once you locate the splice, wiggle test that connection (also twist the splice in your fingers) while monitoring the data link resistance. (If a resistance check does not show any fault, repeat this test monitoring data link voltage as well)
- Cab temperature was effecting the data link behavior in one of the vehicles found to have this issue
- Inspecting the splice is destructive, you will need to remove the splice section use a closed barrel butt connector to crimp, solder and heat shrink the splice location. Use proper wire repair techniques as outlined in [IK0800269 - Proper Wire Repair](#)

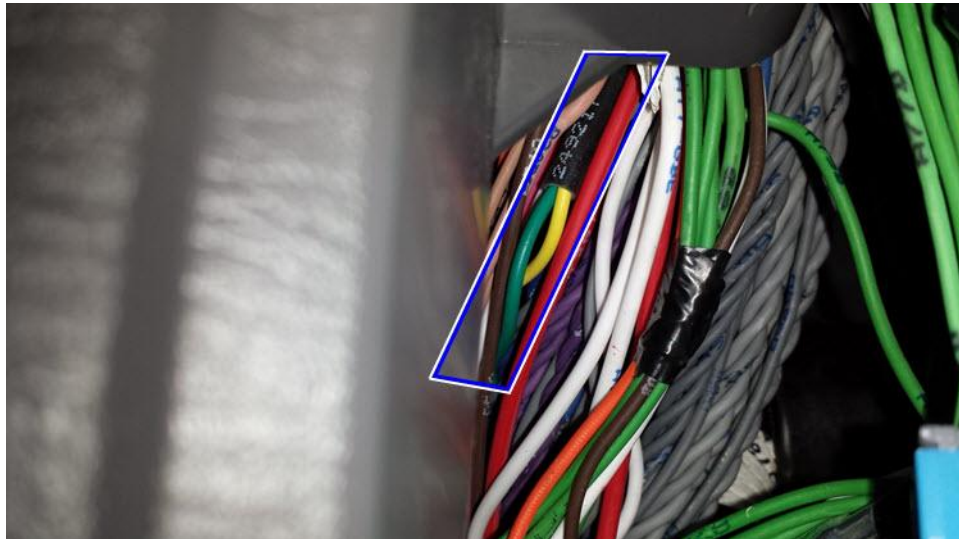
Close view of crimp location

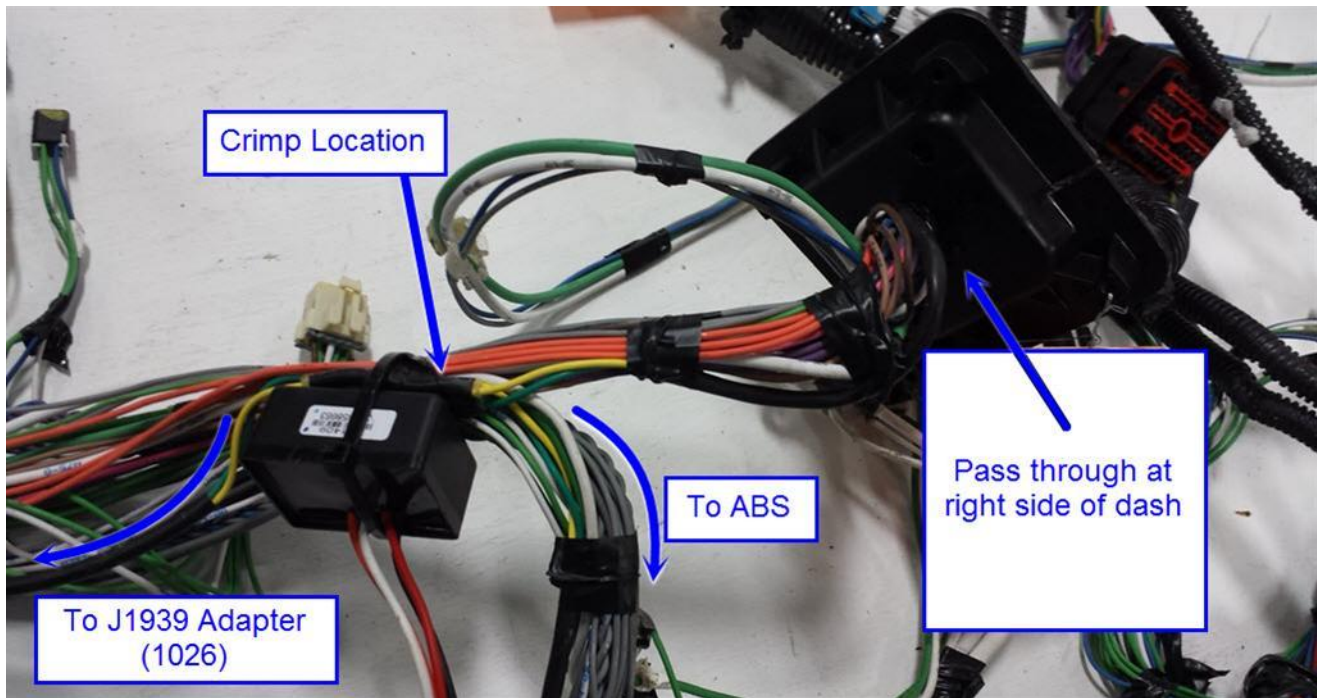
Harness removed from truck for identification

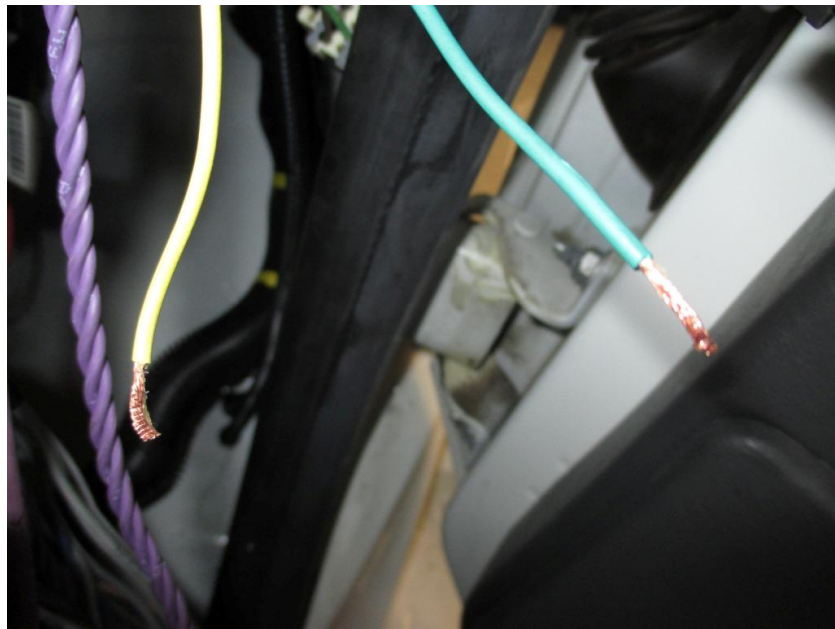
Wire condition at crimp to ABS module

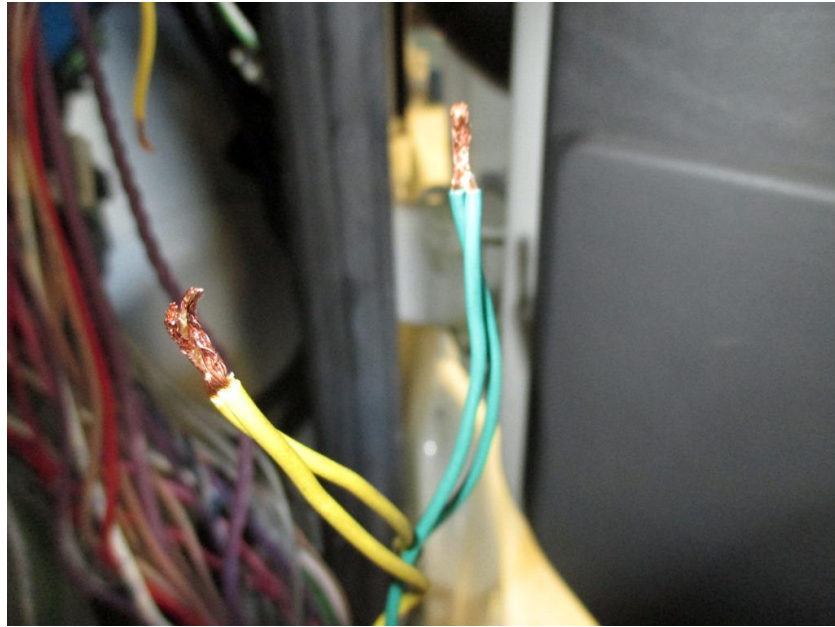
Wire condition at crimp to ABS module (2nd photo)
