[Less Info](#)

Hide Details

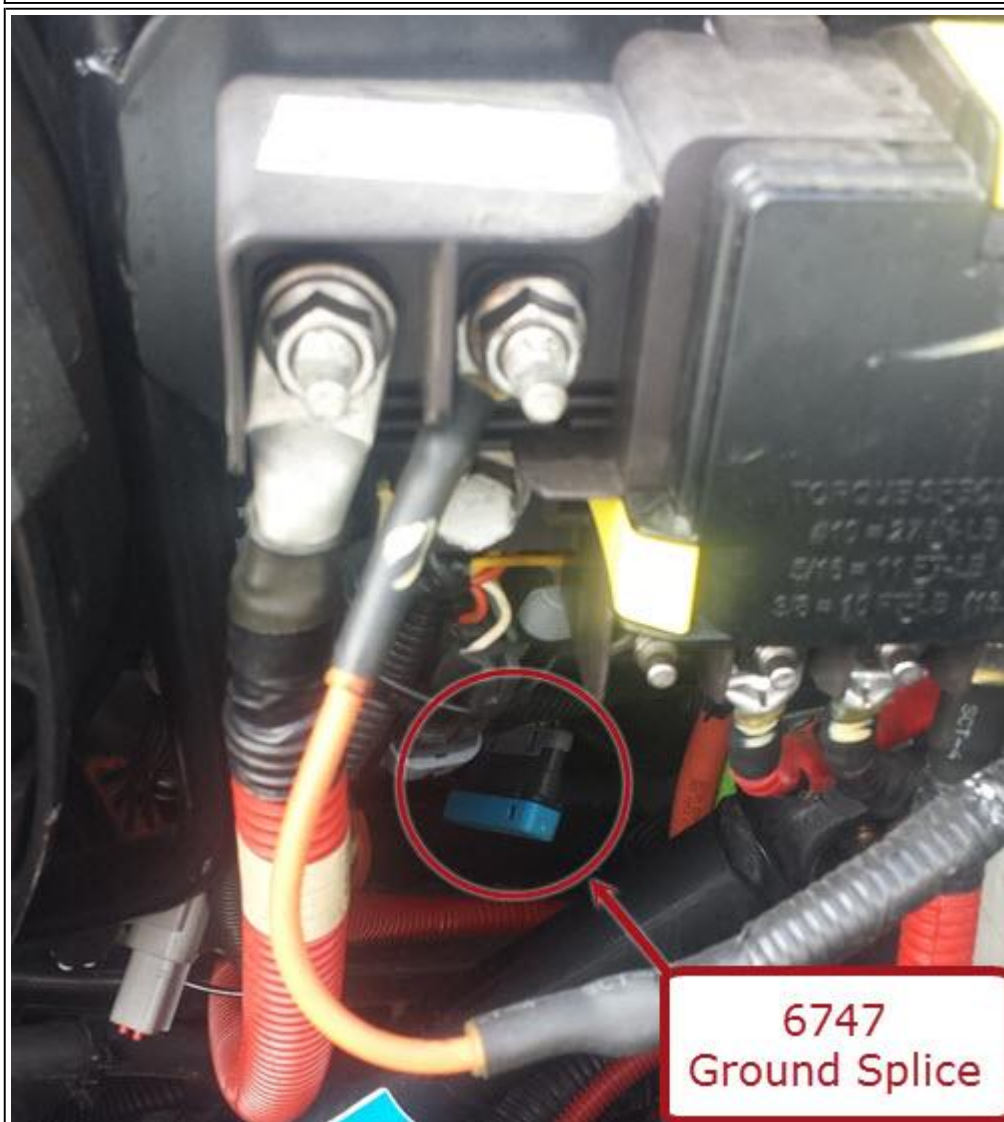
Note: The 6747 may be located closer to the wiper bracket depending on truck model and configuration. Verify circuit numbers to ensure you are at the correct connector.

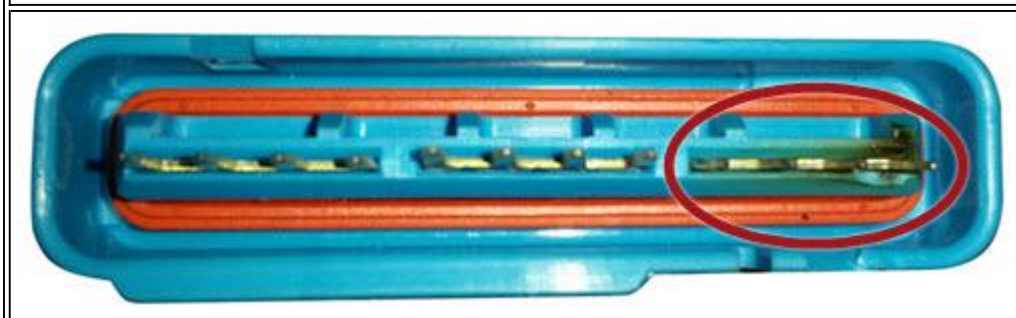
Note the damage to the connector and terminals
