VW Elsa Newsletter

Edition 170: January 25, 2016

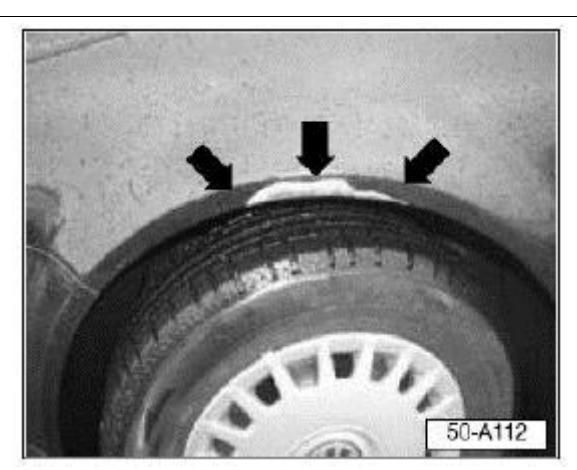
50 16 01 · 2011761 Supersedes Technical Bulletin V501501 dated January 2, 2015 to include additional model and model year applicability. Corrosion, Front Fenders, at Upper Wheel Opening (U.S. Only)

Model(s)	Model(s)YearEng. CodeTrans.VIN Range FromVIN Range To								
Jetta, Sportwagen, Golf, Rabbit									
Eos 2007– All All All All All									
Surface corrosion or corrosion perforation can occur on various locations around the front wheel arch.

Corrosion at front fender -arrows-, as shown.

To determine if this procedure is covered under Warranty, always refer to the Warranty Policies and Procedures Manual. Documentation required per Warranty Policies and Procedures Manual. For vehicles outside of the Limited Warranty Against Corrosion Perforation this Technical Bulletin is for information only. **Production Solution:** Improved process.

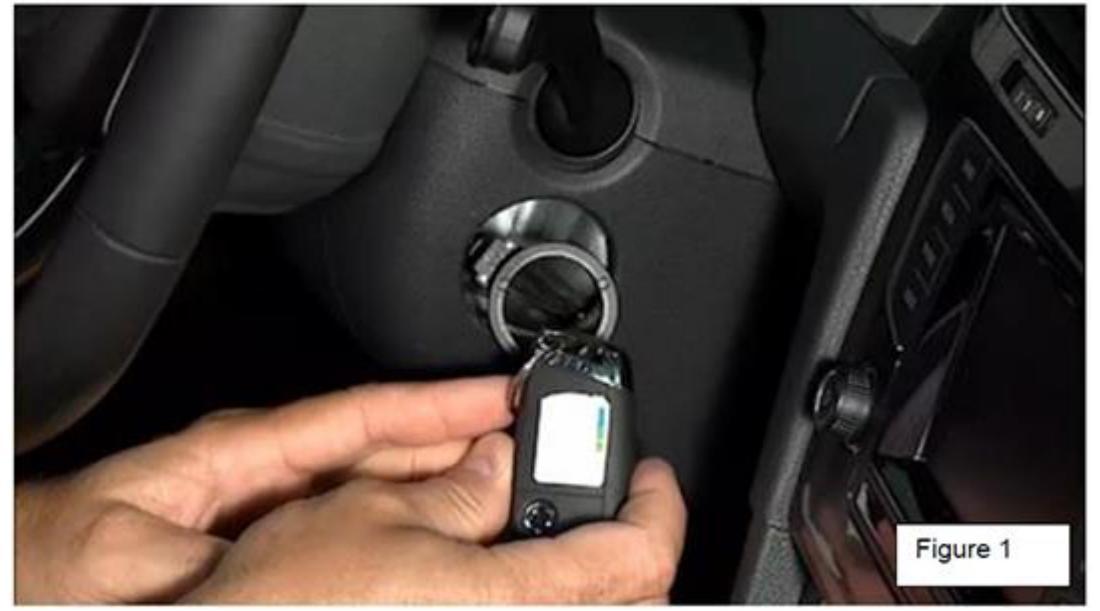
96-14-05 Immobilizer Key/Key Remote Adaptation Test Plan - Date: August 22, 2014

To adapt keys to a 2015-2016 Golf, GTI, Golf R or Sportwagen (MQB chassis,) it is necessary to complete the "Adapt Immobilizer" test plan. Kessy Vehicles: Verify that the reader coil (figure 1) is removed from the steering column and the key is touching the reader coil during key adaptation. Bladed key vehicle, it is not necessary to remove the reader coil. The test plan can be found under the ODIS Special Functions Tab (figure 2) or by navigating to "Immobilizer functions" under 'Elect. Immobilizer 5A" after clicking the "Select self-test" button in the Test Plan tab (figure 3). This procedure adapts both the remote and immobilizer functions of the key.

Note: Vehicle may not start and or have warning lights on cluster after immobilizer / key adaptation is completed. See pg. 5 information in this tech tips after immobilizer / key adaptation for further instructions.
