**Availability:** ISIS, Bus ISIS, FleetISIS, Body Builder, IsSIR

**Major System:** ELECTRICAL SYSTEM

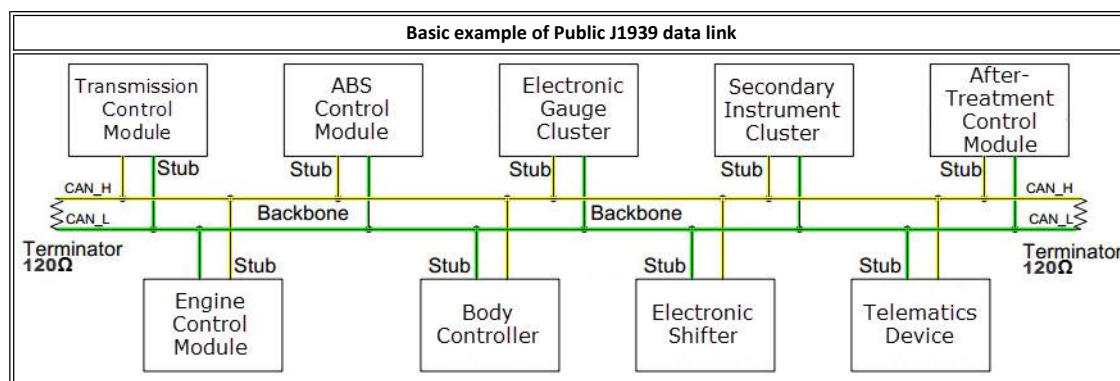
- The J1939 Splice Adapters (1024, 1025, 1026) are part of the backbone of the data link (The backbone will come in on 2 terminals and leave on 2 different terminals). The wiring from the connector to each module is a stub.
  - [HPV \(medium duty\) 1939 Troubleshooting Card](#)
  - [CE / BE Bus 1939 Troubleshooting Card](#)
  - [ProStar 1939 Troubleshooting Card](#)

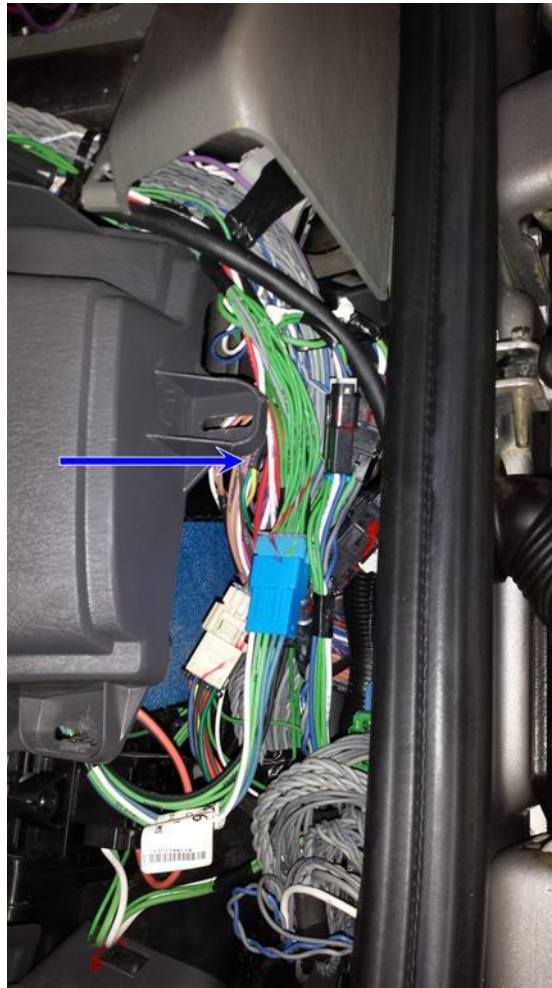
Close view of crimp location

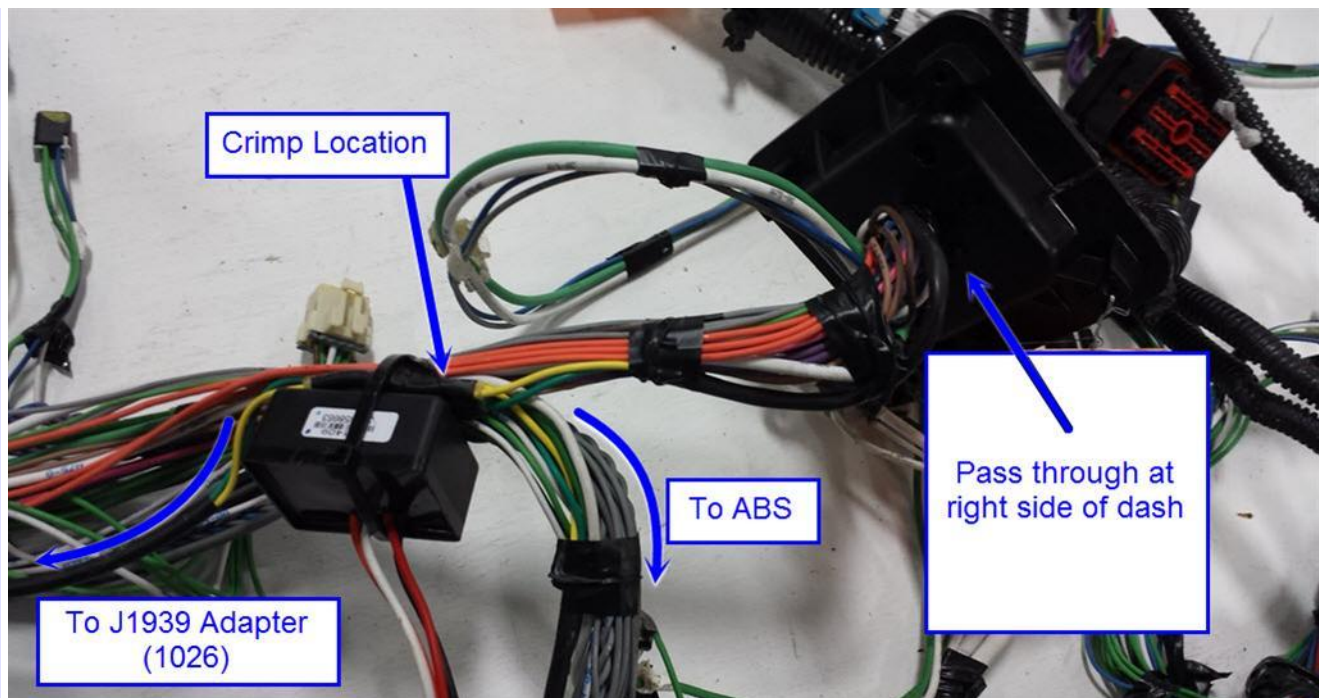
Wire condition at crimp to ABS module

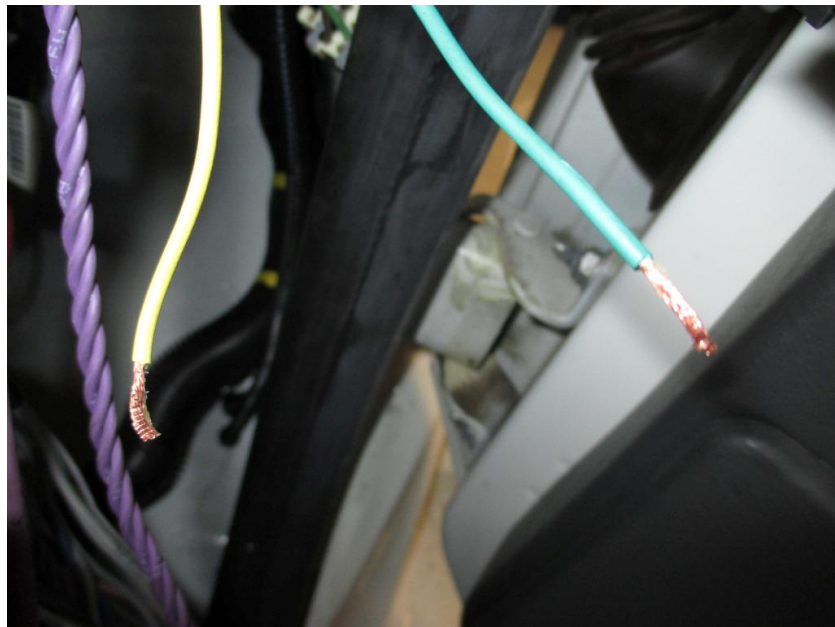
Wire condition at crimp to ABS module (2nd photo)
