Service Bulletin

Subject: Sunroof Glass and/or Sunroof Sunshade Inoperative

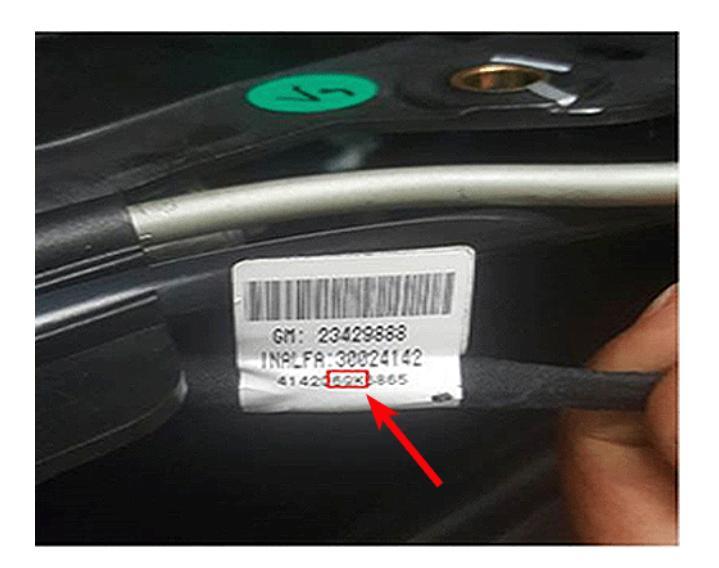
Date codes

Follow the information listed below for inspecting the sunroof wiring harness label for date codes.

• If the harness code is prior to 6QK (June 25, 2016), then the harness is suspect and needs to be replaced following the procedure below.

• If the harness code is after 6QK, then the sunroof motors should be inspected. Refer to further diagnostics in SI.

Follow the procedure listed below for lowering the rear headliner and replacing the sunroof wiring jumper harness:

- 1. Disable the SIR system. Refer to SIR Disabling and Enabling in SI.
- 2. Lower the headliner from the rear up to the B-pillar. Refer to Headlining Trim Panel Replacement (With Sunroof) in SI.
- 3. Disconnect the sunroof wiring jumper harness from the sunroof window motor to the headliner harness.
- 4. Connect the new sunroof wiring jumper harness starting from the sunroof motor while re-clipping it to the headliner down to the headliner harness.
