This bulletin provides information related to a software upgrade of the Hybrid Control Unit (HCU) and the Transmission Control Unit (TCU) of some 2011~2016MY Optima Hybrid (TF HEV) vehicles after replacement of the transmission with <u>improved 100 mesh</u> solenoid filters has taken place. To apply the improved logic, the HCU/TCU should be reprogrammed using the GDS/KDS download, as described in this bulletin.

SUBJECT: HCU/TCU UPGRADE – FOR 100 MESH SOLENOID EQUIPPED HYBRID TRANSMISSIONS

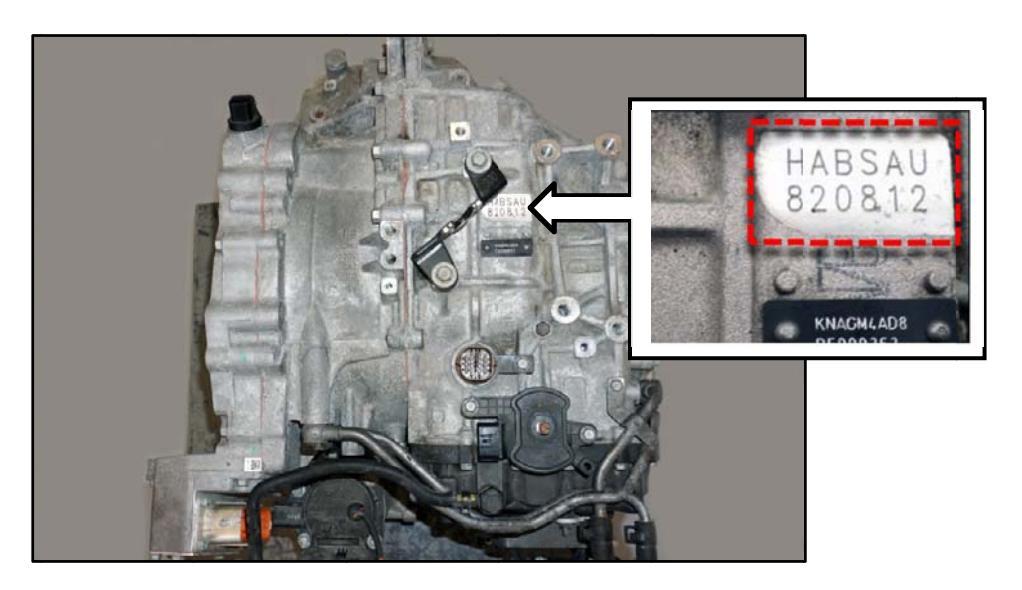
Parts Identification Information:

• The following information applies <u>ONLY</u> to <u>NEW</u> transmissions and <u>NOT</u> remanufactured units.

A/T Part #	A/T ID*	Solenoid Mesh #	Update Required		
45000 3D000	HA*SAU				
45000 3D300	45000 3D300 HA*SBU		No		
45000 3D320	HB*SAU				
45000 3D010	HB*SBU	100	Yes		
45000 3D340	HA*SCU	100

This update must be performed when a 100 mesh solenoid transmission is being installed in a vehicle which previously had a 400 mesh unit, otherwise, the customer may experience drivability issues. Use the identification matrix on Page 2 to correctly identify the replacement transmission. <u>Do NOT apply this update unless a 100 mesh solenoid transmission is installed.</u>
