## SERVICE ACTION

Reference number:	SA-18-0252		Issued: 19 February 2016	
Subject:	Modification to the Electrical Connections on the V12 Starter Solenoid			
Model(s):	Vanquish (13 MY onwards), DB9, Rapide S, V12 Vantage, Vantage GT12.			
VIN range:	Refer to the VIN list published on the DCS Portal			
Applicable to:	All Dealers			
Distribute to:	After Sales Manager W	′arranty		
	Executive Manager Te	echnician(s)		
	Service Manager Pa	arts		
	Sales Manager

### **Reason for this Service Action**

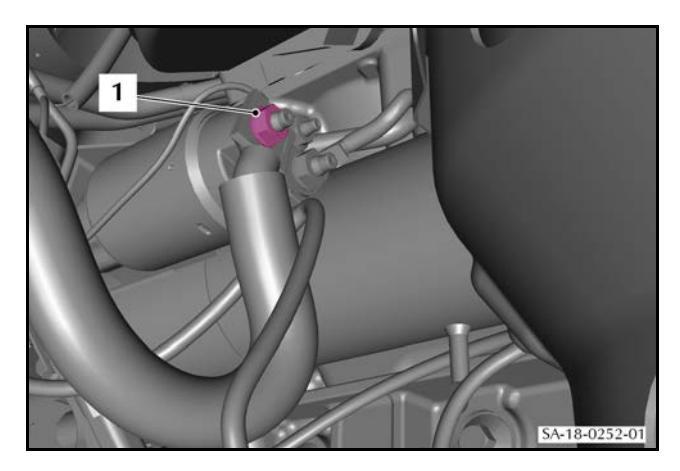
Figure 1

There are two modifications that you need to do to the starter solenoid electrical connections on some V12 engined models. The first problem is that there is a quantity of vehicles that have an incorrect nut installed that attaches the battery positive cable to the solenoid. The coating on the nut can corrode and cause a poor connection. The second problem is that it is possible that the signal wire to the solenoid coils has an acute angle. This can cause the insulation to fail and increase the risk of a short circuit or failure of the wire. The system fuse can also blow. The two problems can cause the engine not to start, or be difficult to start.

5. Remove the nut (1) that attaches the battery supply cable to the starter solenoid (solenoid) (refer to Figure 1).

- 7. Examine the terminal on the battery cable. If necessary, clean the terminal.
- 8. Examine the stud on the solenoid. If necessary, clean the stud.
- 9. Put the battery cable back into position on the stud of the solenoid.
- **10.** Install and tighten a new nut that attaches the cable to the stud of the solenoid.

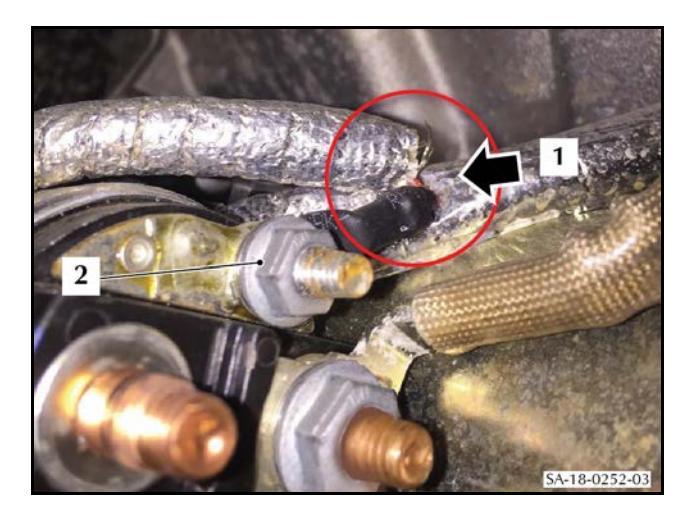
Figure 3

- **11.** Examine the position and condition of signal wire to the solenoid.
- **12.** If the wire is at an acute angle (1) (refer to Figure 3), failure of the wire insulation can occur.

- **13.** If the angle is too acute, remove the nut (2).
- **14.** Remove the wire from the stud and examine the insulation.
- **15.** Wind self-amalgamating harness tape around the wire from the terminal for approximately 4 cm (2) (refer to Figure 4).
