## Service Bulletin

16-NA-020 Date: February, 2016

#### Subject: Turbocharger Noise and/or Malfunction Indicator Lamp Illuminated with DTC P2261

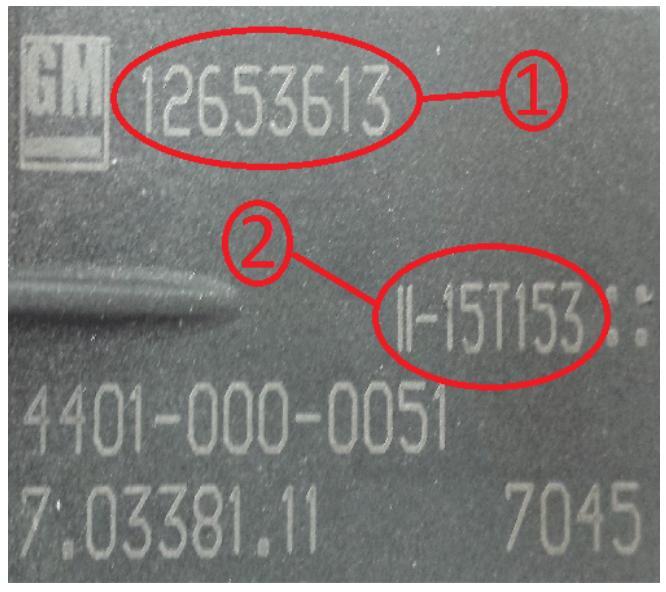
4367888

If diagnosis does not lead to an electrical concern, check the Julian date (2) on the turbocharger bypass valve.

- If prior to Julian date 15T327, replace the • turbocharger bypass valve per SI repair procedure.
- If the Julian date is 15T327 and after, refer to SI diagnostics.
