Service Bulletin

Subject: Visible Oil on Hybrid Air Conditioning Compressor Module (ACCM) – Should Not be interpreted as a Refrigerant Leak

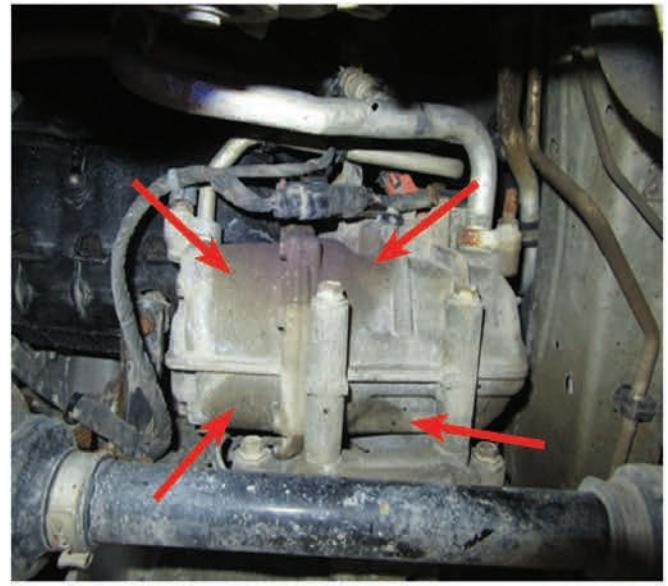
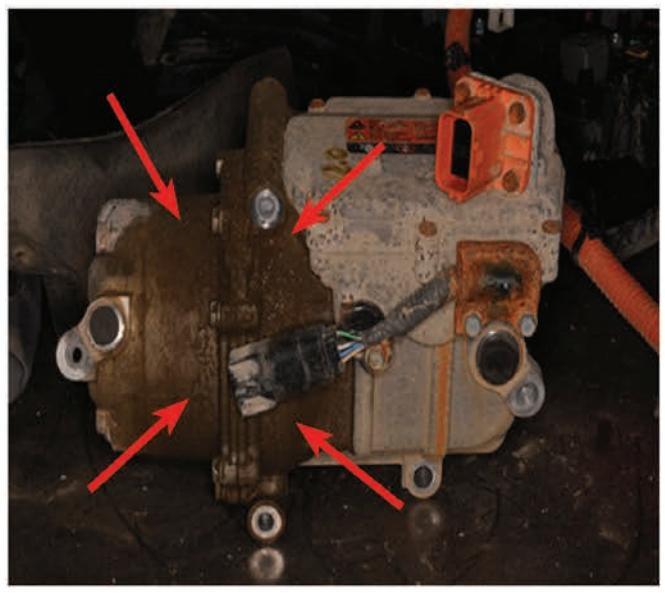
Examples of Oil Weepage

Involved Region or Country	North America and N.A. Export vehicles		
Condition	Some customers or technicians may comment on seeing staining on the air conditioning compressor module (ACCM) housing.		
Cause	This condition may be due to a potential small amount of oil weeping from the ACCM housing sealing area. This condition is acceptable and is not accompanied with refrigerant loss, which results in a loss of A/C performance.

The graphics above are photo example, which include arrows showing some of the common areas where oil may be evident after the vehicle has been driven for a length of time.

The ACCM must not be replaced to correct this condition. If there is no customer concern regarding A/C performance, clean oil off ACCM if necessary and allow customer to take vehicle.

Note: Technicians need to verify using a SAE J-2791 electronic leak detector that it is **NOT** an active leak. If no leak is found and the vehicle has full charge, clean the area of oil/dye. No harsh cleaners, such as a heavy solvent or brake cleaner, should be used to clean of the ACCM. Using harsh chemicals could deteriorate the seals on the ACCM. If cleaning off the ACCM is necessary, use a soft cleaner such as dish washing soap.
