2016 MAXIMA; NAVIGATION UNIT FREEZES

NTB16-067

APPLIED VEHICLE: 2016 Maxima (A36) only in the following states: California (CA), Nevada (NV), Arizona (AZ), Oregon (OR) and Utah (UT)

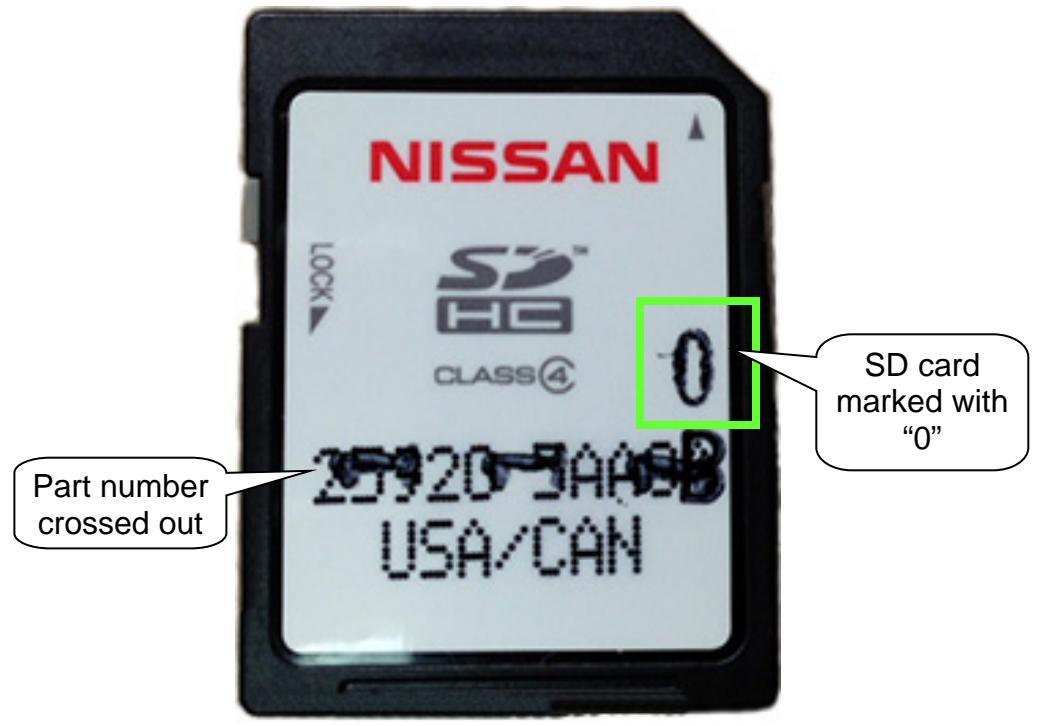
Figure A

- Software is updated with SD card with "**0**" to the right and above crossed out part number (see Figure A).
- SD cards with updated software have been sent to dealers only in the following states:
 - > California (CA), Nevada (NV), Arizona (AZ), Oregon (OR) and Utah (UT)
- Replacement software update SD cards, due to loss or damage, can be obtained only by those states listed above and by contacting Clarion: 1-800-347-8933.

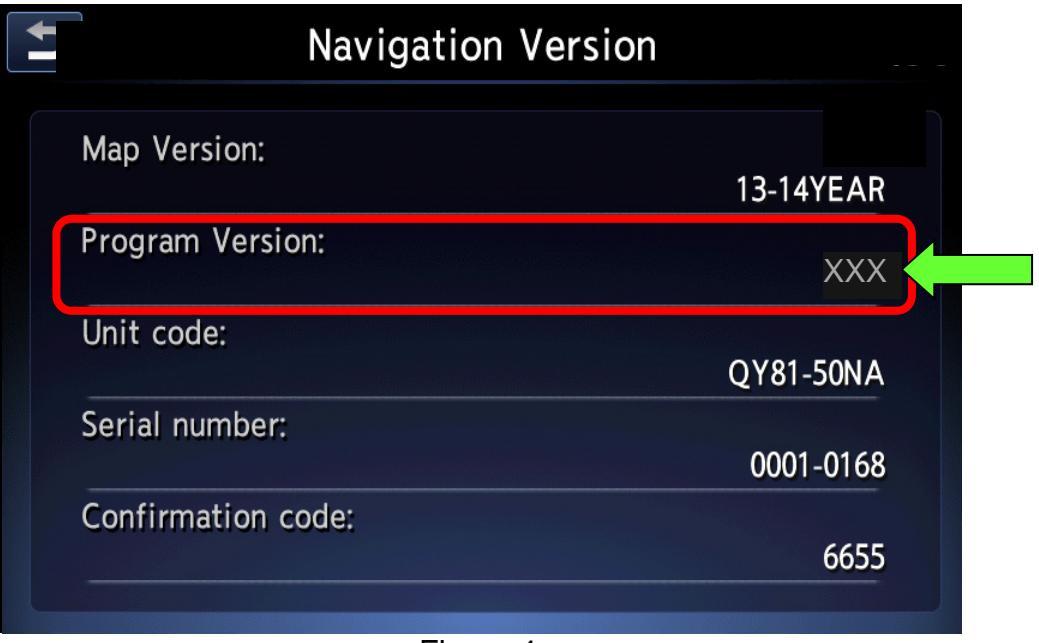
Figure 4

- 6. Check the Program Version number.
 - If **107** or **124**, a software update is needed.
 - Write down the values for Program Version, Unit code, and Serial number on the repair order and then go to page 5, AV Control Unit Software Update with Software Update SD Card.
 - > This information is for possible future reference.
 - If **140**, a software update has already been successfully performed.
