Technical Service Bulletin

PSS 91 MMI volume cannot be adjusted with volume knob

91 16 65 2044951/1 August 4, 2016.

Model(s)	Year	VIN Range	Vehicle-Specific Equipment
Q7	2017	All	Not Applicable

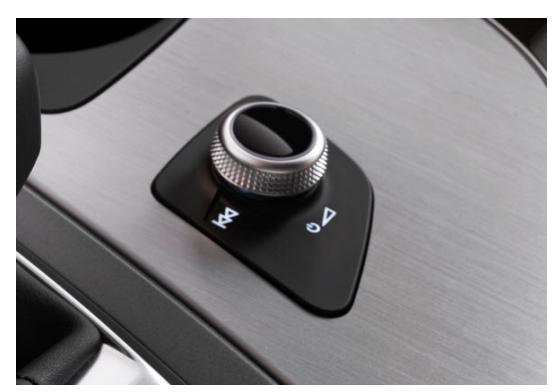
Figure 1. E67 Driver Side Volume Control

- The customer complains the volume of the MMI system cannot be adjusted with the main volume knob on the MMI control panel (Figure 1).
- The following conditions are true:
 - The vehicle is a 2017 Q7
 - The condition is sporadic
 - The volume can always be adjusted using the steering wheel volume control
- DTC U11B900 (Volume control No communication) is stored in the information electronics control unit 1, J794 (address word 5F).

There is a known software concern that can cause an issue with the LIN communication between the E67 driver side volume control and the information electronics control unit 1.

- 1. Explain to the customer that a solution is forthcoming and that no repairs are necessary at this point. Do not replace any components for this condition since this will not resolve the customer's concern.
- 2. Create a PSS record in the PSS application through the Pending Service Solutions (PSS) link in AccessAudi (under Related Links>>Service), or through the Technical Assistance page in Elsa.

When the customer experiences the condition, the volume control can be reestablished with the following workaround:

- Press down on the volume knob.
- Turn the volume knob again to adjust the volume.
