Service Bulletin

Subject: Diagnostic Tip for Intermittent Crank/No Start After Removal of Camshaft Sprockets

Models: 2013-2016 Buick Encore 2014-2015 Cadillac ELR 2011-2015 Chevrolet Volt 2011-2016 Chevrolet Cruze (VIN P for 2016) 2012-2016 Chevrolet Sonic 2013-2016 Chevrolet Trax 2012-2015 Opel Ampera Equipped with 1.4L Engine (RPOs LUU, LUV or LUJ)

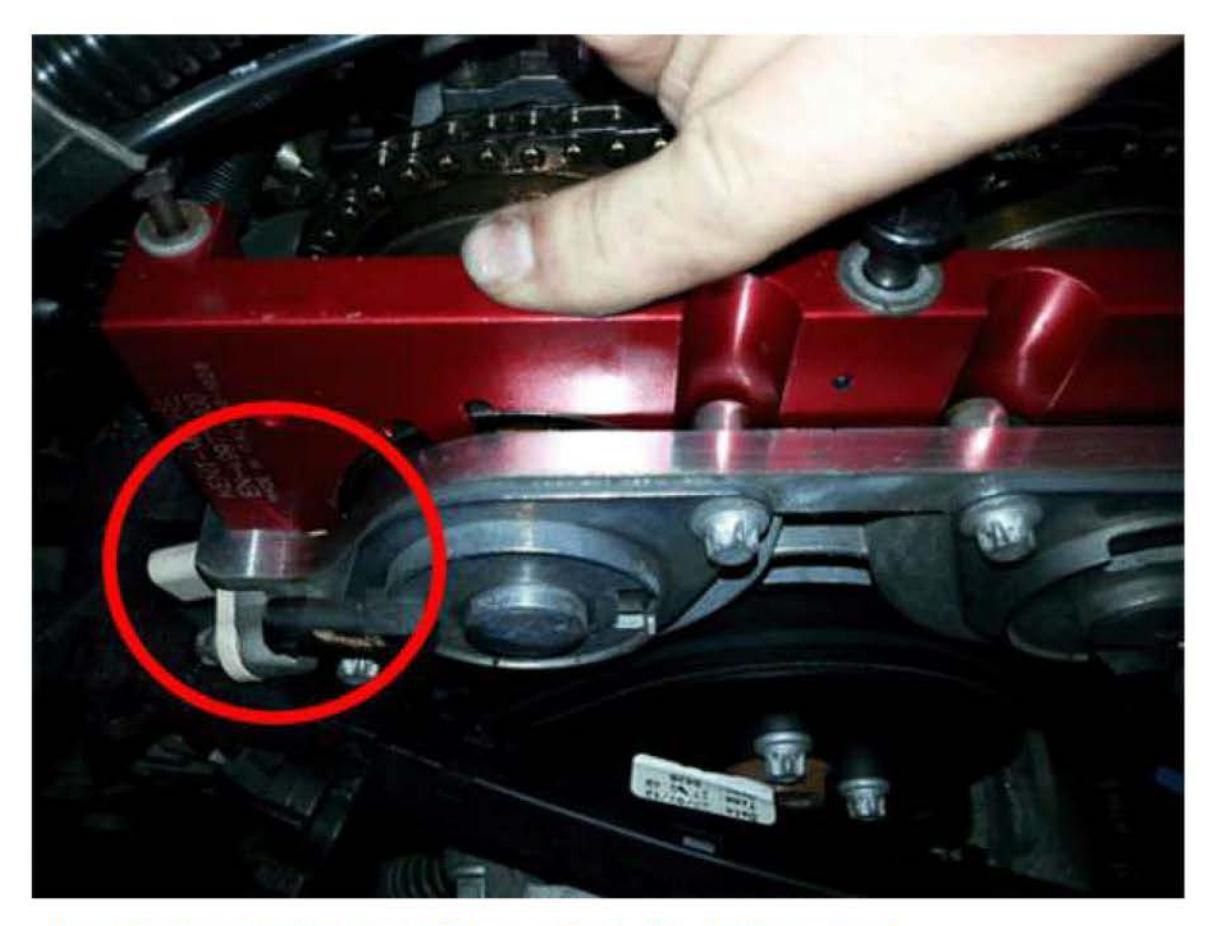
Rear Cylinder Head with Tool Showing Proper Exciter Wheel Alignment

The exhaust and intake camshaft position exciter wheel must be installed properly with special tool EN-49977-100, fully seated on the cylinder head, before tightening the camshaft sprocket bolt. Refer to the pictures below for proper alignment installation and tool usage.

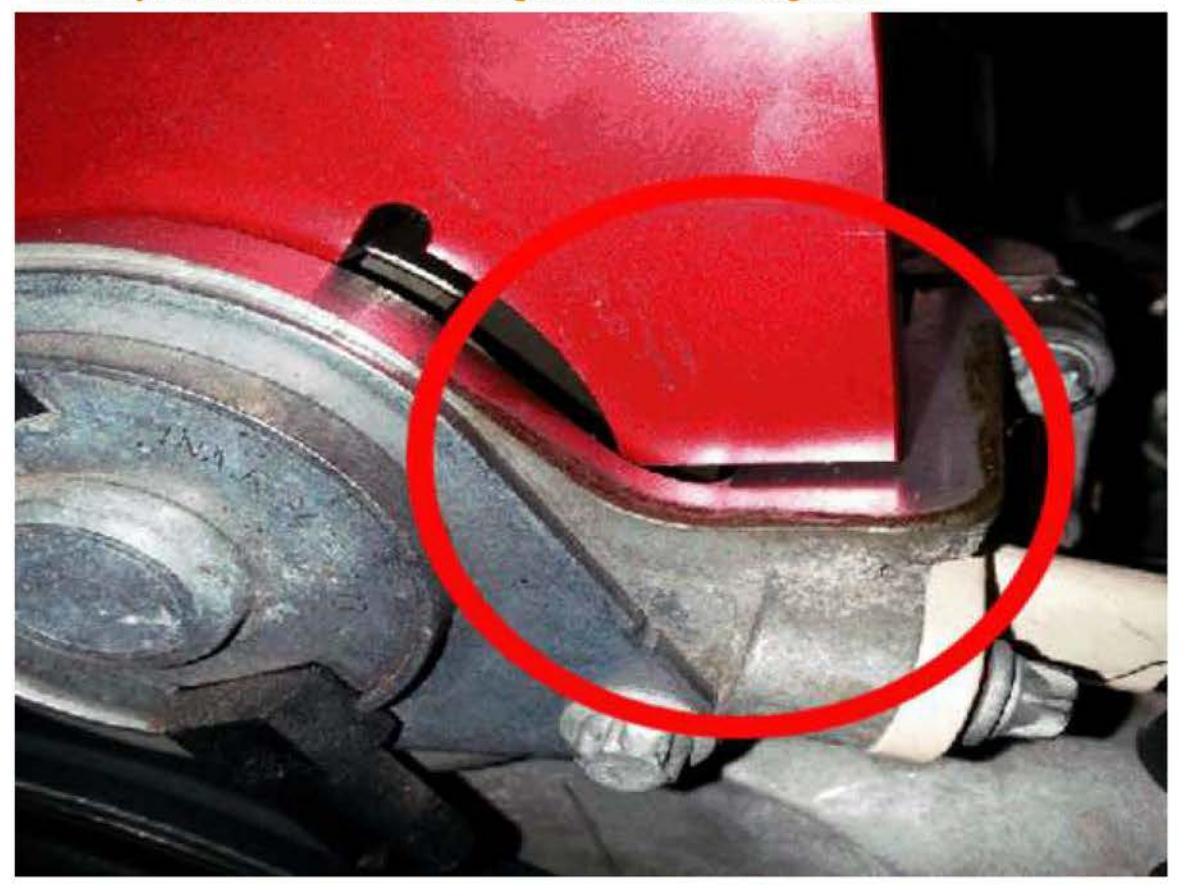
Some customers may comment on an intermittent crank/no start. After cycling the key, the vehicle will start. This may be caused after having the camshaft sprockets being removed for any type of engine service performed.

Front Cylinder Head with Tool Showing Exciter Wheel Misalignment

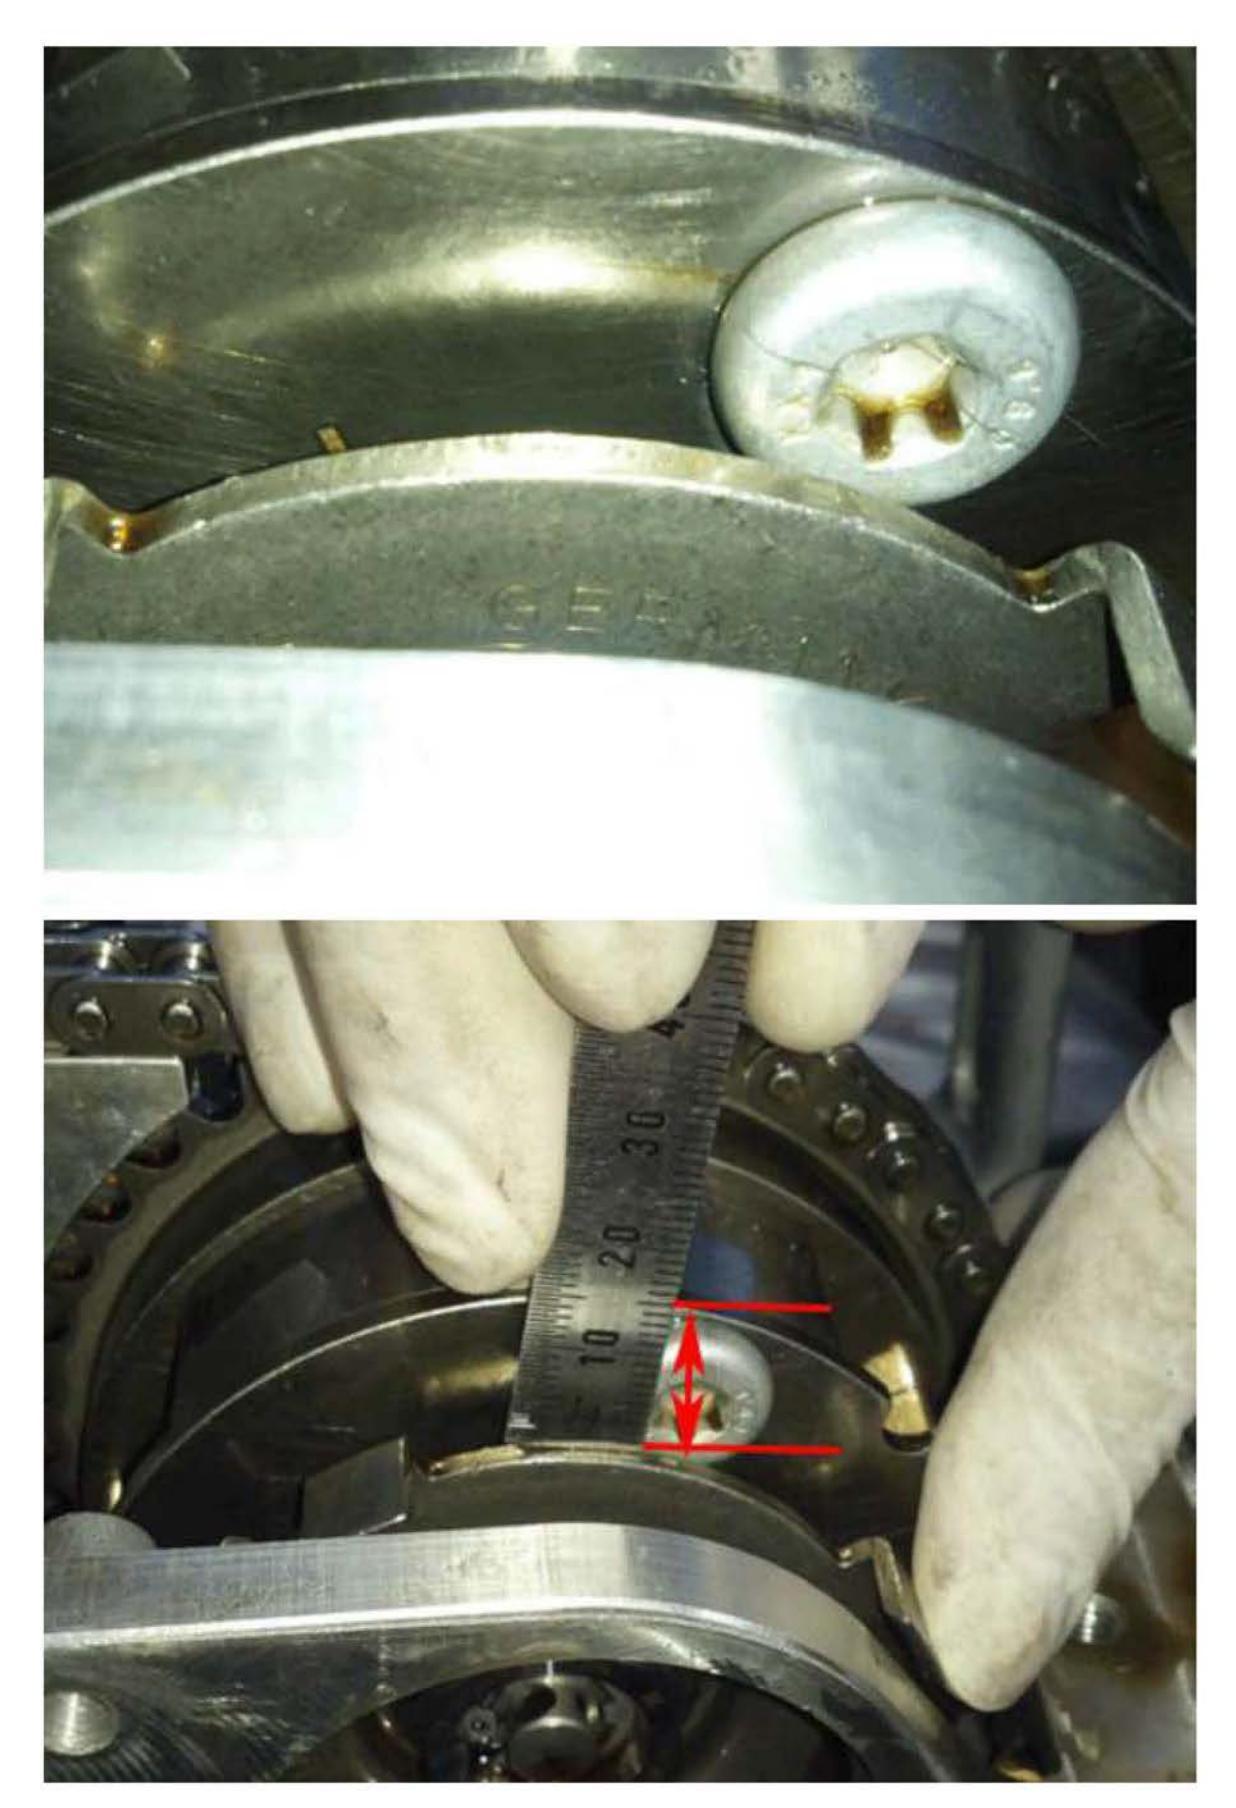
Exhaust Exciter Wheel Incorrect Alignment

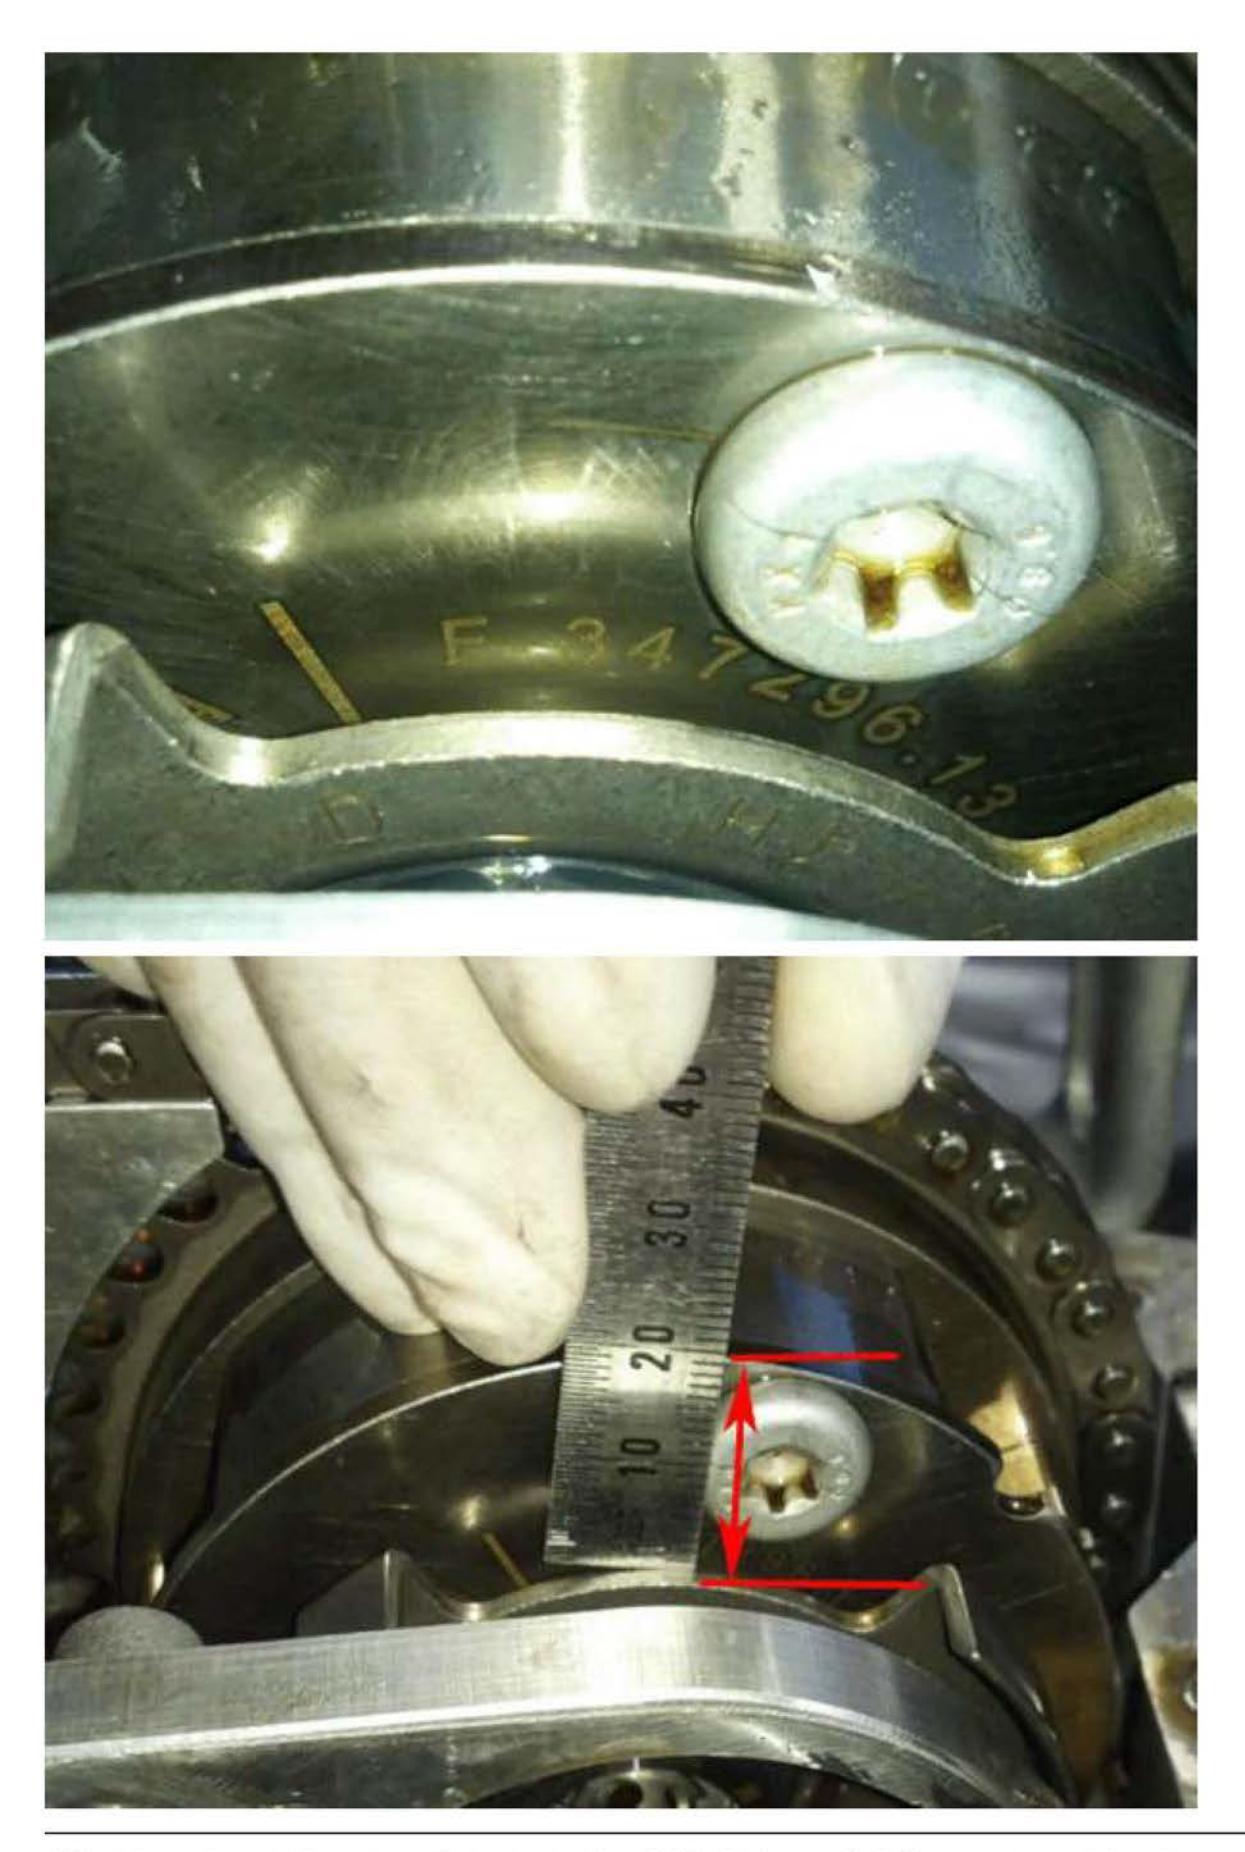
Exhaust Exciter Wheel Correct Alignment
