Service Bulletin

Subject: Steering Jerks Or Kicks Back / Reduced Power Steering Assist / Engine Stall / No Start / Service Stabilitrak / IPC / Radio / HVAC Goes Blank Various DTCs

Models: 2015-2017 Cadillac Escalade Models 2014 Chevrolet Silverado 1500 2015-2017 Chevrolet Silverado, Suburban, Tahoe 2014 GMC Sierra 1500 2015-2017 GMC Sierra, Yukon Models

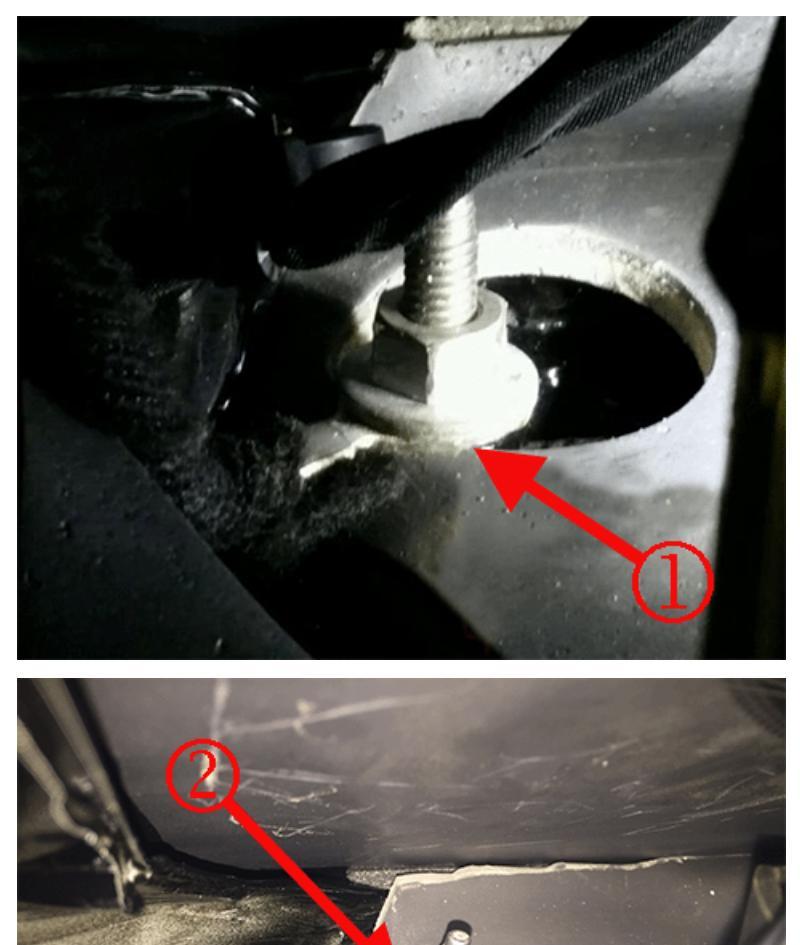
- 1. A poor BCM ground at G218.
- 2. A shorted B+ Battery cable (3) at the Starter Solenoid caused by:
 - A loose starter shield contacting the starter battery cable terminal ring
 - A starter cable ring terminal that has been mis-installed and/or rotated when installed on the starter solenoid
- 3. Battery cables with high resistance and/or loose connections at the:
 - Battery fuse block
 - Positive or negative battery cables
- 4. A discharged or faulty battery.
- 5. A loose connection at the main power and ground 2-way connector (X183 or X133 depending on model) for the power steering rack.

- 1. Inspect G218
 - Check for the nut being loose or cross threaded, repair and tighten as necessary.
 - Check for the front of dash insulator mat (2) being trapped between the ground eyelet and the body/stud as shown below (1). If the dash insulator mat is trapped, cut the mat away from the ground stud so it will no longer interfere. Reinstall the ground eyelet, the nut, and retighten.
