# **Service Bulletin**

# PRELIMINARY INFORMATION

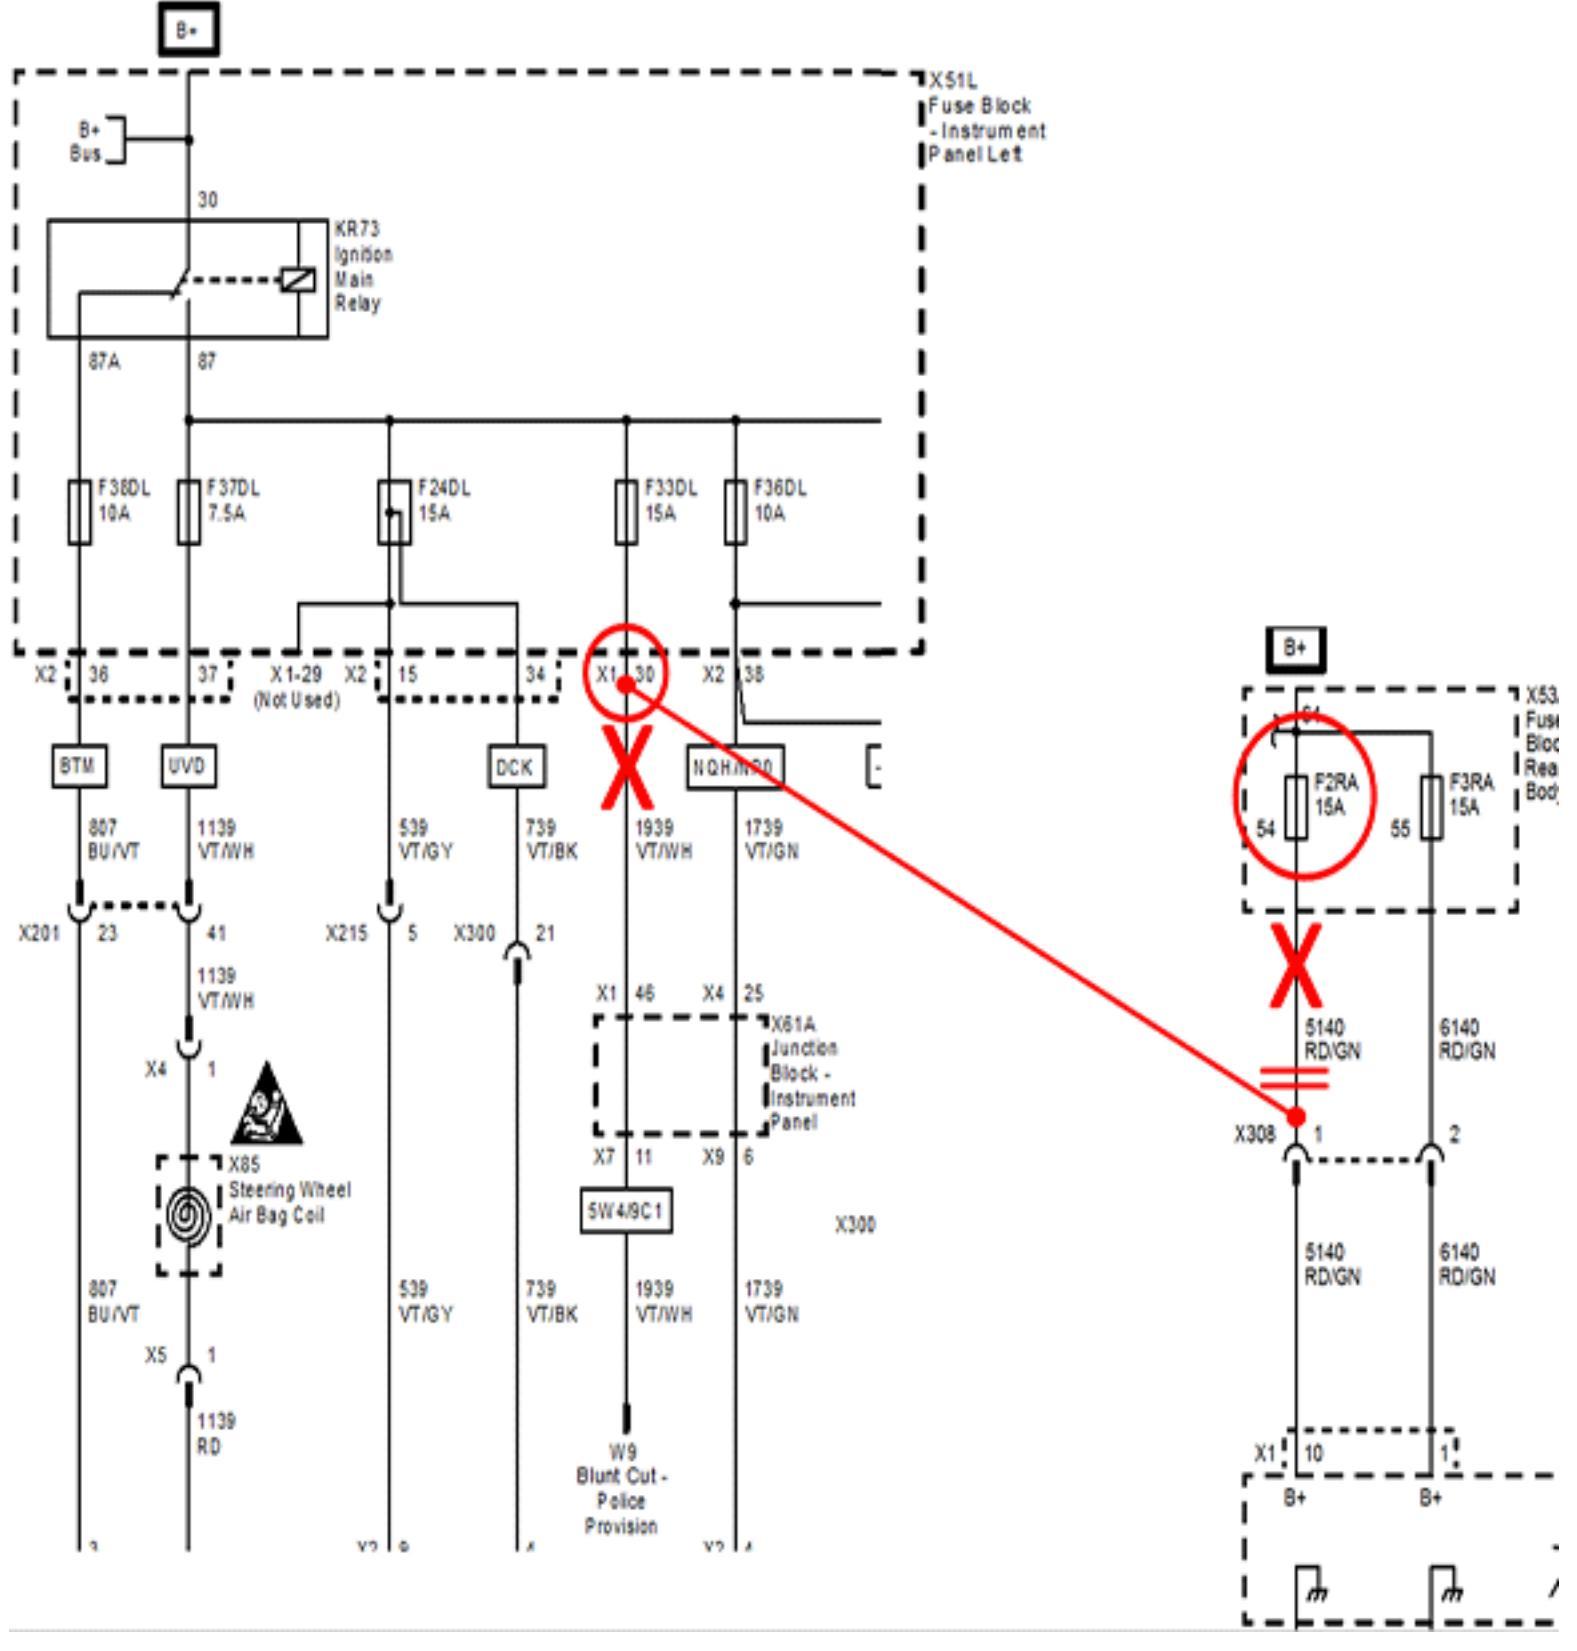
Involved Region or Country	North America and N.A. Export Regions
Additional RPO/s:	With Theft Protection Package (RPO UTT) and 2nd row heated seats (KA6).
Condition	Some customers may comment on a dead battery, only if the vehicle sits for an extended prior of time (more than 20 days).
Cause	This concern could be caused by the (K29R) Rear Heated Seat Control Module's power circuit 5140 being incorrectly wired to the hot-at-all-times F2RA fuse. This allows the Rear Heated Seat Control Module to wake up periodically, adding an extra parasitic load to the battery.

To correct this concern, rework the Rear Heated Seat Control Module power circuit 5140 from a hot-at-all-times fuse to a hot-in-run/crank fuse by following the instructions listed below.

Use the wiring diagram shown below to help understand the rework. When printing the wiring diagram, do not adjust the size in the browser window. First, select the magnifying glass to enlarge the schematic and then print a copy of it.
