# **Preliminary Information**

### PIC6163A Normal Characteristic - Fasteners Under The Hood Appear To Be Loose

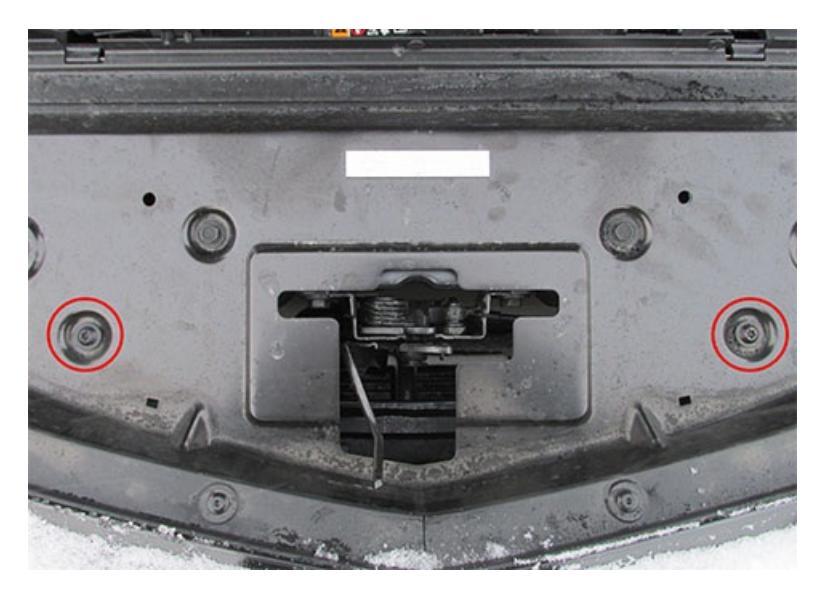
Some customers / technicians may comment that several fasteners, located on either side of the hood latch, appear to be loose. These two fasteners can be seen in the two photos below.

The first photo shows both fasteners as a point of reference in relation to the hood latch.

IMPORTANT: Do NOT tighten, or otherwise move these two fasteners.

These fasteners are part of the front fascia support bracket.

They have a preset gap by design, and they have Loctite applied to the threads of the fastener so that this preset gap does not change.

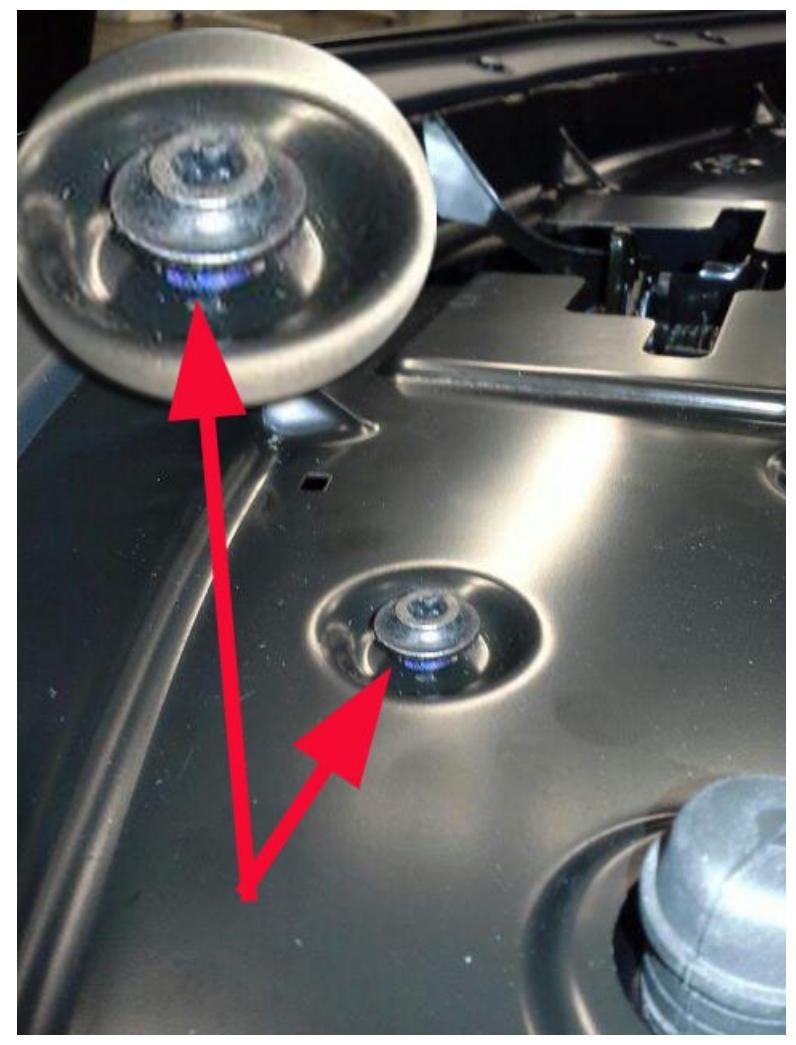
The second photo is a close-up of these fasteners to clearly show the gap that exists between the head of the fastener and the plastic trim panel underneath.
