**Countries:** CANADA, UNITED STATES **Document ID:** IK1201325  
**Availability:** ISIS, Bus ISIS, NotSIR **Revision:** 36  
**Major System:** ENGINES **Created:** 3/4/2016  
**Current Language:** English **Last Modified:** 4/28/2017  
**Other Languages:** NONE **Author:** Mark Ehlers  
**Viewed:** 14328

**Title:** CPA BEAM RCT+, CCP and BBT tips (used with new CPA PressurePlus tool)

**Applies To:** MaxxForce 7, DT, 9, 10, 13, N9, N10, N13

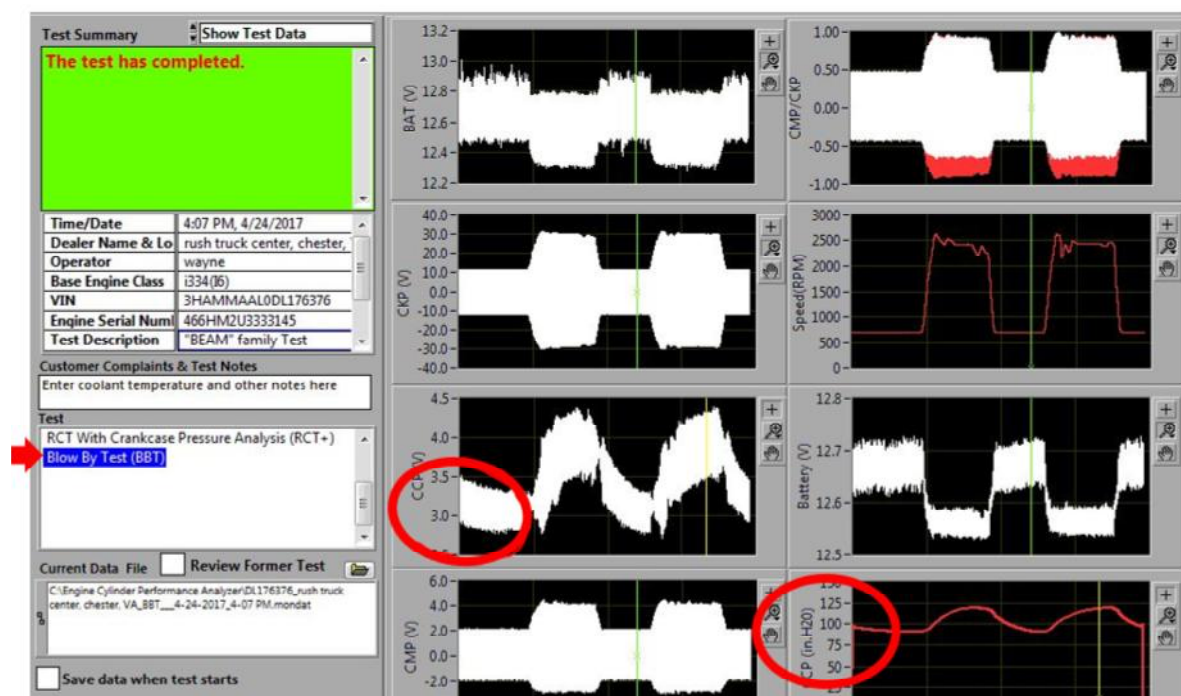
- The fan must be OFF in order to achieve accurate results
  - A common mistake made is leaving the PressurePlus Module connected to the oil fill adaptor when performing BBT. For BBT the PressurePlus Module hose connects the the orifice tool (on crankcase breather outlet).

- BBT signals may look like the example below if connected incorrectly

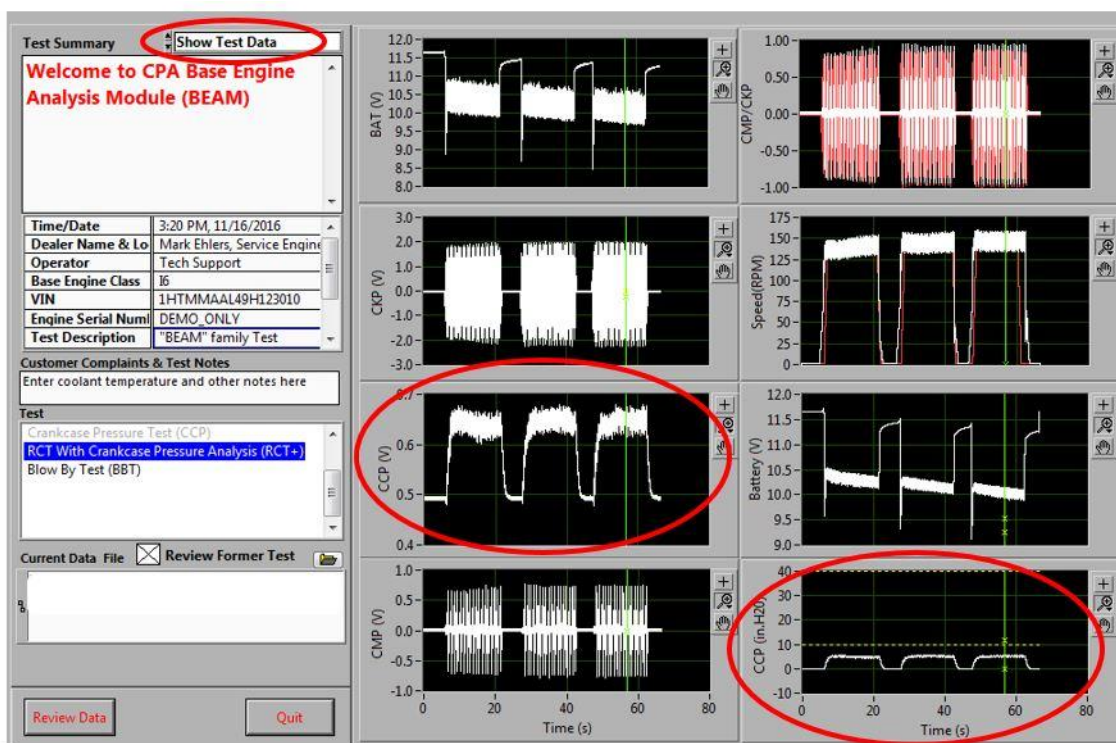
- When CPA requests the Navistar Engine Diagnostics™ test, hold the throttle wide open (WOT) for 5 seconds (fan OFF)
  - Idle for 4 seconds
  - WOT for 5 seconds (fan OFF)
  - Press "Stop Test"
  - CPA will process the test and create the Results Graph
- Crankcase Leak Detected Message
    - This message can be caused by several factors. Click [HERE](#) for more explanations.
    - If after performing RCT+ the "Crankcase Leak Detected" message appears the "Test Data" screen may look like the screen below

- Confirm that the crankcase breather outlet is properly plugged
- Confirm that the oil dipstick is seated and sealing (MF7 and 13L only)
- Confirm that the O-ring on the RCT+ oil fill cap adapter is not damaged (see image below)
- Verify all connections are correct
- Retest

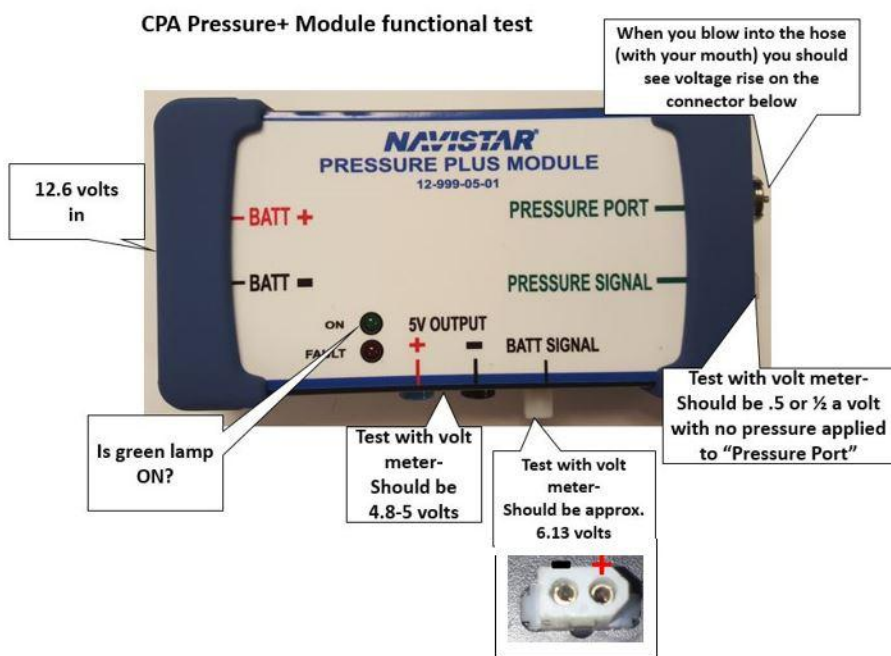
- Pressure signal errors can occur at times. Click [HERE](#) for some examples
- CPA Pressure+ Module failures are rare but have occurred. Use the info below to see if the Pressure+ Module has a problem.
