Title: CPA BEAM RCT+, CCP and BBT tips (used with new CPA PressurePlus tool)

Applies To: MaxxFORCE 7, DT, 9, 10, 13, N9, N10, N13

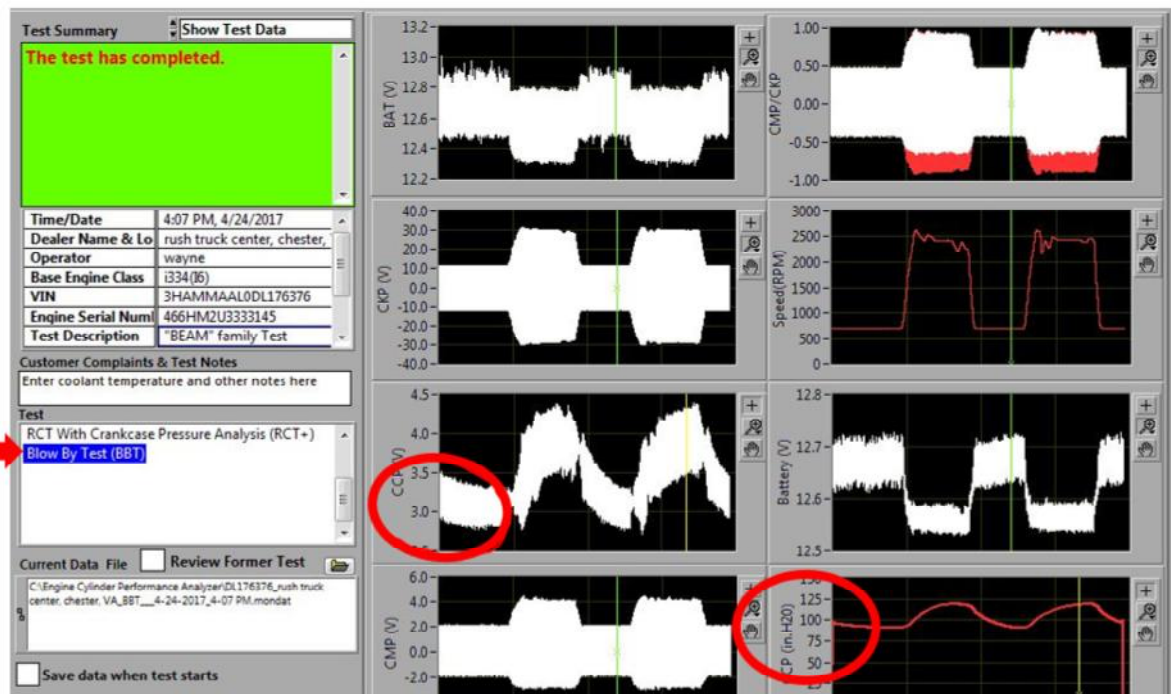
- Swapping channels 3 and 4 is also a common mistake
    - BBT signals may look like the example below if connected incorrectly

- The fan must be OFF in order to achieve accurate results
  - A common mistake made is leaving the PressurePlus Module connected to the oil fill adaptor when performing BBT. For BBT the PressurePlus Module hose connects the the orifice tool (on crankcase breather outlet)

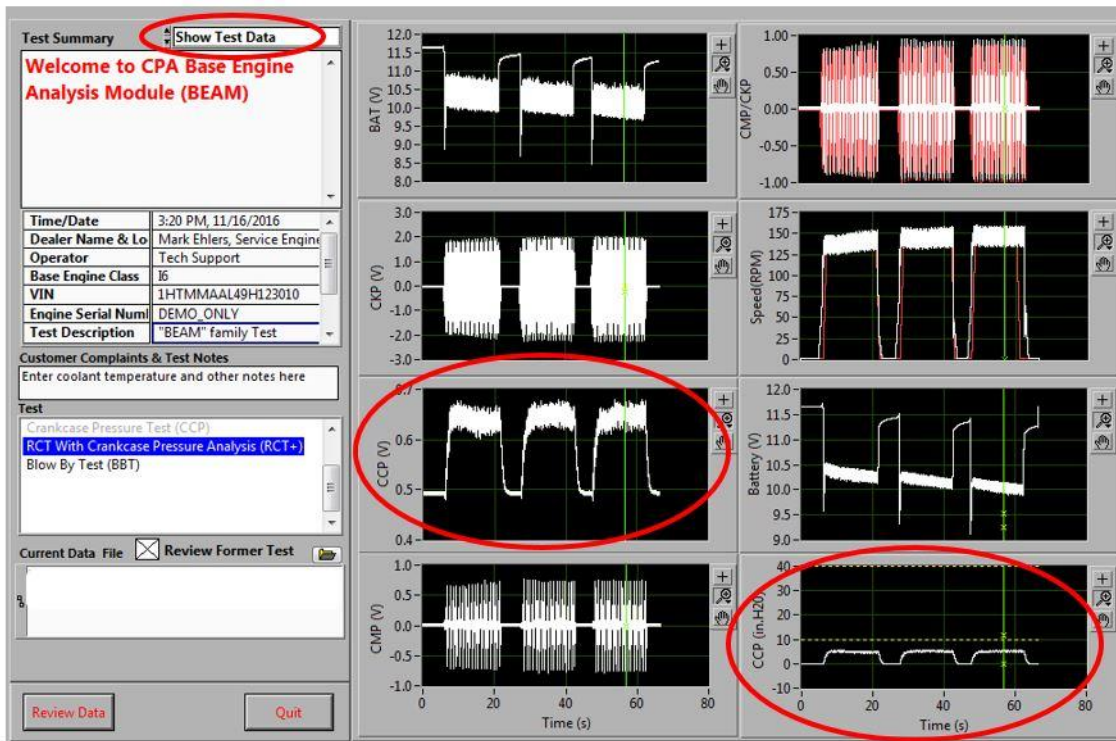
- When CPA requests the Navistar Engine Diagnostics™ test, hold the throttle wide open (WOT) for 5 seconds (fan OFF)
  - Idle for 4 seconds
  - WOT for 5 seconds (fan OFF)
  - Press "Stop Test"
  - CPA will process the test and create the Results Graph
- Crankcase Leak Detected Message
    - This message can be caused by several factors. Click [HERE](#) for more explanations.
    - If after performing RCT+ the "Crankcase Leak Detected" message appears the "Test Data" screen may look like the screen below

- Confirm that the crankcase breather outlet is properly plugged
- Confirm that the oil dipstick is seated and sealing (MF7 and 13L only)
- Confirm that the O-ring on the RCT+ oil fill cap adapter is not damaged (see image below)
- Verify all connections are correct
- Retest

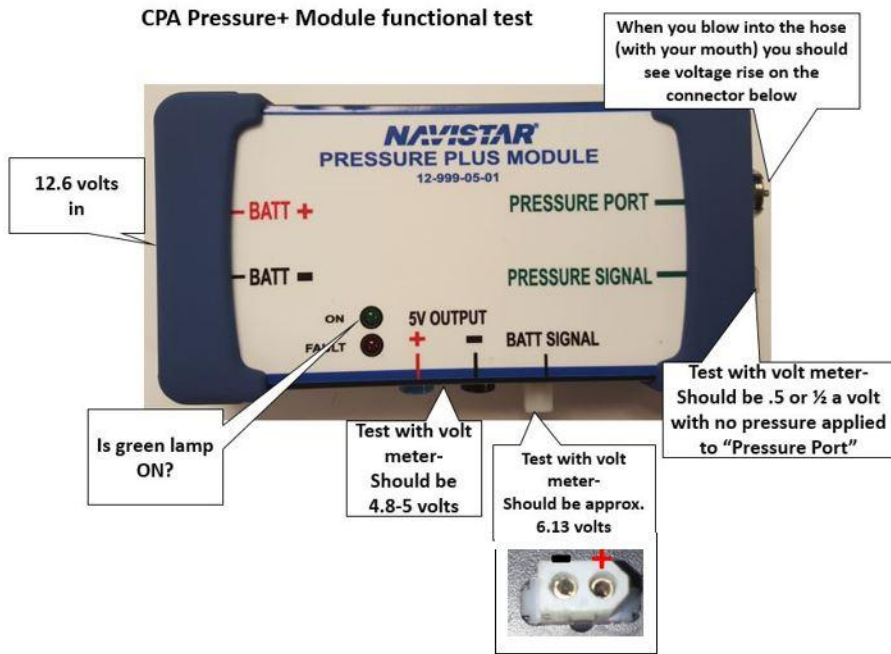
- Pressure signal errors can occur at times. Click [HERE](#) for some examples
- CPA Pressure+ Module failures are rare but have occurred. Use the info below to see if the Pressure+ Module has a problem.
