Maintenance Manual MM-1719

# **Anti-Lock Braking System (ABS) and Electronic Stability Control (ESC)**

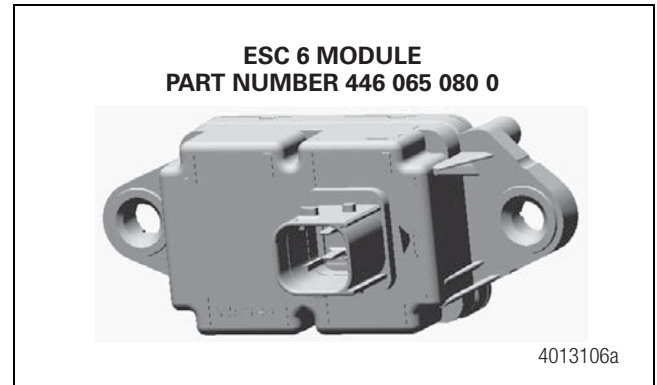
The ESC module is part of the mBSP™ ESC system. It measures the vehicle yaw rate as well as vehicle lateral acceleration. It exchanges data with the ECU via the ESC system internal data link. The ECU supplies the module with voltage and ground. The ESC module must be initialized by diagnostic tools whenever the ECU or the ESC module is replaced. Figure 1.8.

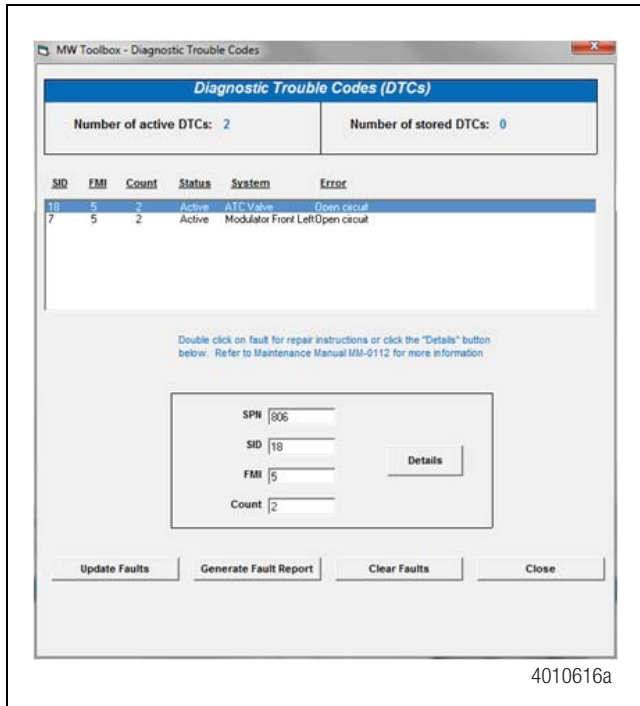
### 3 Diagnostics, Troubleshooting and Testing
