ATTENTION: This Technical Service Bulletin was issued by Southeast Toyota Distributors, LLC.

Category: Audio/Visual/Telematics Section: Navigation/Multi Info Display

SET Advent Navigation System Hard Reset Procedure

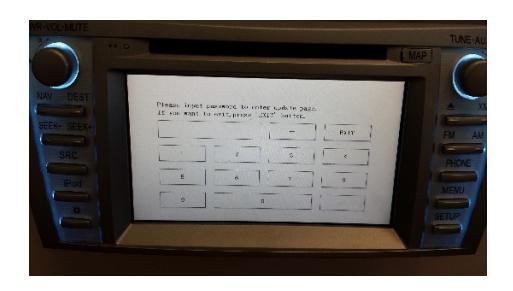
ERROR MESSAGE

- If you get an error message
 "@@@00000.FLY Not Found! Please try again" press the NO button, then press
 EXIT and confirm by selecting YES.
- The error message indicates new software is required. To request updated software SD card, Contact Southeast Toyota Accessory Hotline (888)851-2722, Press prompt 3 for Technical Assistance.
