SERVICE BULLETIN

EL15-002f

NTB15-009f

NAVIGATION SYMPTOMS WHEN SD CARD IS MISSING OR WRONG CARD INSTALLED

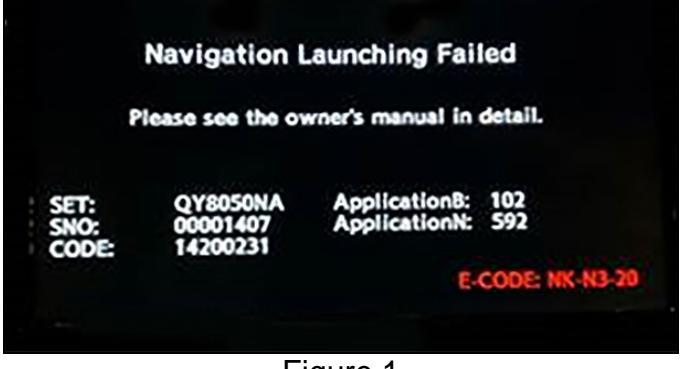
If the wrong SD Map Card has been inserted into the Navi/audio unit:

• A "Navigation Launching Failed" screen will be shown (Figure 1).

If the SD Map Card has been removed from a Navigation/audio unit and was:

- Mixed up with other SD Map Cards
 - Continue to insert individual SD Map Cards until one can be found that the error message in Figure 1 is not displayed.

Check the "Unit code" (page 3) and then look up the correct SD card part number with SD Card Numbers by Unit Code starting on page 5.
