Preliminary Information

PIP5348B Vibration At Idle In Gear Or Low Speeds

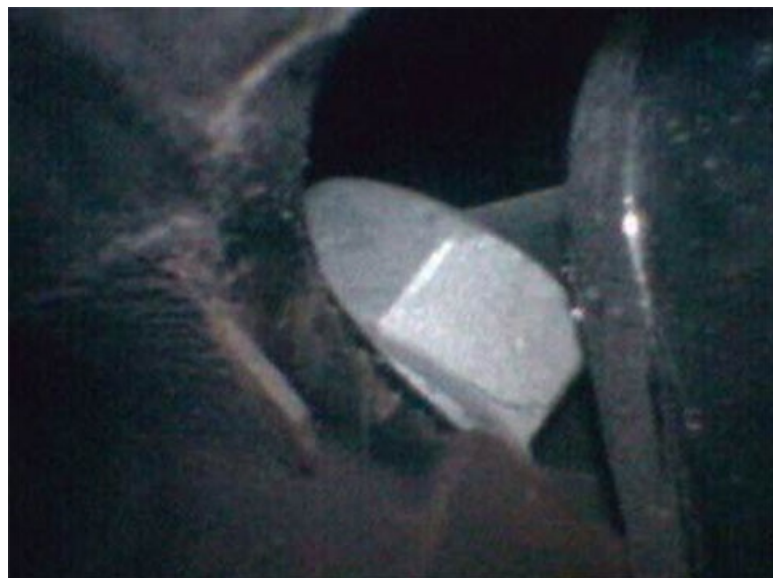
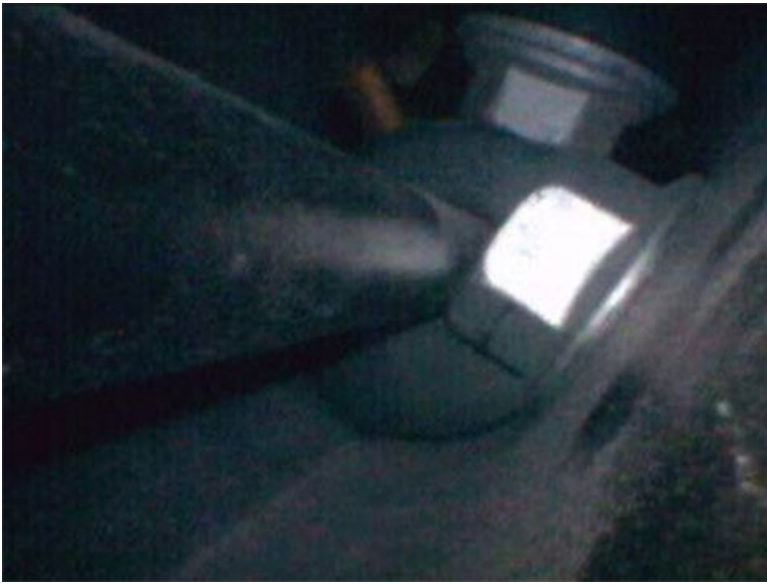
The technician should inspect for a stray nut or debris such as a rock wedged between the rubber and metal portions of the transmission mount.

This debris can be very difficult to find. The technician may have to use a borescope to locate it. See pictures below.

Loosen the transmission mount fasteners and manipulate the mount to allow removal of the stray debris.

Torque all fasteners back to specification.
