NUMBER: 08-094-17

**GROUP:** 08 - Electrical

DATE: September 28, 2017

RG3 RG4 RJ3 RJ4 Radio Enhancements

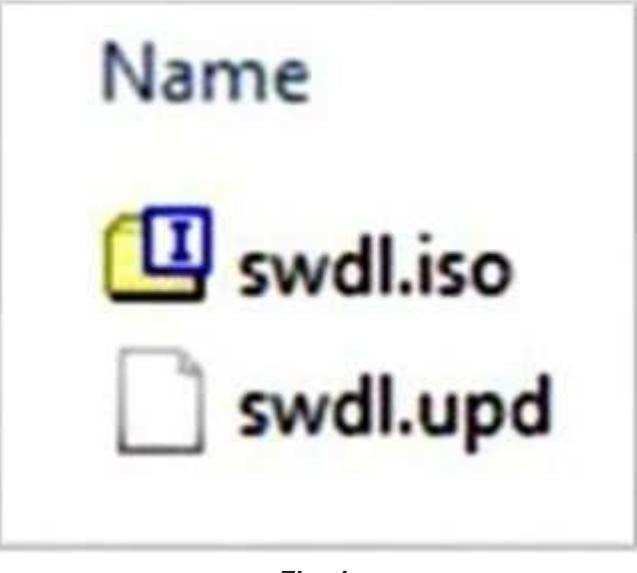
Fig. 1 Two USB Files

NOTE: \*\*Two files will be loaded onto the USB flash drive (Fig. 1).

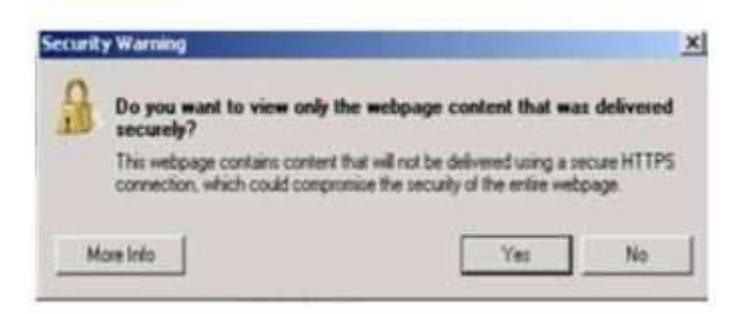
- 1. Has a USB flash drive been created?
  - a. YES >>> Proceed to Step 5.
  - b. NO >>> Proceed to Step 2.
- 2. Go to DealerCONNECT> Service> Uconnect Information & Utilities> Uconnect Dealer software downloads to download the files.
- 3. If a security message appears "Do you want to view only the web page content that was delivered securely? (Fig. 2) Press No to continue.

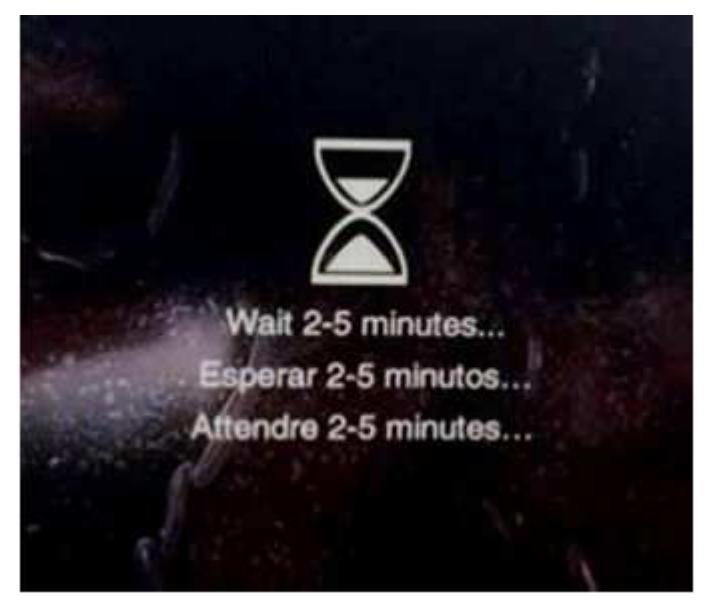
Fig. 3 Hourglass Screen

NOTE: During the update process you will see multiple hourglass and "Please Insert Update USB" screens for extended periods of time (several minutes)(Fig. 3) or (Fig. 4). DO NOT remove the USB flash drive at this time. Only remove the USB flash drive when the update has completed, when the screen displays the software levels again. The screen will say "Software updated successfully".

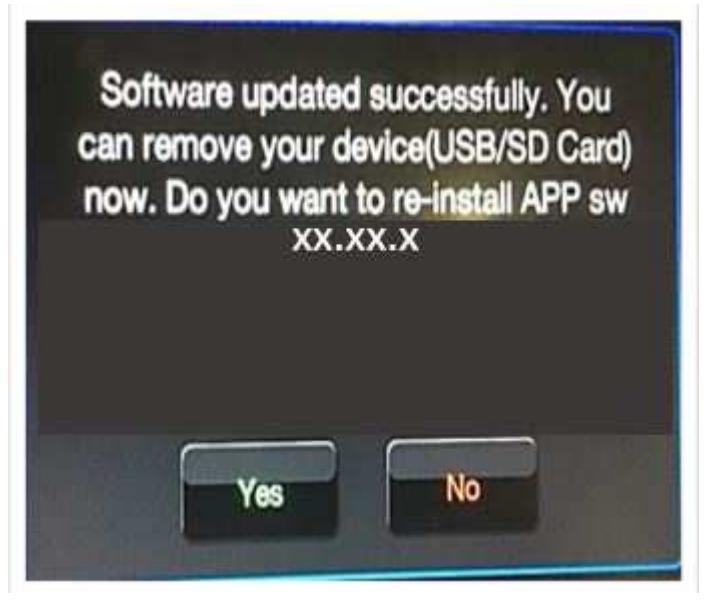
Fig. 5 Software Updated Successfully

12. After the update is done the screen will display the software levels again and will prompt to remove USB (Fig. 5).
