Technical Service Bulletin

WARNING LIGHT ILLUMINATION OR OTHER SYMPTOMS DUE TO DAMAGED OCCUPANCY SENSOR HARNESS Bulletin No.: 09-040/17

Last Issued: 10/12/2017

2016 CX-5 vehicles with VINs between JM3 KE ****** 600001-752233 (produced before December 09, 2015)

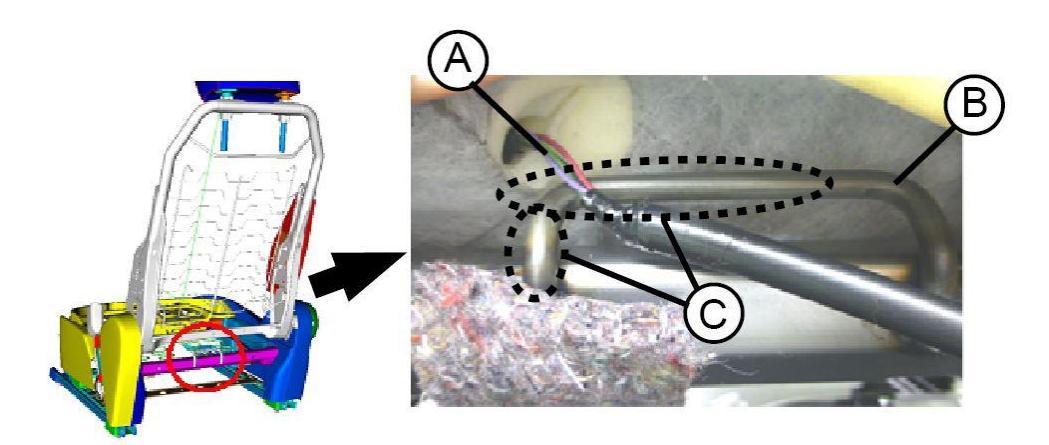
The front passenger seat harness (A) may be damaged by internal seat frame (B) weld spatter. Image below shows possible area of weld spatter (C).

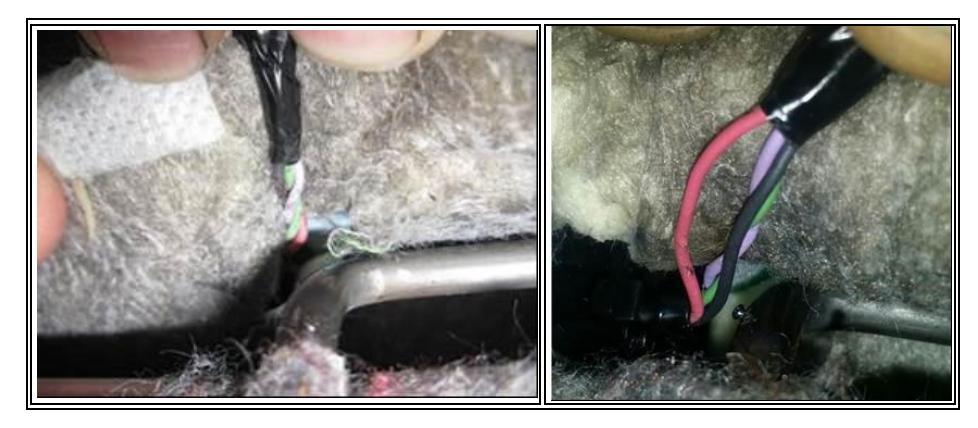
7. Check wire harness insulation for damage on all four (4) colored wires.

Examples of wire damage.

Wire image	Condition	Note
	Wire insulation is scratched and pin hole(s) is/are visible.	If no wire damage is found, this
		service bulletin does not apply. Go to normal Workshop Manual diagnosis.
	Lead wire strands are broken.
