Title: Telematic Installation Guidelines

Applies To: Units with 500K Data Link

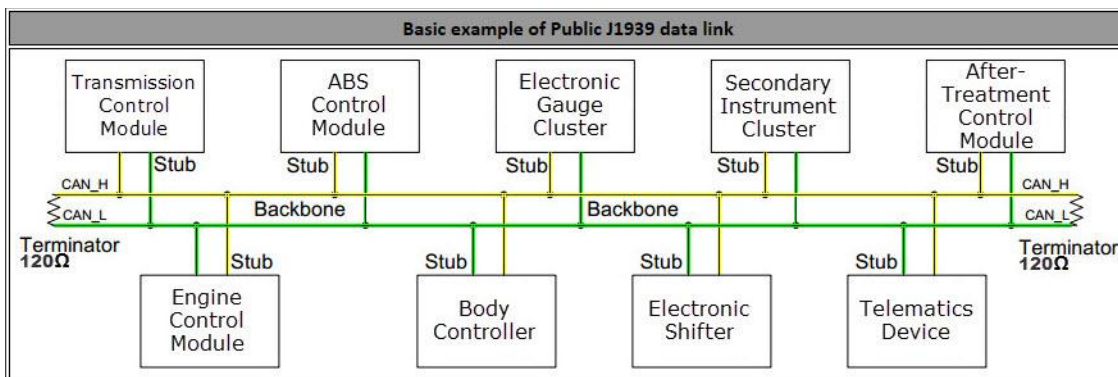
Data Link Connector Receptacle

1. It is recommended that telematic devices are installed on the 250K Data Link and not spliced into the 500K Data Link.
 - Splicing into the data link may result in erroneous fault codes and/or accessories to not operate properly.
2. If a connection to the 500K Data Link is required a Y-Cable should be used to make the connection.
3. Once telematic device has been installed be sure to verify proper operation of accessories and that no codes become active.
 - If accessories do not operate properly or codes become active contact the telematic manufacturer for assistance.
4. There can only be one telematic device attached the data link, if more then one device is connected it will cause the data link to crash.
