Service Bulletin

Date: July, 2017

Subject: Information On Fuel Odor and/or Fuel Leaks from Underhood SIDI Pipes Between High Pressure Pump and Fuel Rails

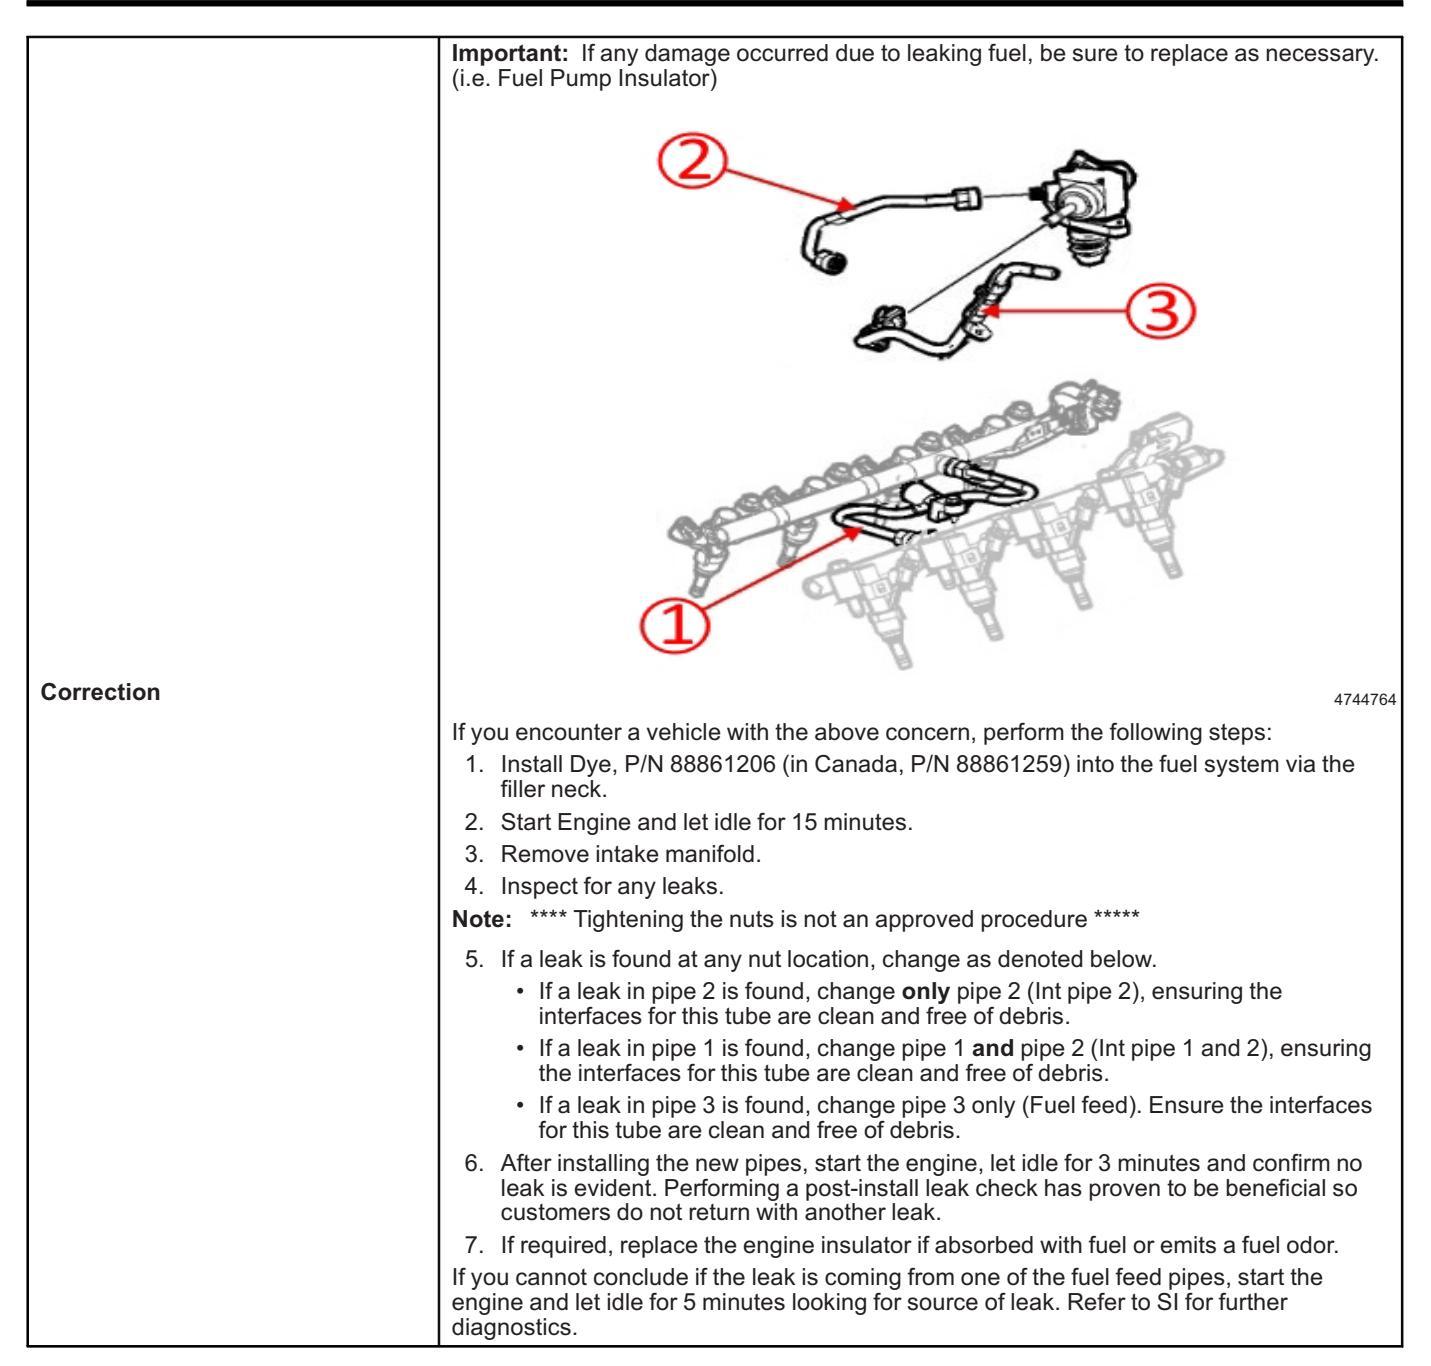
Involved Region or Country	North America and N. A. Export Regions			
Condition	Some customers may comment on one or more of the following conditions: Fuel odor smelled Fuel leak in front of vehicle Low/poor fuel economy Vehicle hard start or engine stumble Vehicle no start Wet foam insulator on engine The technician may find fuel leaking around the bellhousing or VLOM. Note: The conditions listed may occur with or without the Malfunction Indicator Lamp (MIL) illuminating.			
Important: It is required to replace the engine fuel feed intermediate pipes during any service repairs that required one or more of the pipes to be loosened or removed.				
Cause	This condition may be caused by the result of a fuel leak at one of the high pressure fur rail pipe connections that was installed incorrectly during service of another engine component, that required the fuel system to be opened. (i.e. fuel rail, lifter, head gaske High pressure pump, injector, etc.)

Refer to the Electronic Parts Catalog (EPC) to determine the proper part numbers required for the Fuel Feed Pipe and the Fuel Feed Intermediate Pipes, if replacement is required.

Refer to Fuel Feed Pipe Replacement in SI. Refer to Fuel Feed Intermediate Pipe Replacement -Position 1 in SI.

Refer to Fuel Feed Intermediate Pipe Replacement - Position 2 in SI.
