#### 43 Self-leveling does not work (DTC 02645)

43 17 25 2033587/3 April 20, 2017. Supersedes Technical Service Bulletin Group 43 number 16-24 dated September 19, 2016 for reasons listed below.

Model(s)	Year	VIN Range	Vehicle-Specific Equipment
Q7	2007	099729 - 999999	Self-leveling Suspension
Q7	2008 -2014	All	Self-leveling Suspension

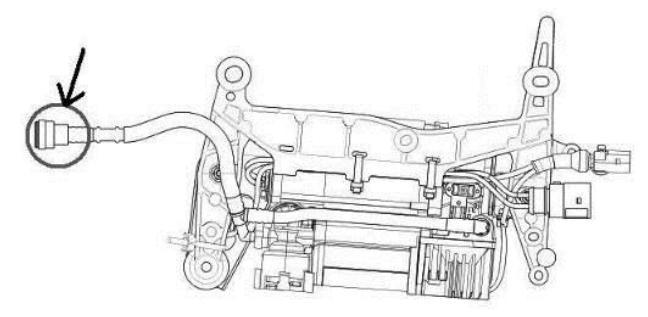
If the dryer on the air supply unit (air compressor) has taken in humidity for a long period of time, it may become saturated. As a result, the increased air humidity may get into the solenoid valve block and create condensation. In freezing temperatures, the condensation can freeze and block the valves, a condition that is recognized as a mechanical fault by the vehicle's self-diagnosis.

On vehicles of model year 2008 a leak on the socket box between the vacuum pipe of the compressor and the air hose to the air filter housing can draw in humidity (Figure 1).

Figure 1. Leak on the socket box.

- 1. Bleed the pressure reservoir and the suspension struts using guided functions.
- 2. Put the vehicle on a lift.
- 3. Remove the air supply unit.
- 4. Replace the dryer of the air supply unit using repair kit 4L0698010.
- 5. Remove the engine air filter element.
- 6. With the air supply unit disconnected from the vehicle, use compressed air to blow out the intake hose between the air filter housing and the air supply unit.

- 7. Re-install the air supply unit.
- 8. Using guided functions, completely fill, then bleed, the pressure reservoir, and the suspension struts. Repeat this process three times to blow out any remaining humidity.
- 9. Perform a test drive in order to check the function of the self-leveling suspension. During the test drive, adjust the self-leveling suspension several times.
