Document ID: IK0800080

Title: J1939 Data Link Troubleshooting

Applies To: All Models with 250k Baud Data Link (Black 9-Pin Diagnostic Connector); Overview information for 500k Baud Data Link

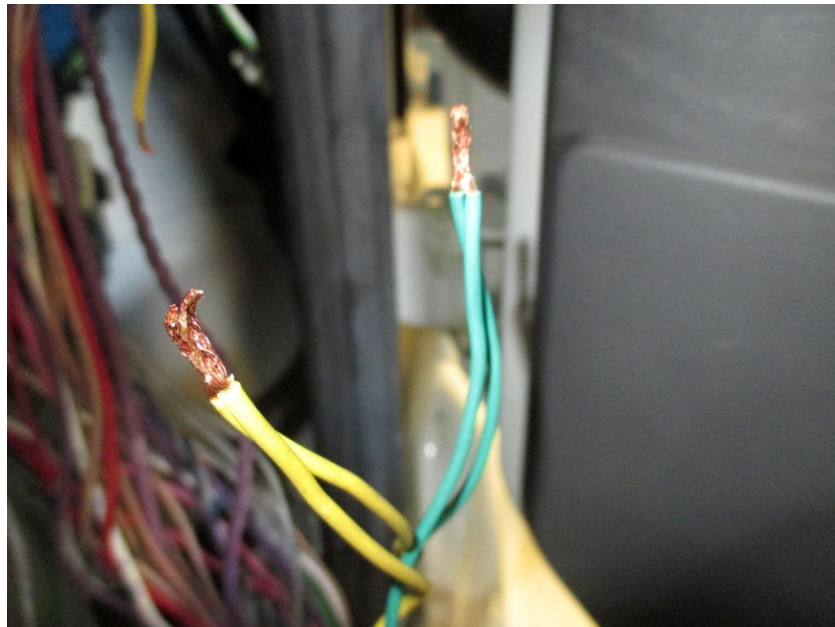
Wire condition at crimp to ABS module (2nd photo)
