**Countries:** CANADA, UNITED STATES, MEXICO **Document ID:** IK1300159  
**Availability:** ISIS, NotSIR **Revision:** 0  
**Major System:** TRANSMISSION **Created:** 9/28/2017  
**Current Language:** English **Last Modified:** 10/5/2017  
**Other Languages:** NONE **Author:** William Katschke  
**Viewed:** 143

**Title:** LT Fuller Advantage Series Transmission Power and Ground

**Applies To:** LT w/ A26 & X15

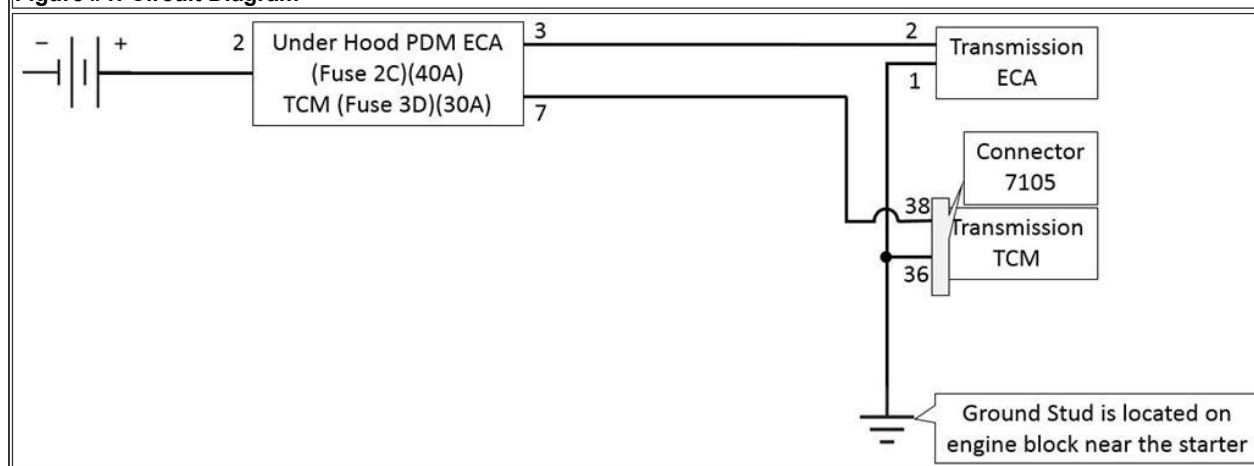
Figure #1: Circuit Diagram

1. While performing Eaton diagnostic steps be sure to inspect the power and ground connections at the Underhood PDM and the Ground Stud located by the engine starter.
2. Ensure the connections are clean (free of corrosion) and tight, Ground Stud Torque (43 N-m (31.7 ft-lb.)).

1. Clean and tighten any loose connections.
2. Clearly document in RO, with Road Ranger, and or Navistar tech service if loose connection was found.
3. Clear DTC's in all modules.
