QUALITY DRIVEN® SERVICE

SERVICE INFORMATION

APPLICABILITY: 2014-18MY Forester with Manual HVAC Systems NUMBER: 10-83-15R 2013-16MY Impreza 2.0L with Manual HVAC Systems DATE: 11/25/15 2013-17MY Crosstrek with Manual HVAC Systems REVISED: 09/06/17

SUBJECT: HVAC Control Panel Removal Precautions

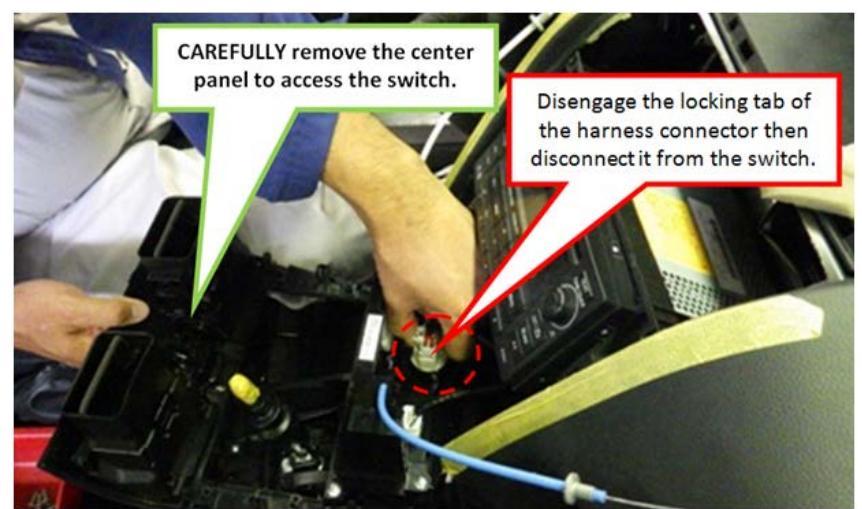
- **CAREFULLY** remove the center panel following the procedure in the applicable Service Manual. **ALWAYS** take proper precautions to protect the face of the panel and the surrounding trim surfaces from scratching / damage as shown in the photo below.
- **DO NOT** allow the blower fan switch harness to become stressed or taught.
- While maintaining slack on the blower switch wiring harness, disengage the lock tab by pressing it in gently and remove the connector from the switch.
- Set the center panel aside in a safe place to protect it while removed from the vehicle.
- Follow the same precautions when reconnecting the blower switch harness. Always avoid placing any stress or tension on the harness during the panel installation process.

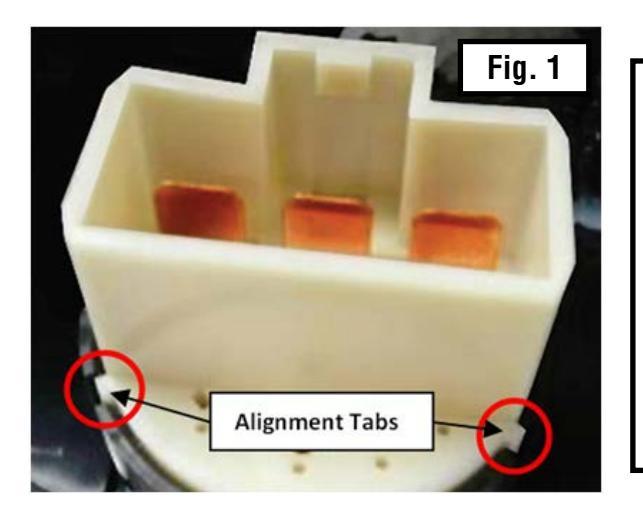
IMPORTANT: If any of the alignment tabs or the lower portion of the switch become disengaged from the body of the switch, the HVAC control panel assembly must be replaced. DO NOT attempt to snap it back together as damage to the internal contacts has most likely already occurred. The resulting high resistance inside the switch may cause it to be damaged and become inoperative.
